**Convertible Top Cover Snap Is Broken**  
(Supersedes 03-014, dated February 25, 2003)

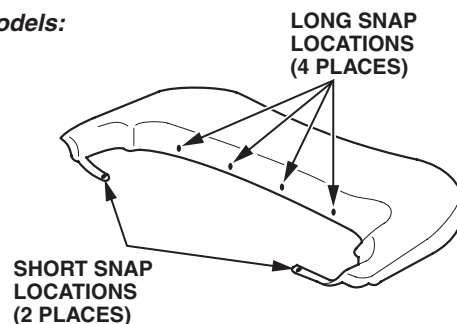
*'00-01 Models:*

1. Inspect the inside of each snap to determine which ones need replacing.
