**HONDA ServiceNews**

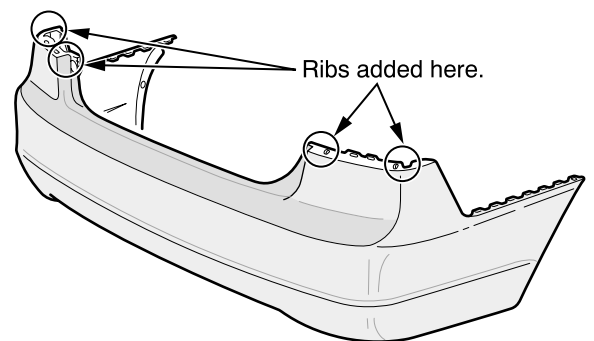
Some '01 Civic 2-door models may have paint peeling on the horizontal surface of the rear bumper under the taillights. S/B 01-076, *Rear Bumper Paint Is Peeling*, filed under Body, was recently issued to fix this problem. The repair adds foam blocks to the bottom lip of each taillight lens.

A factory countermeasure was recently applied that adds two ribs on the horizontal surface of the bumper under each taillight so the taillight doesn't hit the bumper. The countermeasured bumper shares the same part number as the original bumper, so there's a mix of non-countermeasured and countermeasured bumpers in Honda parts stock. However, if you happen to install the foam blocks on a vehicle with a countermeasured bumper, it's *not* a problem.

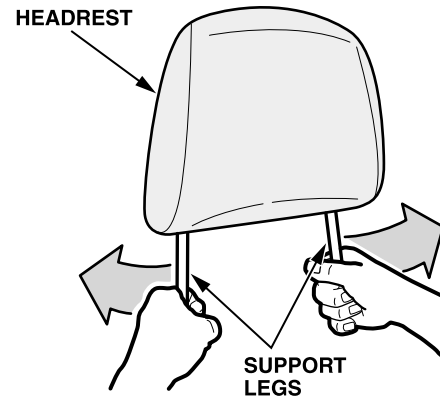
If your customer complains that the headrest rattles when driving on bumpy roads, the headrest support rails may need adjusting. Remove the headrest, and spread the support legs so they press outward against the headrest guide.

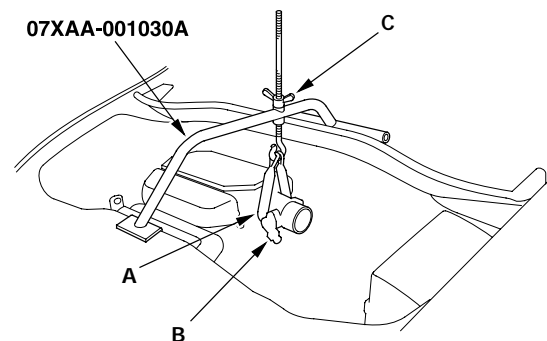
Step 28 on page 14-376 of the 1999-02 Odyssey Service Manual tells you to use an engine hanger (T/N 07XAA-001030A) to lift and support the engine during transmission removal. This hanger *doesn't* work on an '02 model. The '02 model has a higher intake manifold that requires a shorter cable eye/bolt assembly for the engine support hanger. Honda Special Tools recently shipped all dealers a cable eye/bolt assembly (T/N 07ZAA-S0XA100) for this purpose.

28. Lift and support the engine with ~~an engine hanger (T/N 07XAA-001030A, available through the American Honda Tool and Equipment Program).~~ Position the tool over the hood latch. Loop the cable (A) around the throttle body (B), and tighten the wing nut (C) on the tool by hand until the cable is tight.

NOTE: For '02 model, replace the cable eye/bolt assembly (A) on the engine support hanger with T/N 07ZAA-S0XA100.
