REPORT NUMBER: CAL-03-03

**NEW CAR ASSESSMENT PROGRAM (NCAP)  
FRONTAL BARRIER IMPACT TEST**

HONDA OF AMERICA MFG., INC.  
2003 HONDA S2000  
2-DOOR

FINAL REPORT

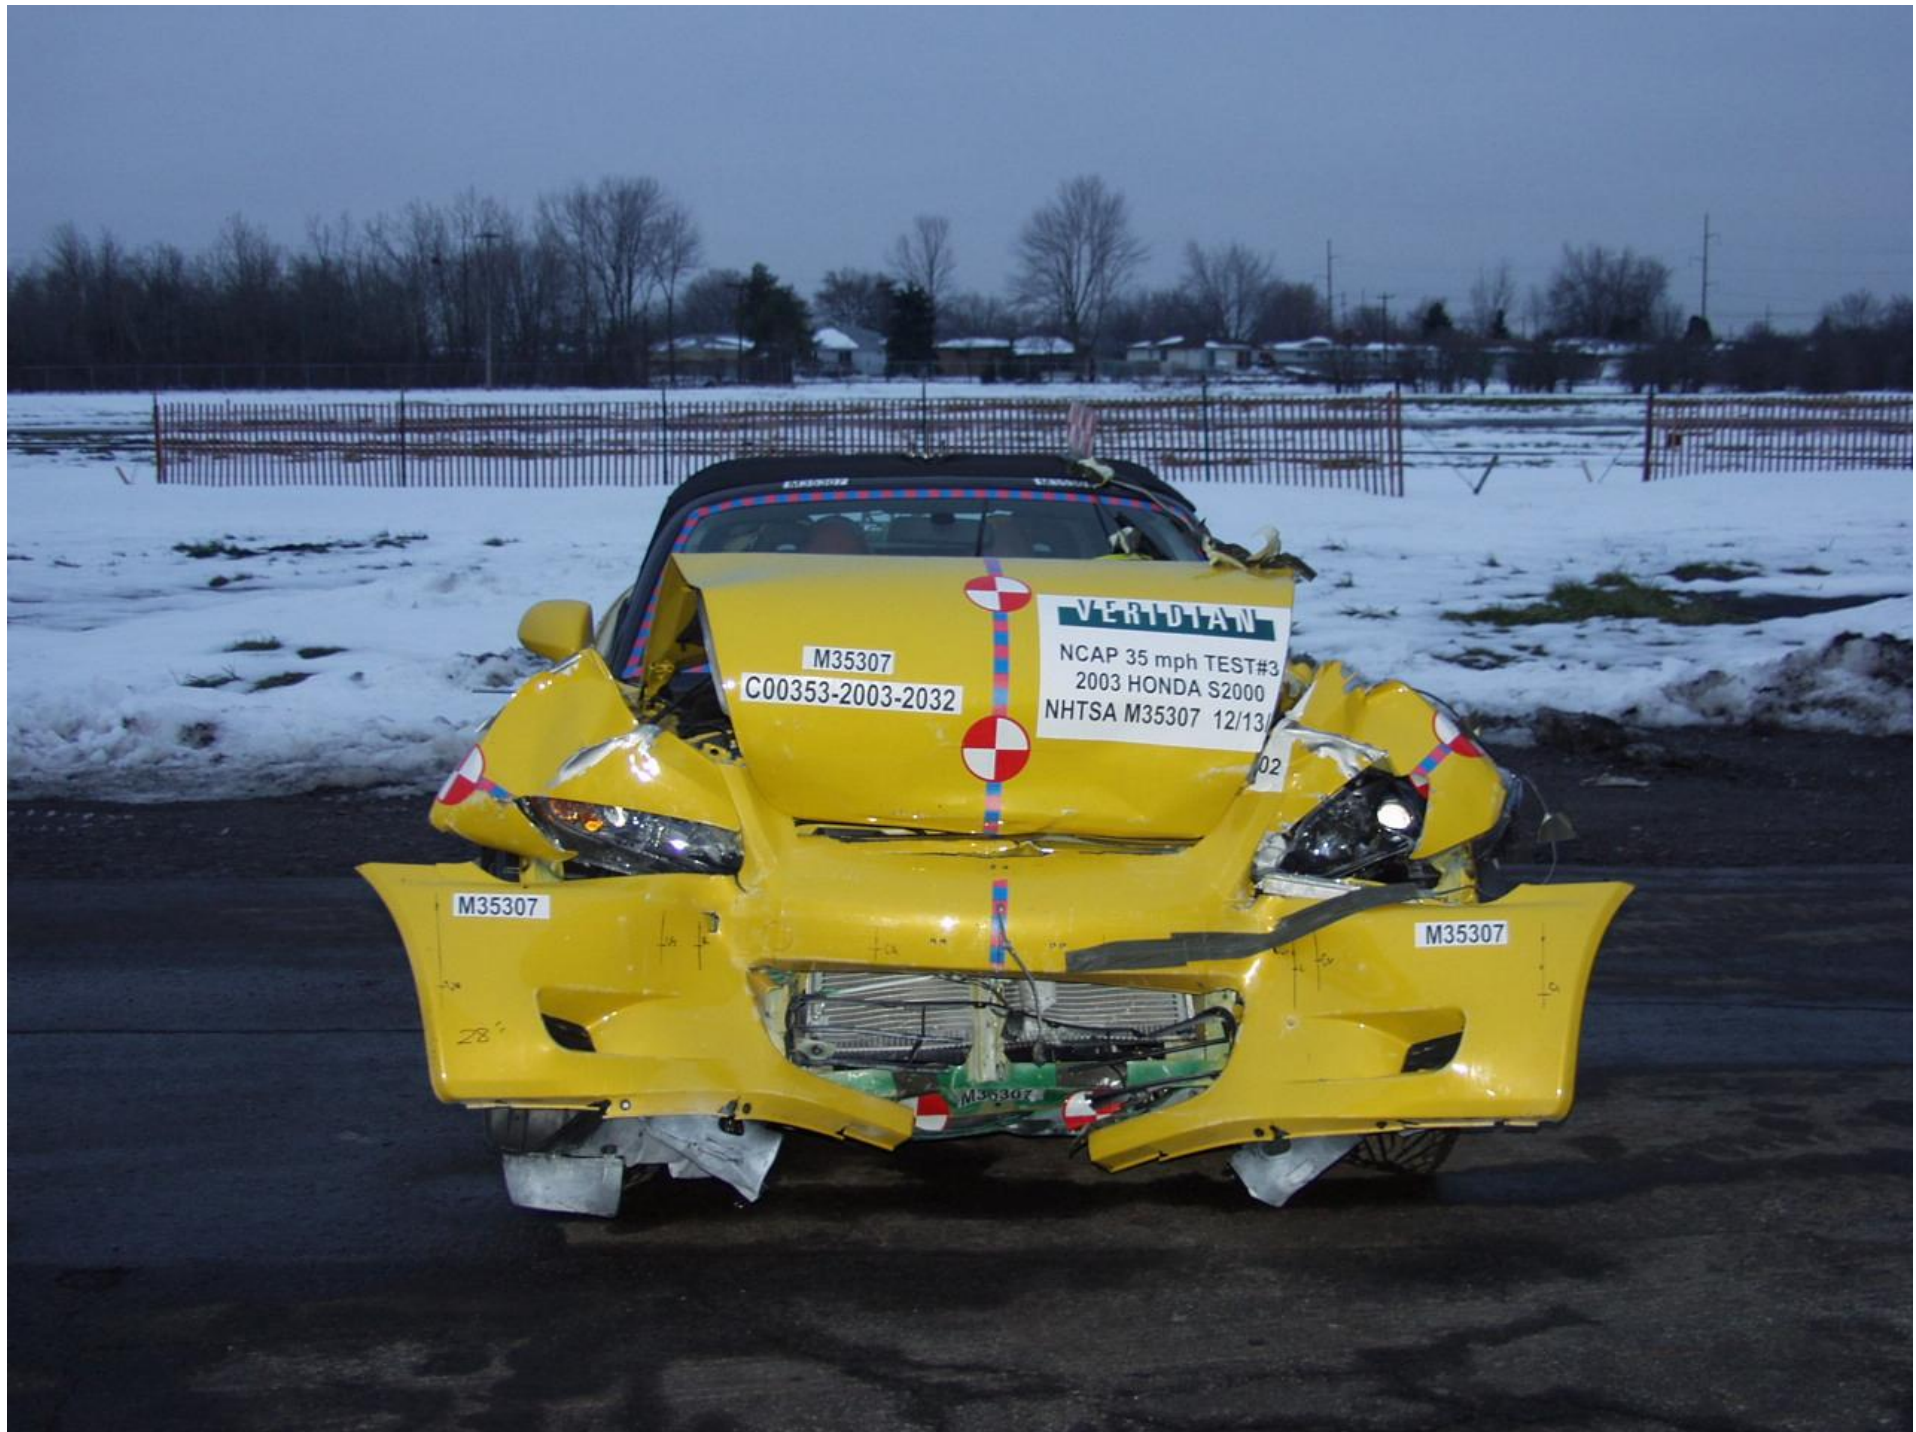
Figure A-7 POST-TEST FRONT VIEW

The maximum vehicle static crush was 545 mm and both the driver and passenger side doors remained closed during the impact event and were operable after the impact.

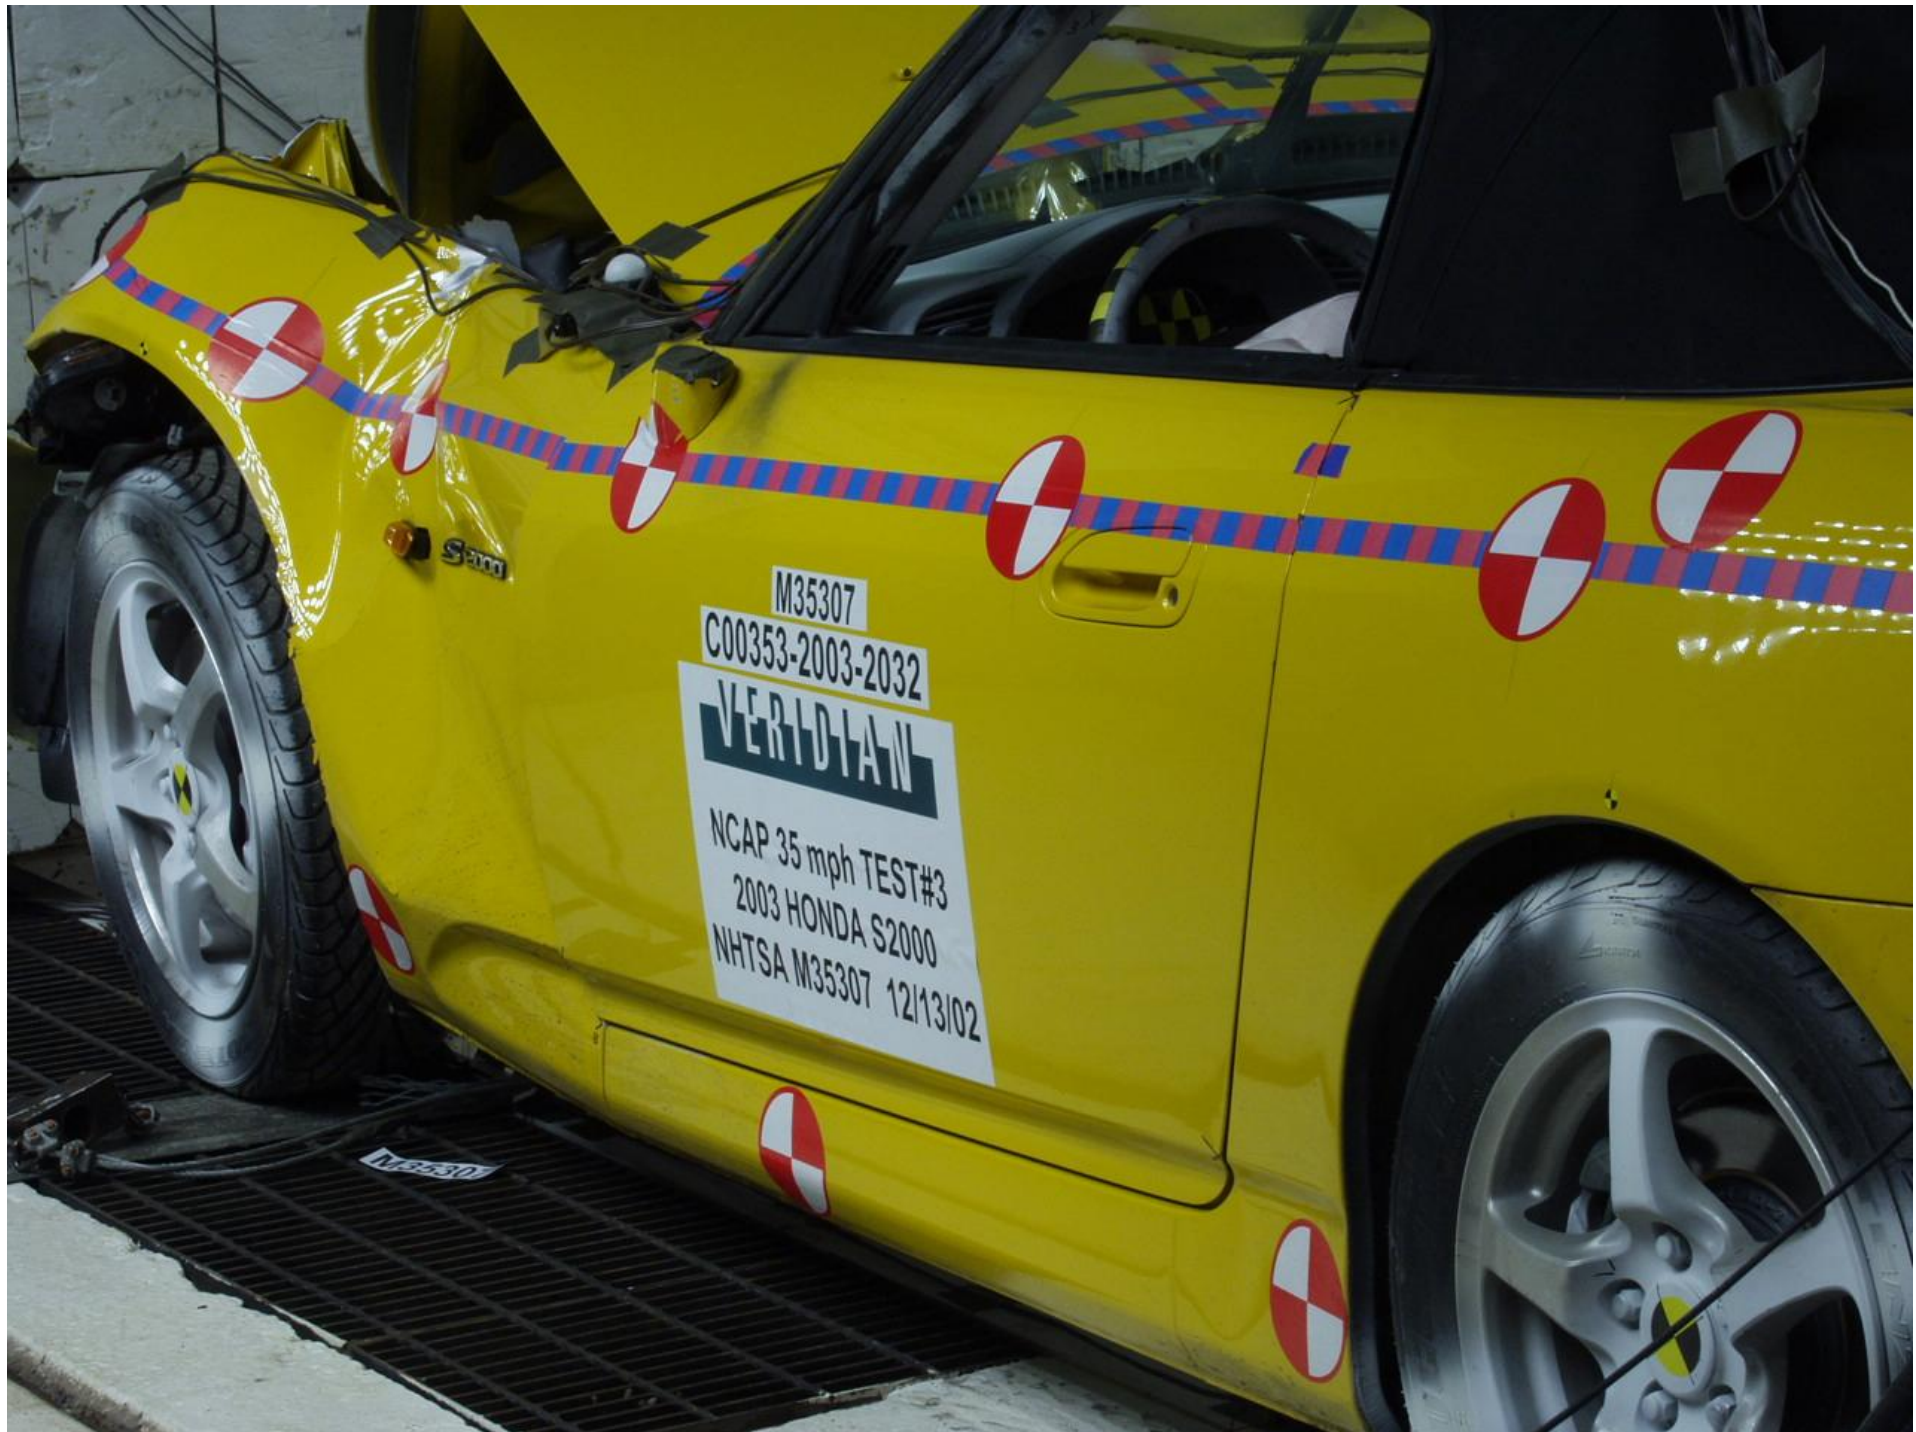
Figure A-16 LEFT REAR THREE-QUARTER VIEW OF DOORS AFTER IMPACT

DOOR OPENING DATA:           Closed, Latched, and Operable without Tools           - Left Front

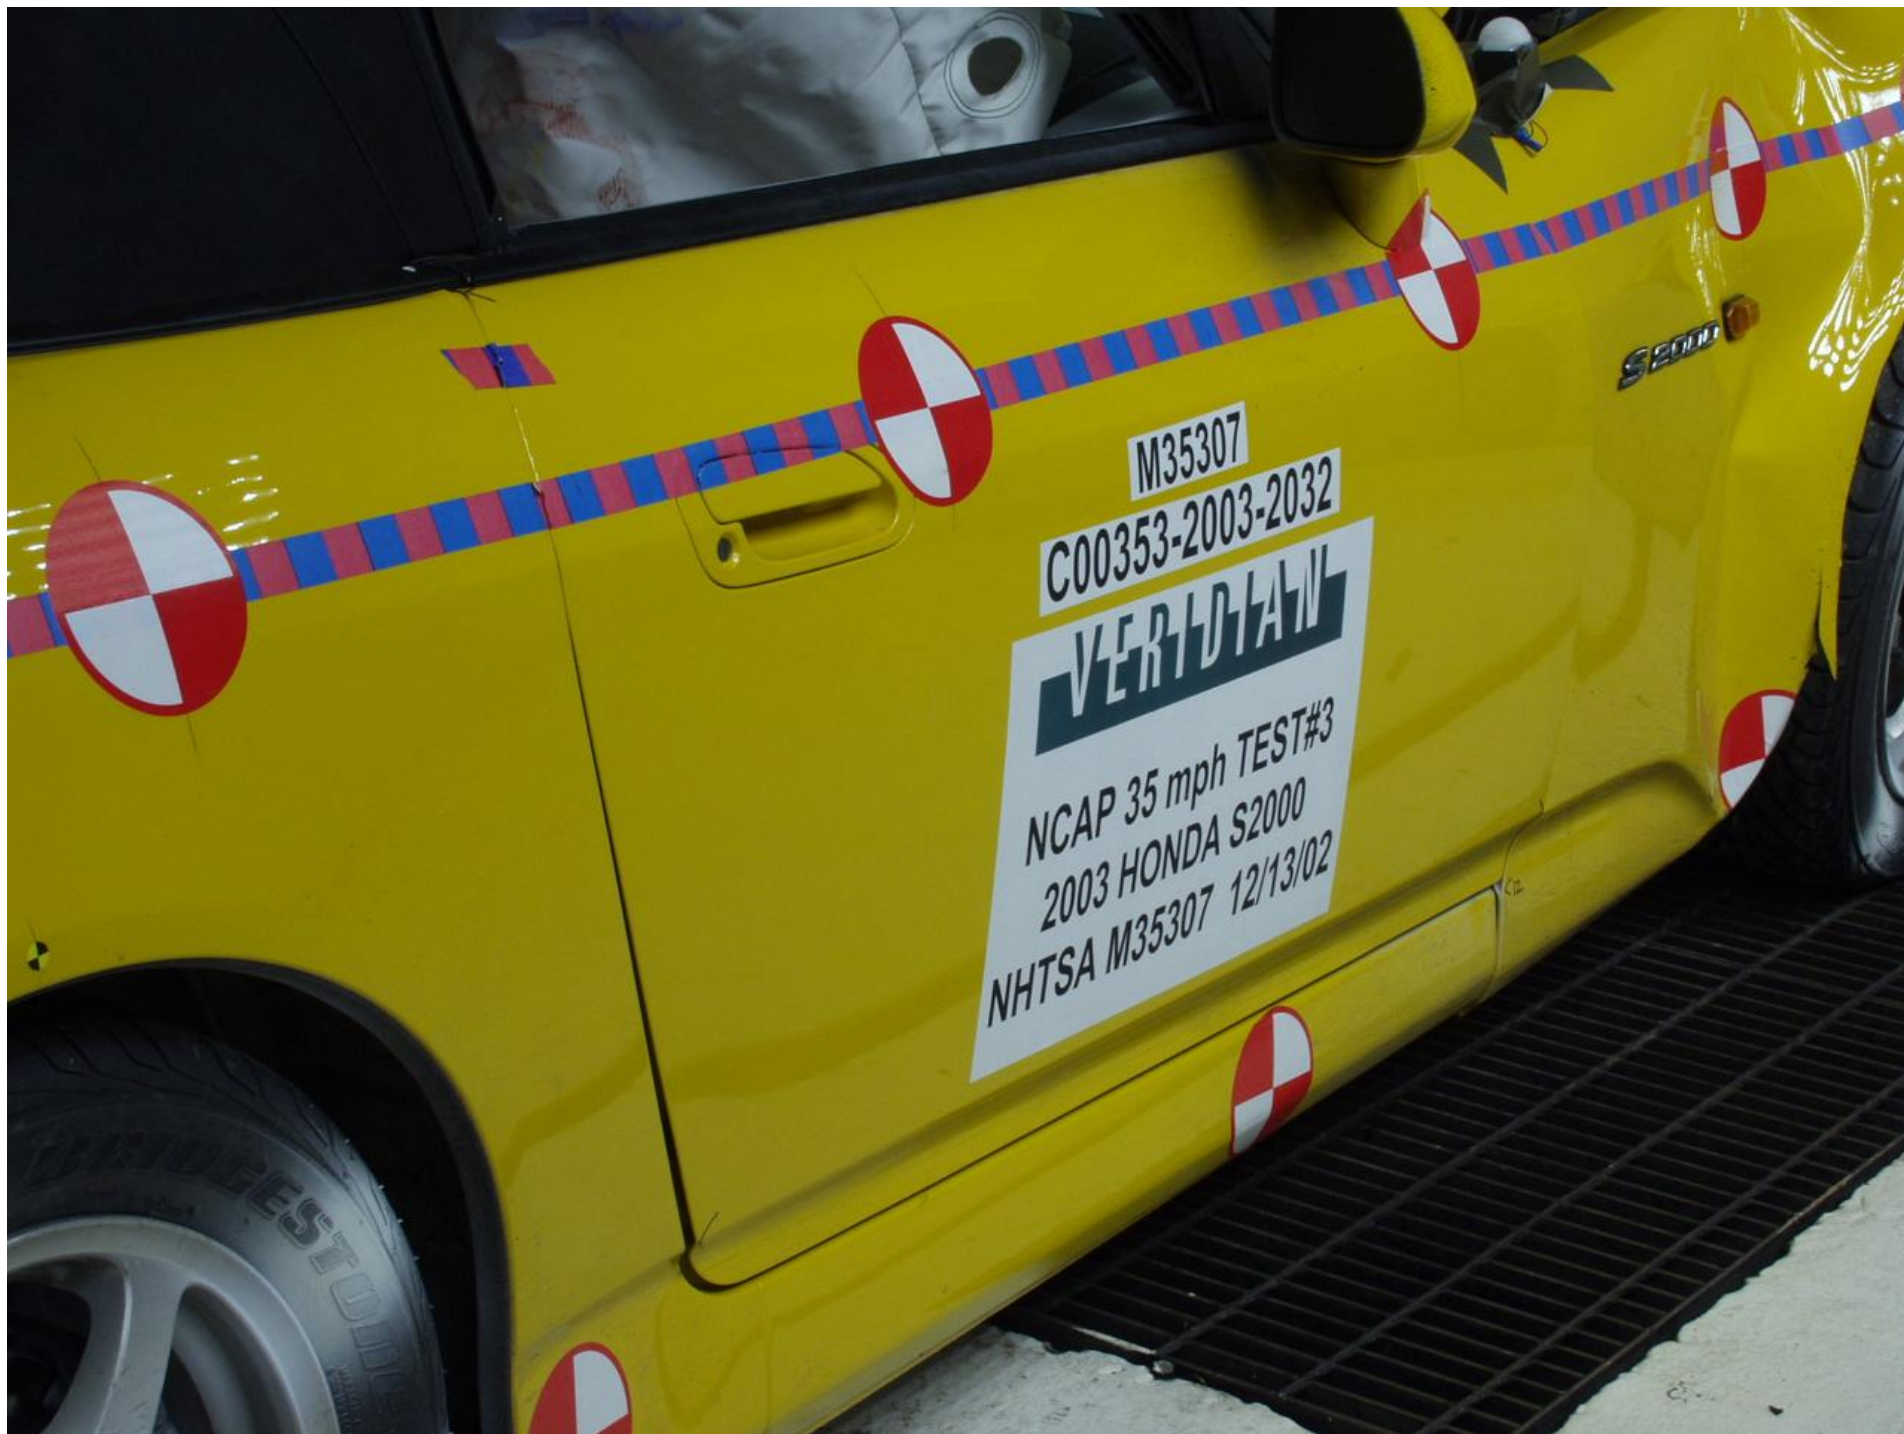
Figure A-17 RIGHT REAR THREE-QUARTER VIEW OF DOORS AFTER IMPACT

Closed, Latched, and Operable without Tools           - Right Front

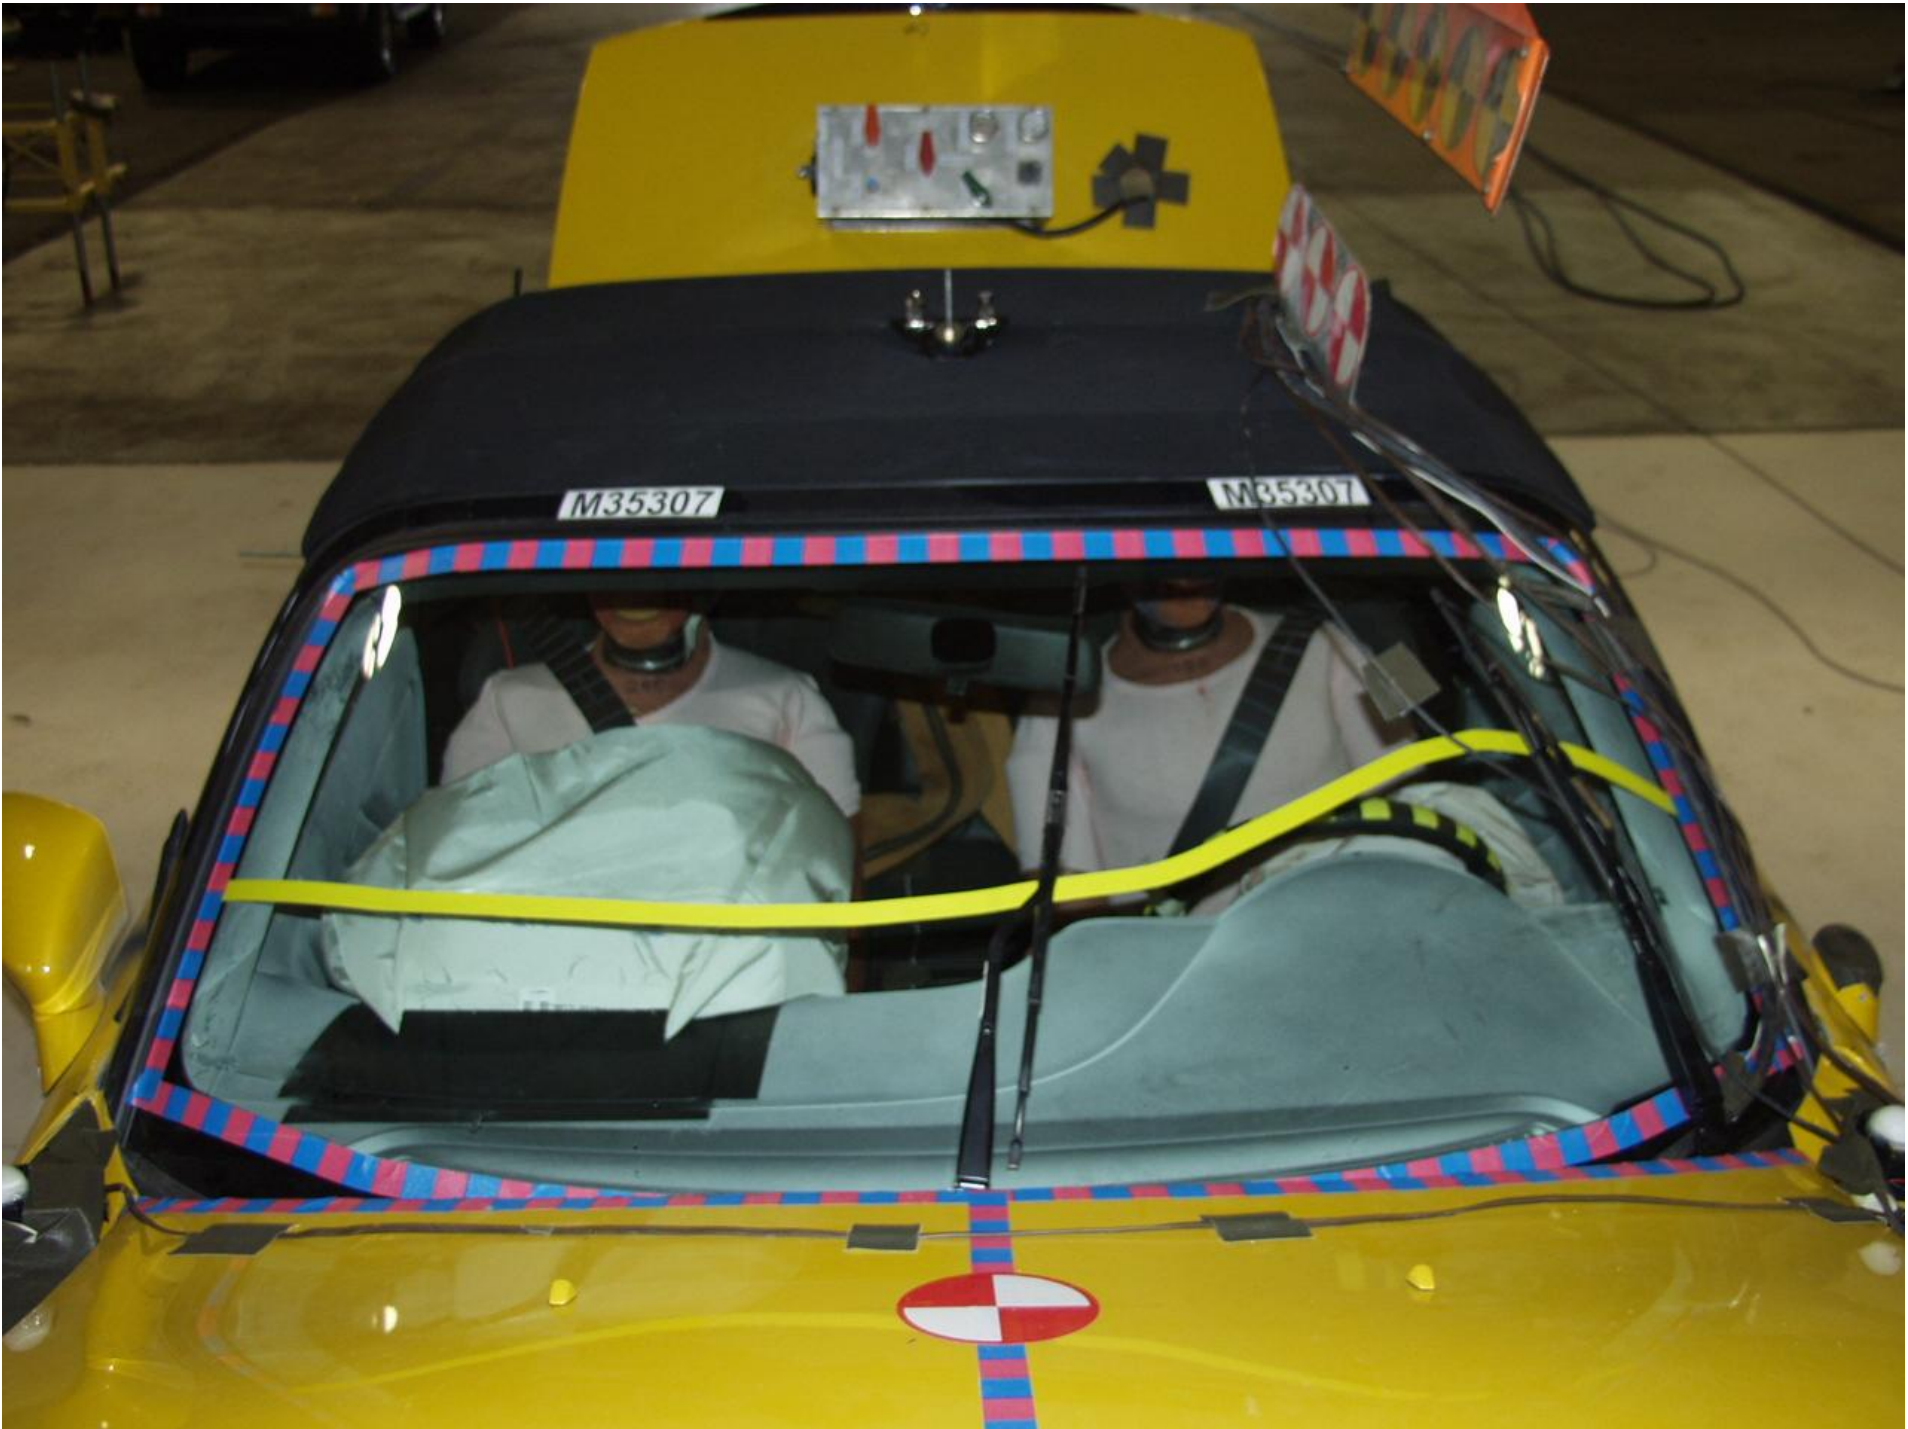
Figure A-19 POST-TEST WINDSHIELDVIEW

There was 100 percent windshield retention and no intrusion into the protected zone of the windshield during the event. There was no Stoddard solvent leakage after the event or during any phase of the static rollover.

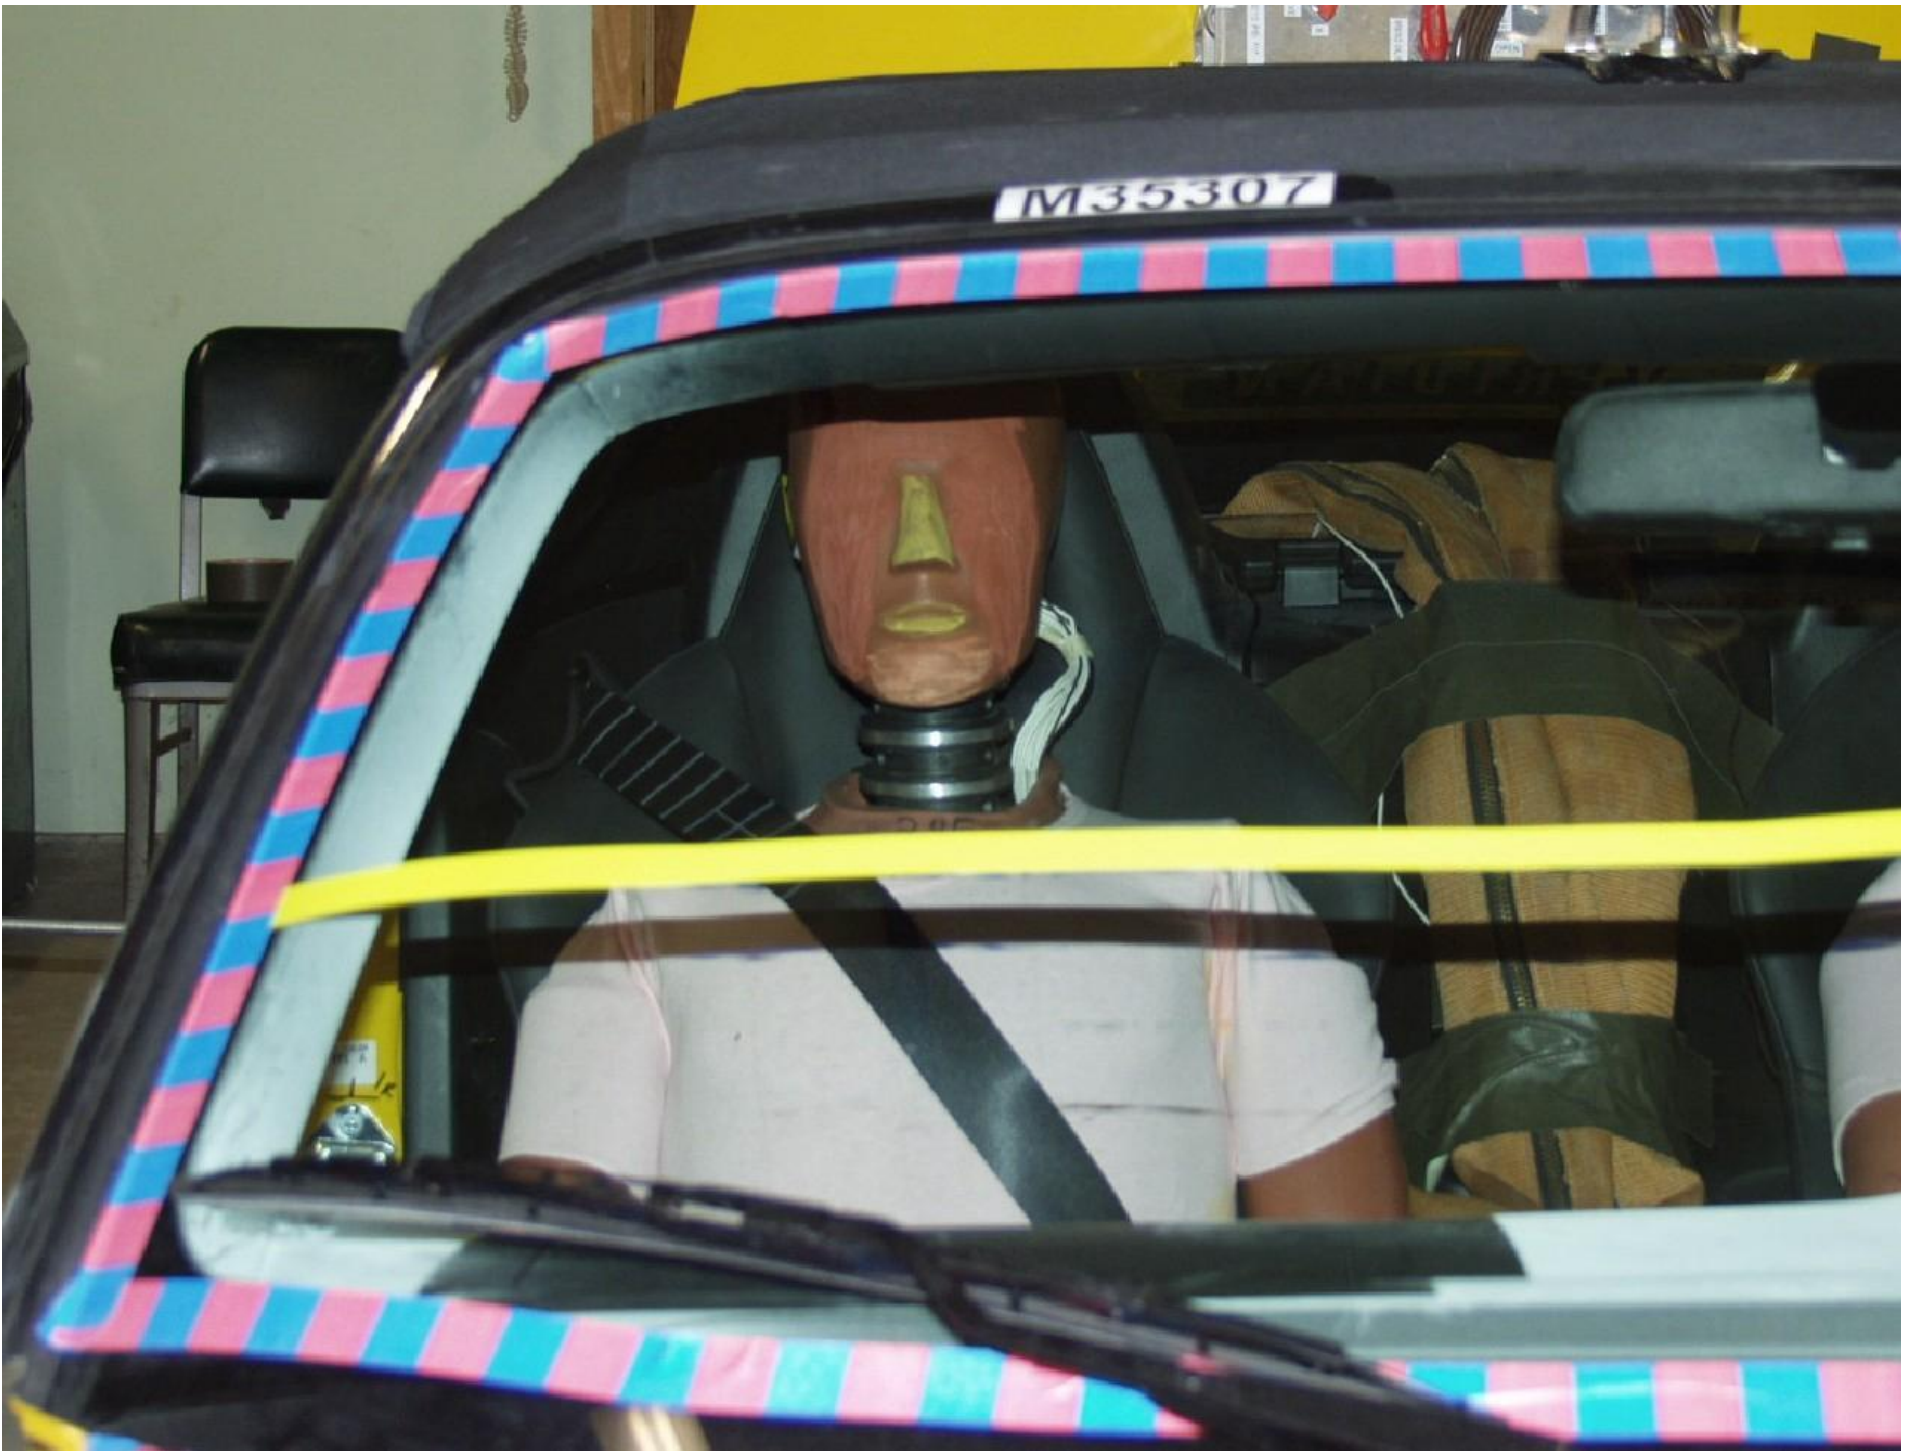
Figure A-43 POST-TEST DRIVER CONTACT TO AIRBAG

The driver's visible contact points were as follows: Face to center of airbag, chest to airbag, left knee to knee bolster left of steering column, and right knee to knee bolster right of steering column. The passenger's visible contact points were as follows: Face to right third of airbag, chest to airbag, left knee to left quarter of knee bolster, right knee to right third of knee bolster.
