Honda S2000 Sound Deadening Installation

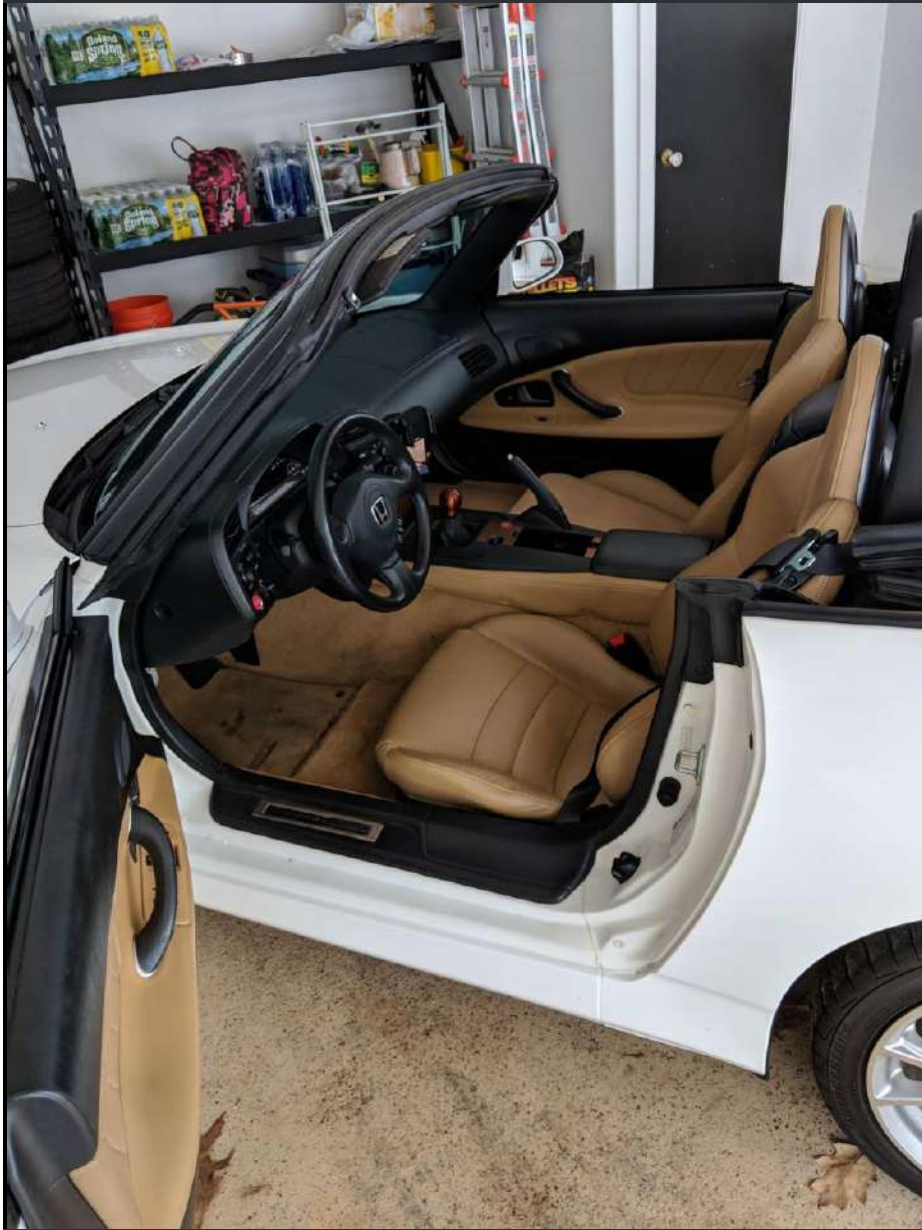
This is the starting point for the interior.

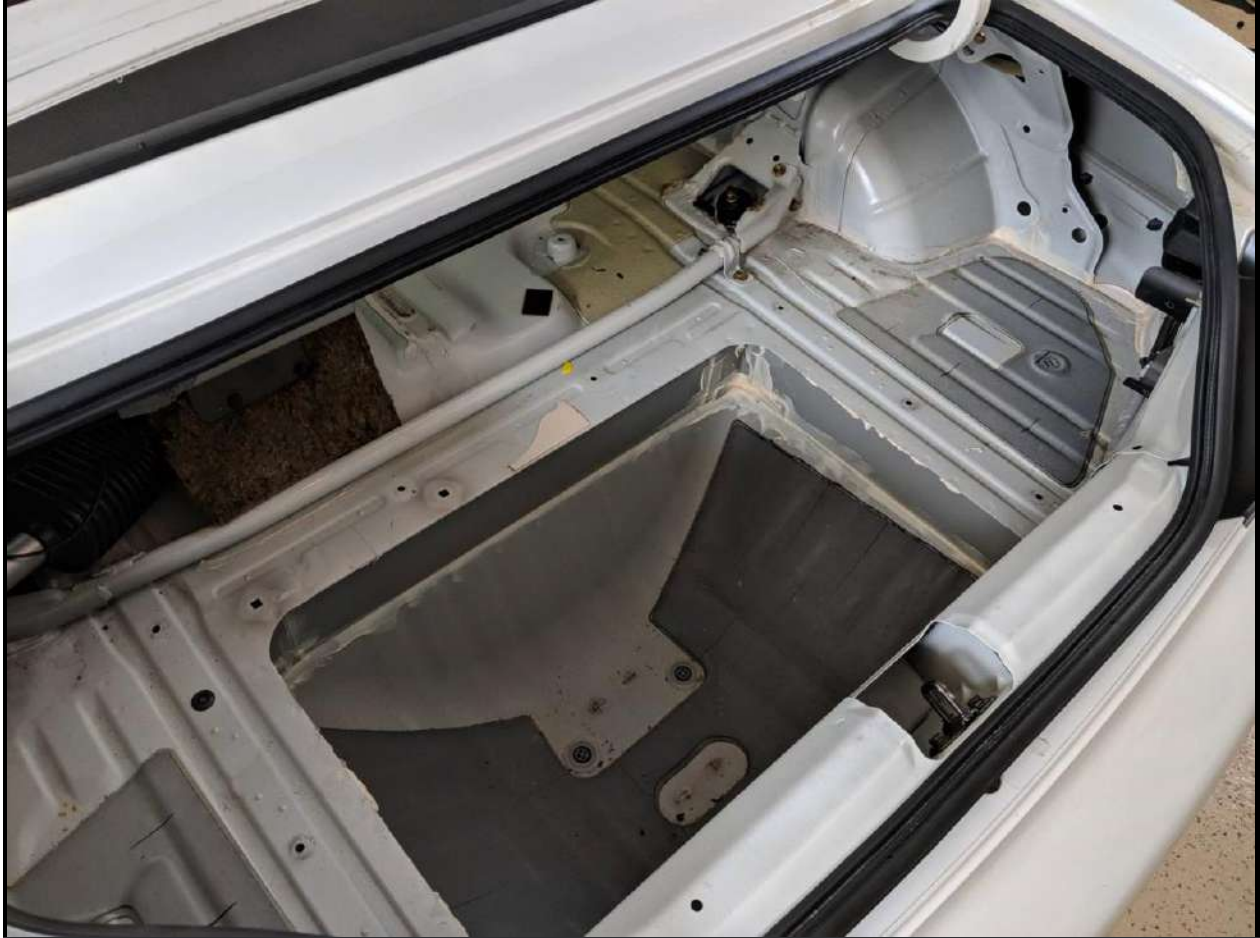
I found that to completely strip the interior, I had to start with the trunk, so that I could access the panels and hardware behind the seats. Stripping the trunk is very easy, there are only 5 panels, all of which are held in place with push clips. This is what it looks like with the panels and the spare tire removed.

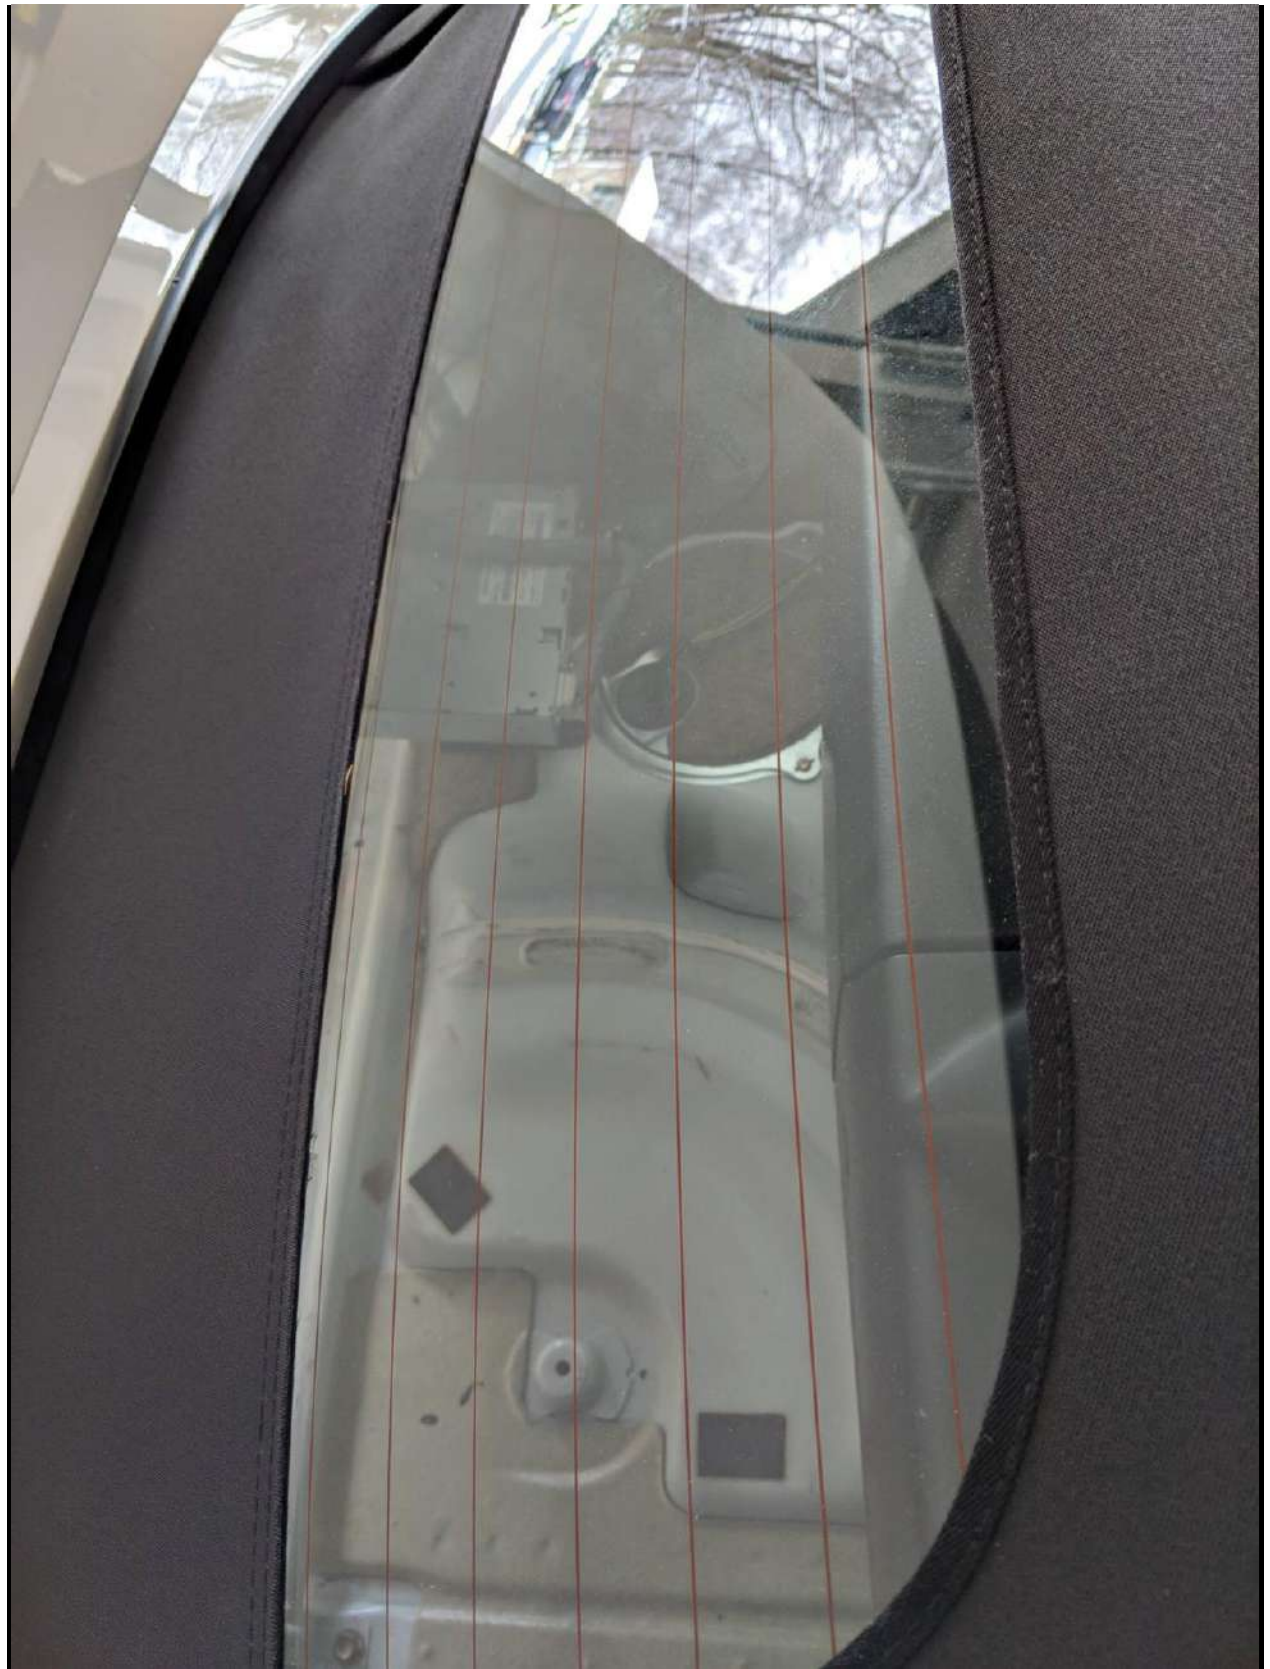
With grit and determination, i.e. colorful language and bloody knuckles, the rear tray is removed. It, and a panel that sits atop it's rear edge, are both held in with varying styles of push clips. Once those panels are removed, the back of the rear console is accessible. A trim panel on the rear of the rear console is removed by removing 2 Philips head screws, which then exposes 3 more Philips head screws that help to hold the rear console in place. Those 3 screws will also need to be removed.

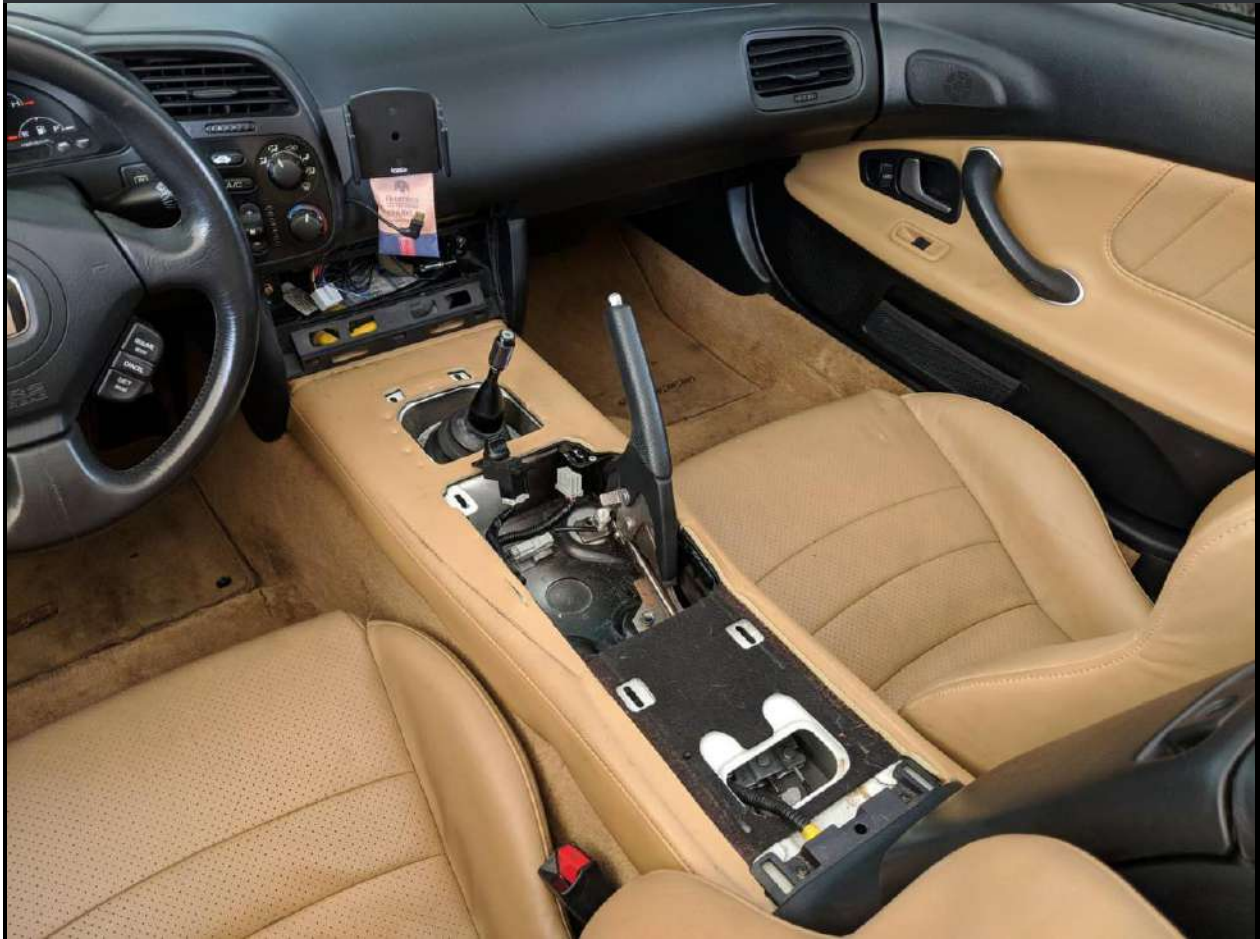
The center console is removed simply by first unscrewing the shift knob, then pulling up on the center console. The two plugs for the hazard light switch and the convertible roof switch will need to be disconnected before the center console can be fully removed.

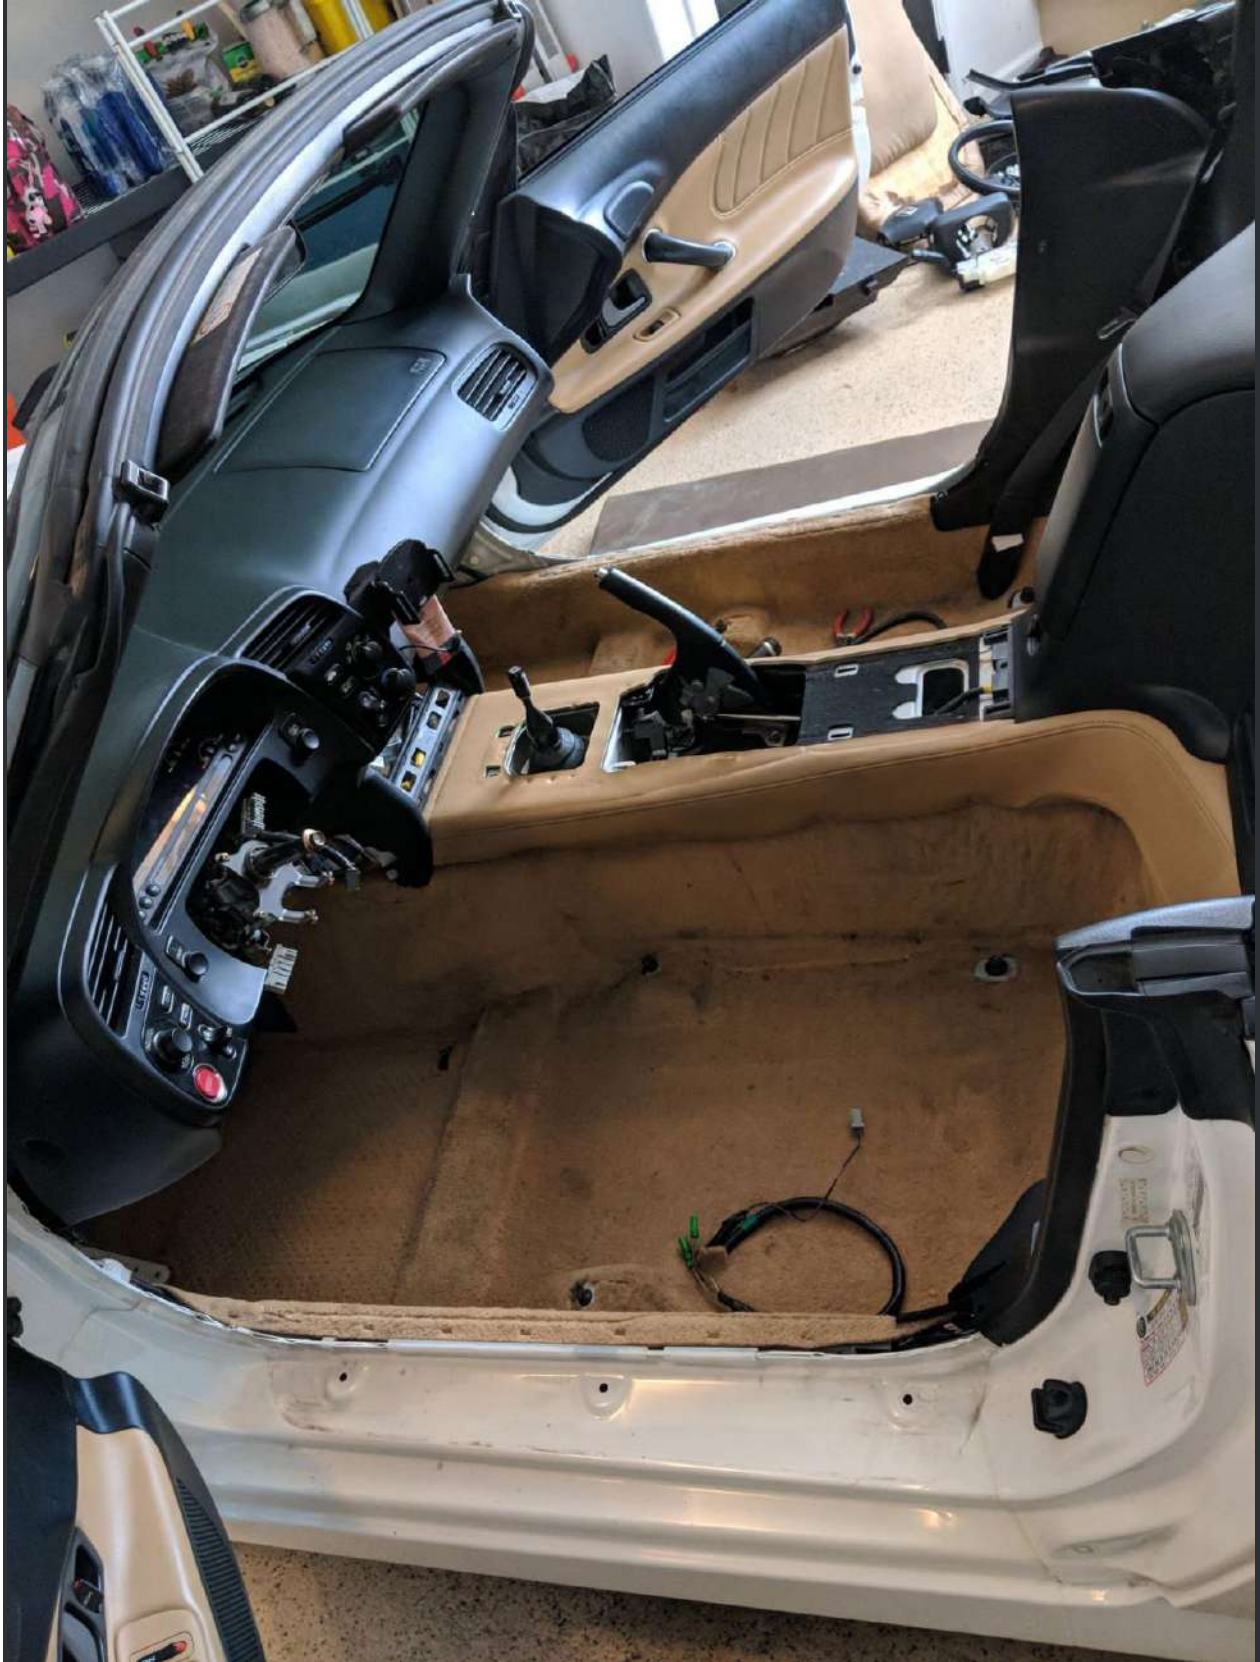
To make the whole project easier, I removed the steering wheel. At this point, you'll need to disconnect

the battery and wait at least 3 minutes (per the Honda factory service manual) before you go messing around with the airbag. The airbag is held to the steering wheel with a pair of T30 Torx bolts. Once the airbag is removed and the wiring disconnected, the steering wheel bolt can be loosened and removed, and then the steering wheel itself can be pulled off. Pro tip: Straighten your wheels and steering wheel before removing the steering wheel. It'll make aligning the steering wheel on reinstallation much easier. After removing the steering wheel, I pulled the seats. Each seat is held in by 4 bolts, 2 are 12mm and 2 are 14mm. My seats have the optional factory headrest mounted speakers, to those connectors need to be disconnected before removing the seats, in addition to the driver's seat seatbelt sensor.

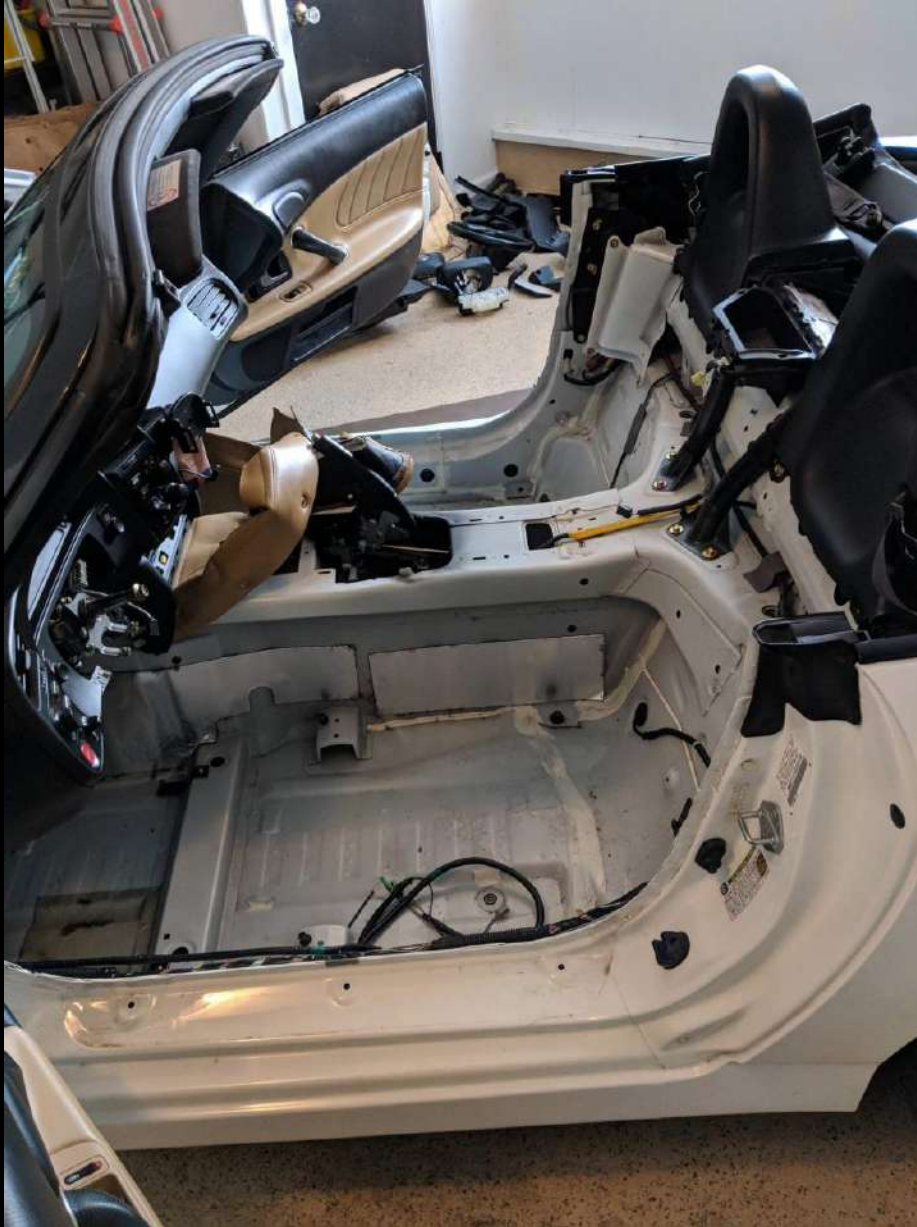
The rear console can be removed at this point. It's held in with 9 more Philips head screws, 2 at the base, 1 on either side, 1 inside the console, and 4 at the very top. The trunk release button and accessory power port will need to be disconnected. The passenger side cargo net needs to be removed, by removing 4 Philips head screws. The dead pedal cover needs to be removed, simply by pulling it up, and

a piece of plastic trim underneath the gas pedal needs to be removed by removing 2 12mm nuts. Then the push clips securing the carpet in place can be removed, and then the driver's side and passenger's side carpets can be removed. The center console carpet can't be fully removed without either fully removing the dash or simply cutting the carpet. Rather than take either of those options, I simply angled the center console carpet out of my way.

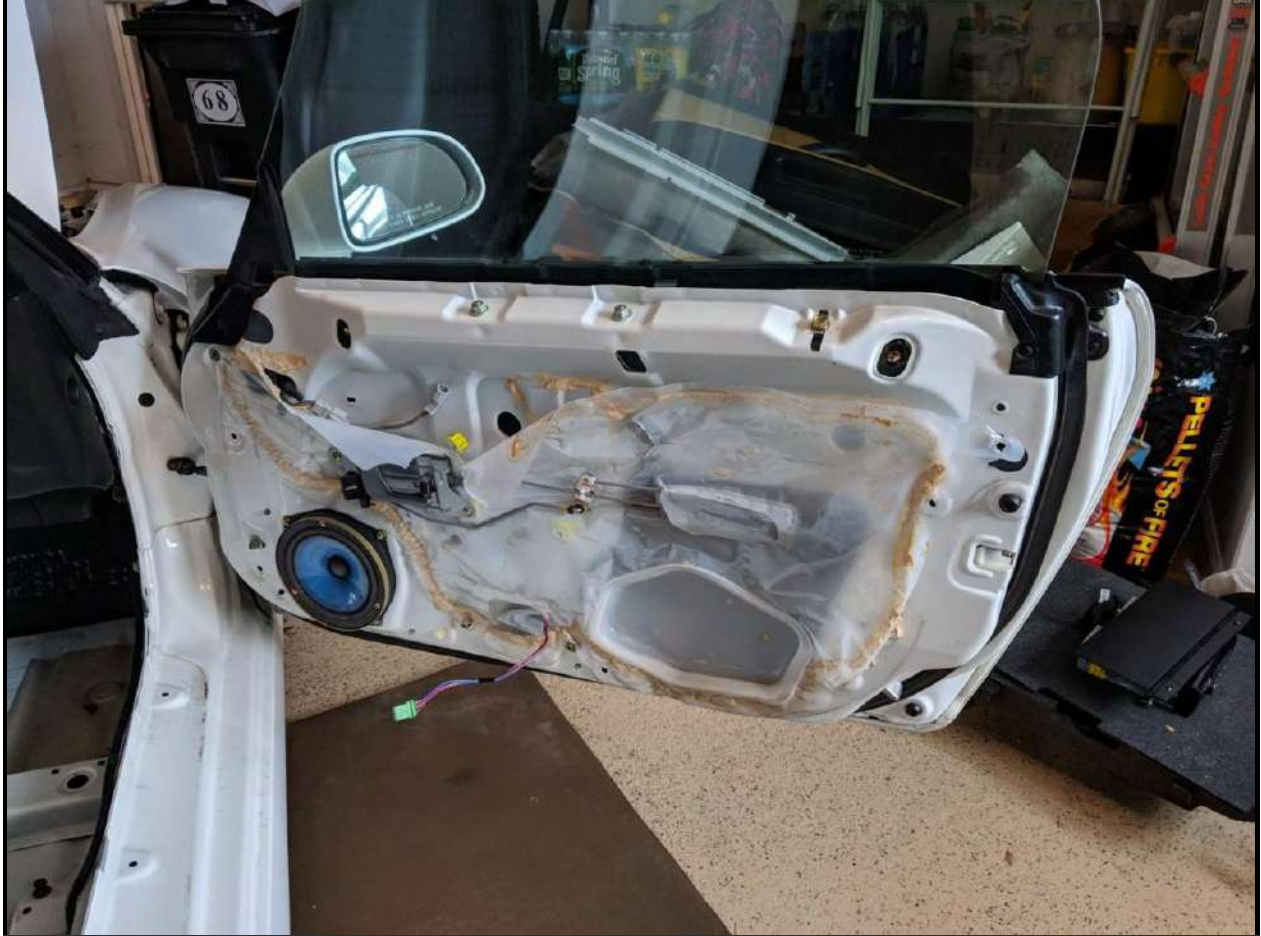
The door panels need to be removed. Each is held in with 3 Philips head screws (2 in the door handle, 1 behind the door pull), a push clip next to the mirror, and a sequence of plastic clips around the perimeter. Disconnect the window switch and tweeter before completely removing.

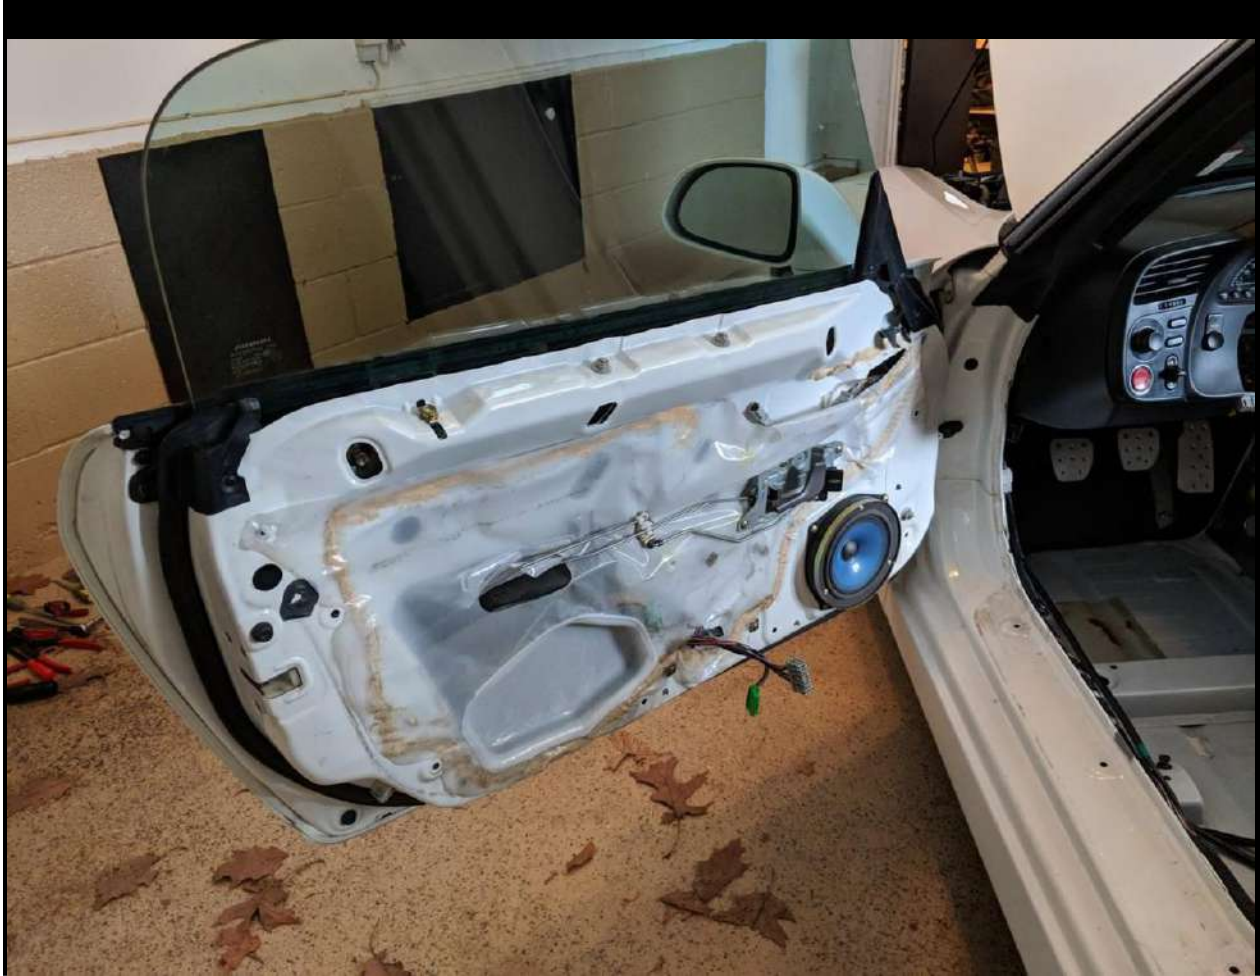
The driver's side is nearly identical to the passenger side, the only real difference being an additional electrical connector for the mirror adjustment controls.

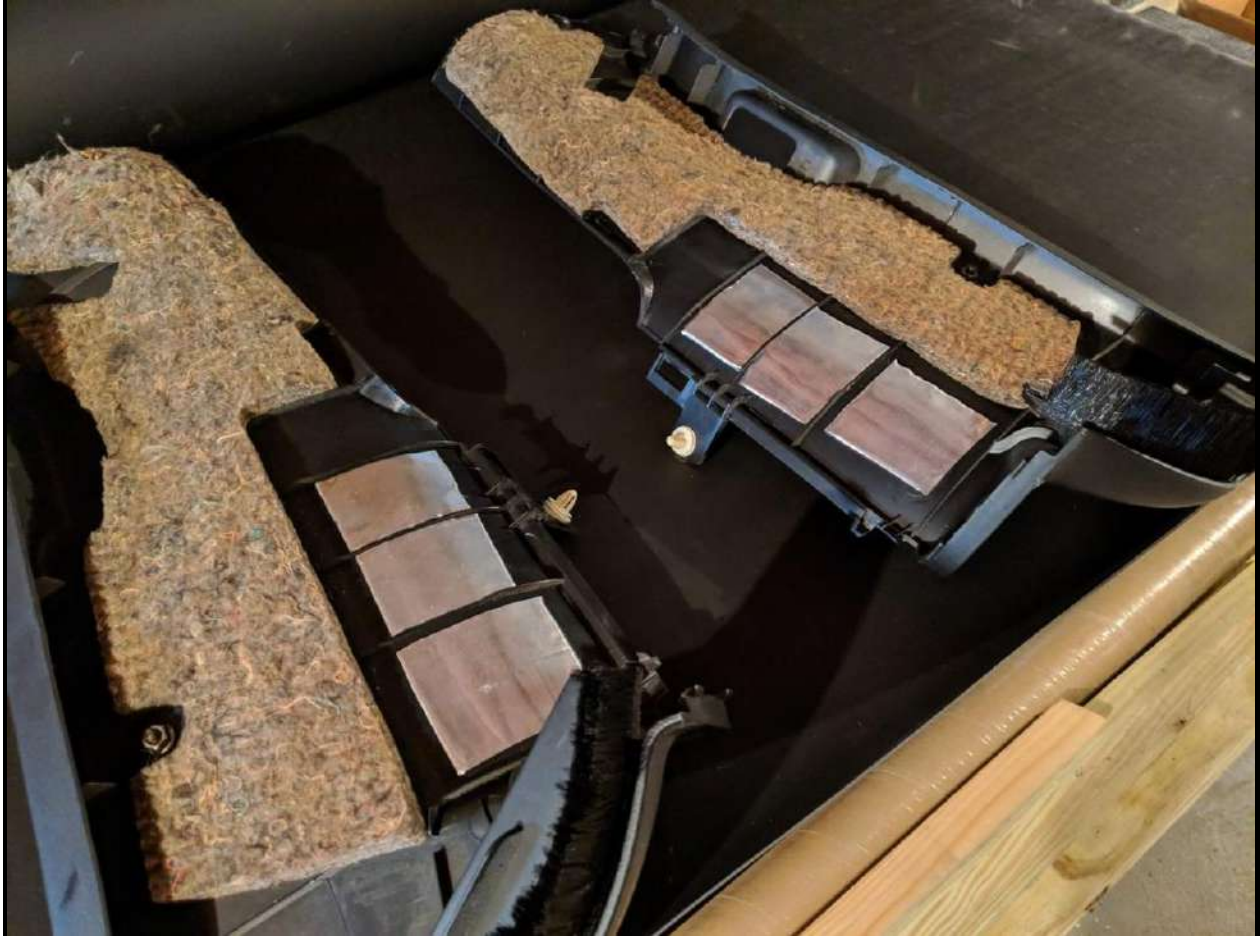
With the interior suitably stripped, we can begin the installation of the first layer of sound deadening, CDL tiles. All of the surfaces that are to receive sound treatment need to be cleaned with isopropyl alcohol or some other sort of oil and grease remover, to promote adhesion of the CDL tiles and velcro tape. Here you can see 6 segments of CDL tile applied to the backside of the interior quarter panel trim pieces.

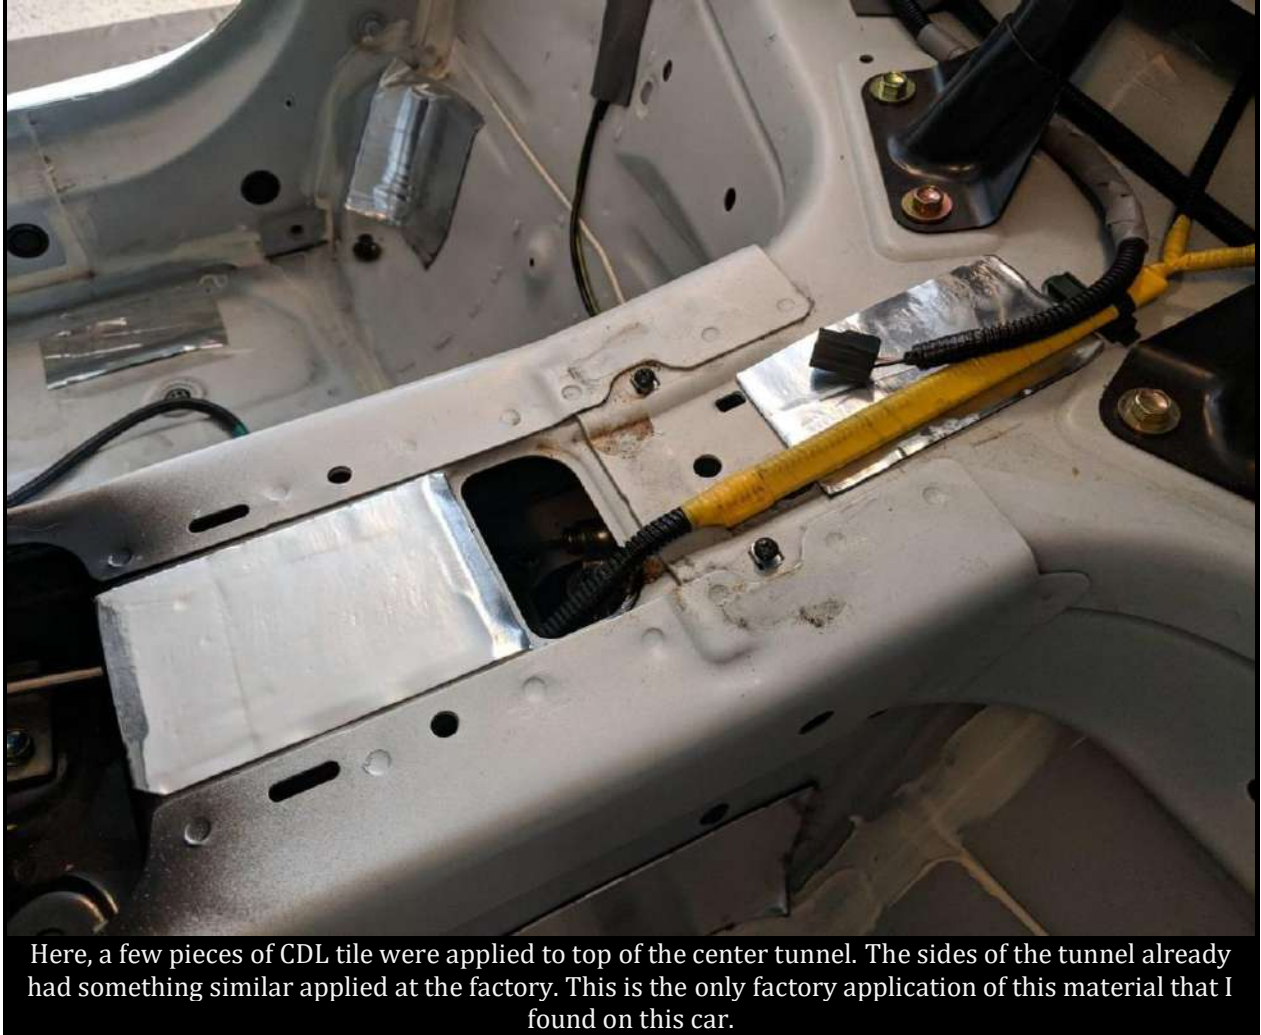
Here, a few pieces of CDL tile were applied to top of the center tunnel. The sides of the tunnel already had something similar applied at the factory. This is the only factory application of this material that I found on this car.

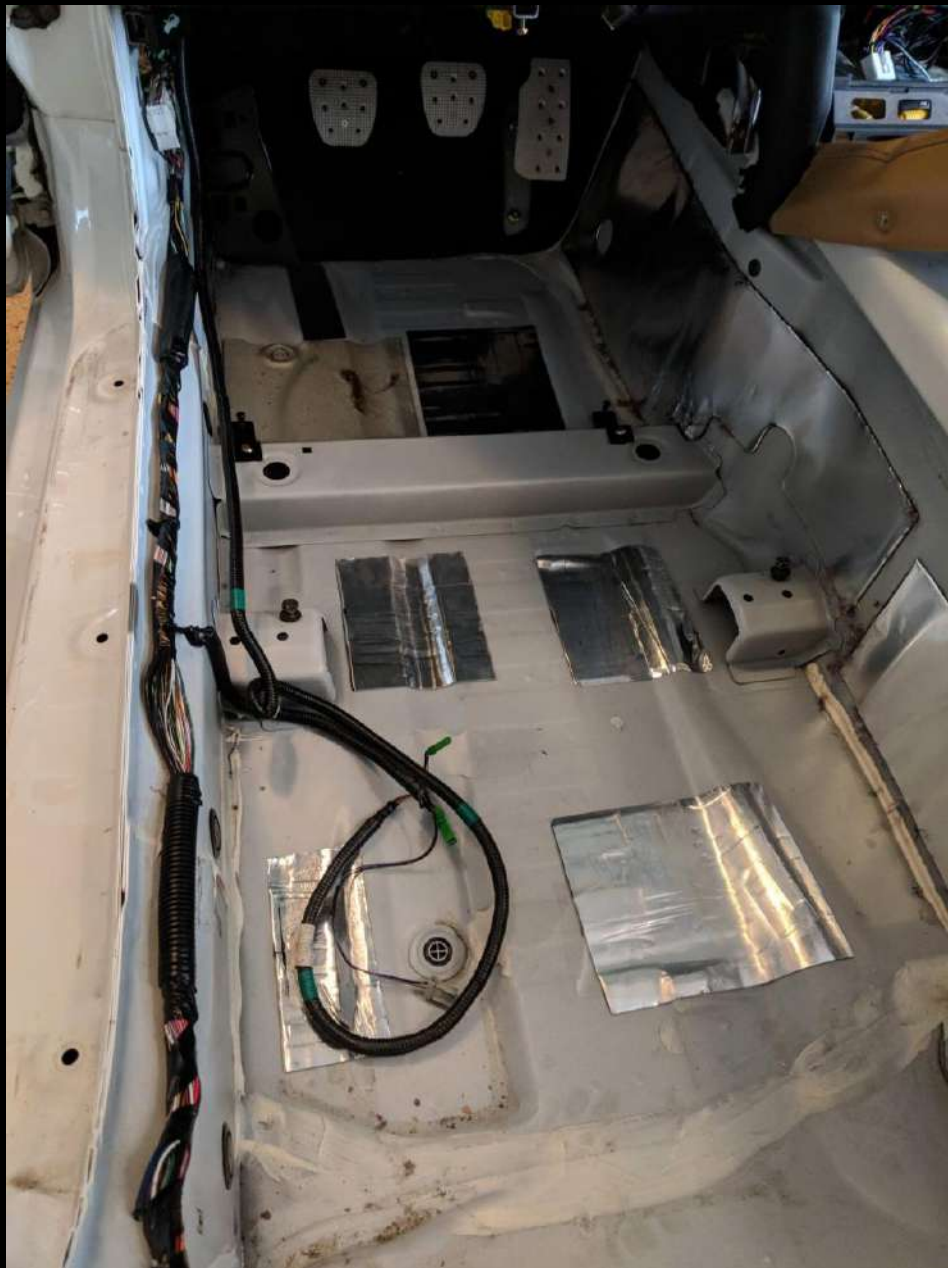
CDL tiles were applied to the driver's side floor. The kit from SDS has recommendations on how many tiles should be applied to each area.

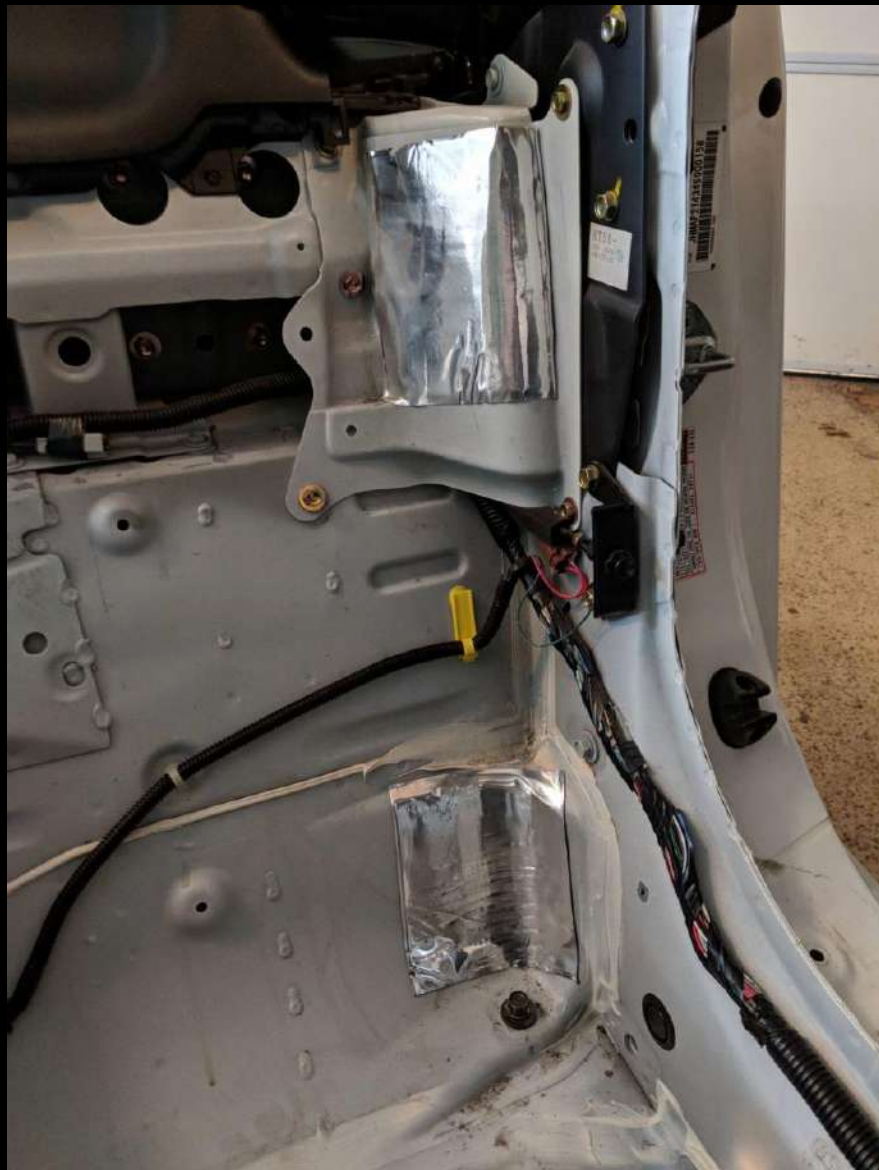
CDL tiles were applied to the interior driver's side quarter panel itself

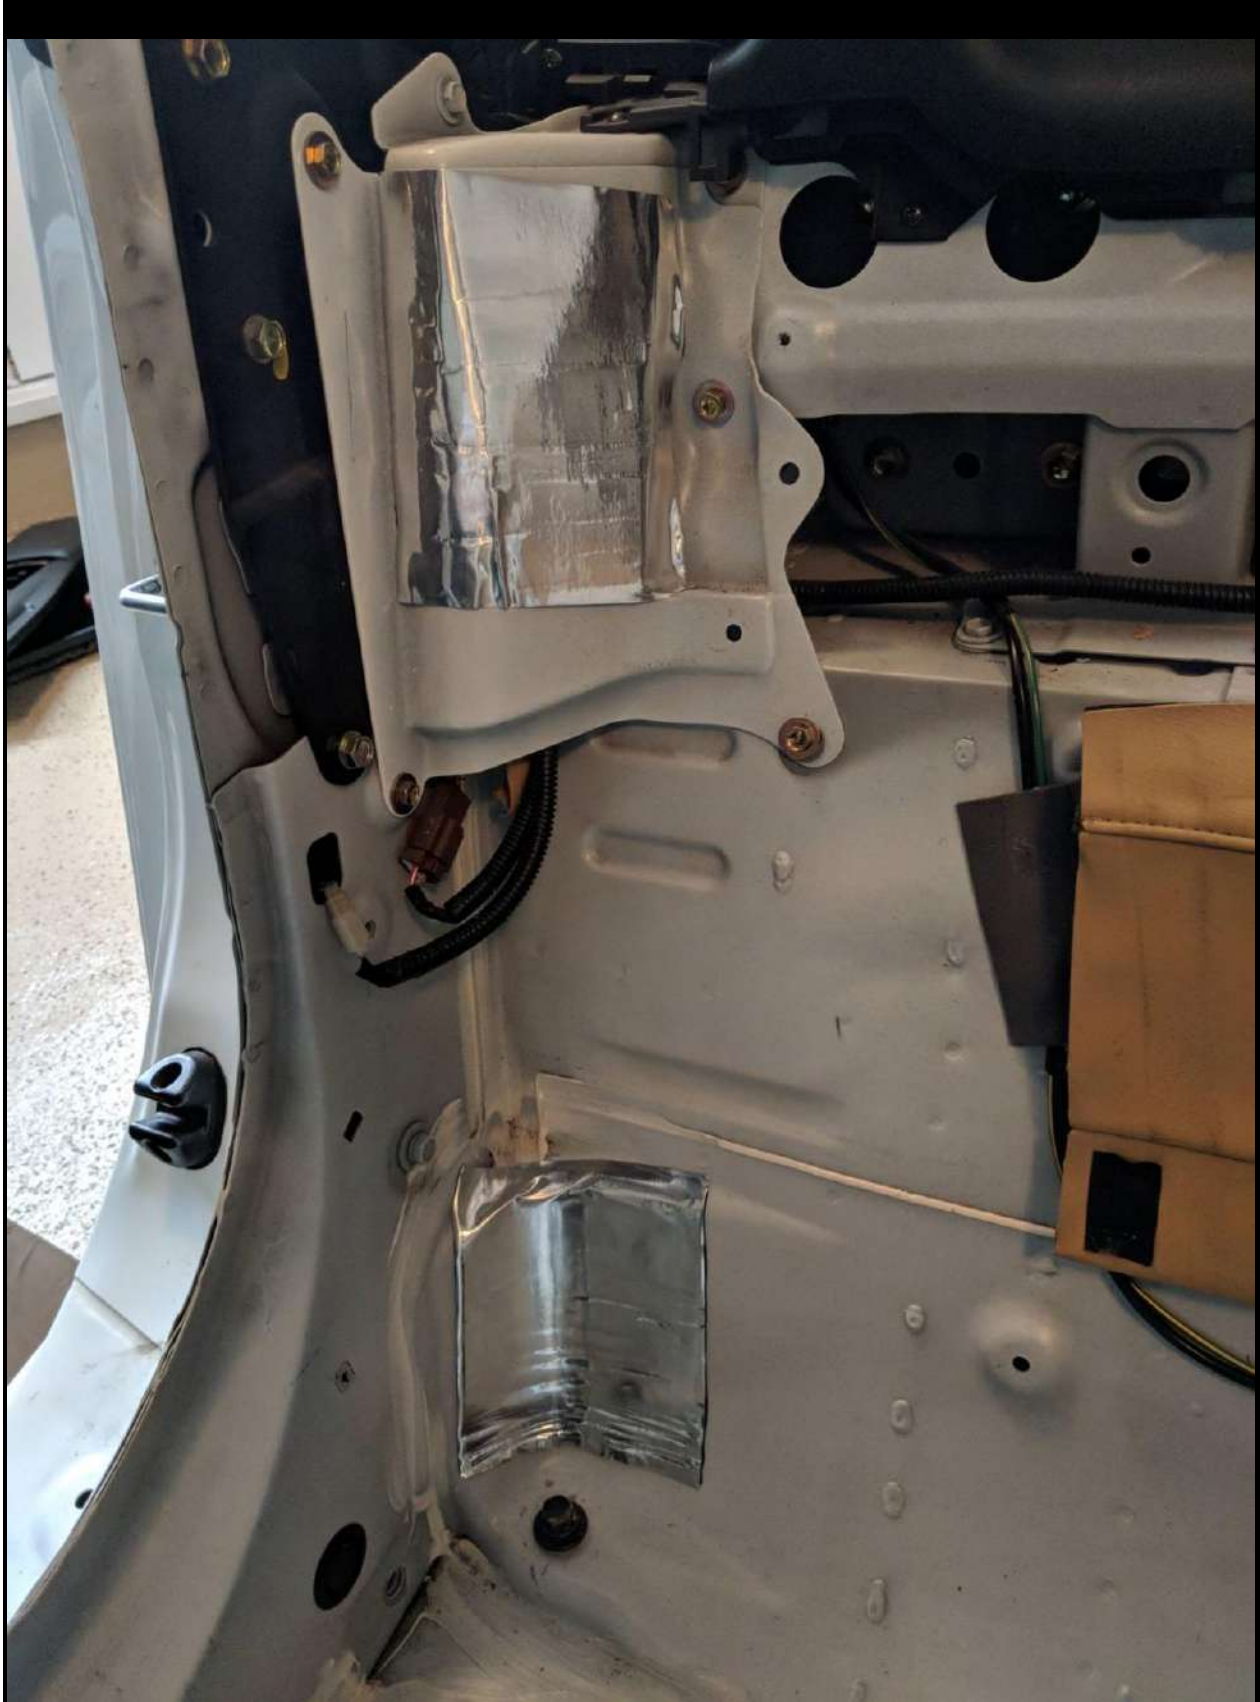
Tiles were likewise applied to the passenger side quarter panels

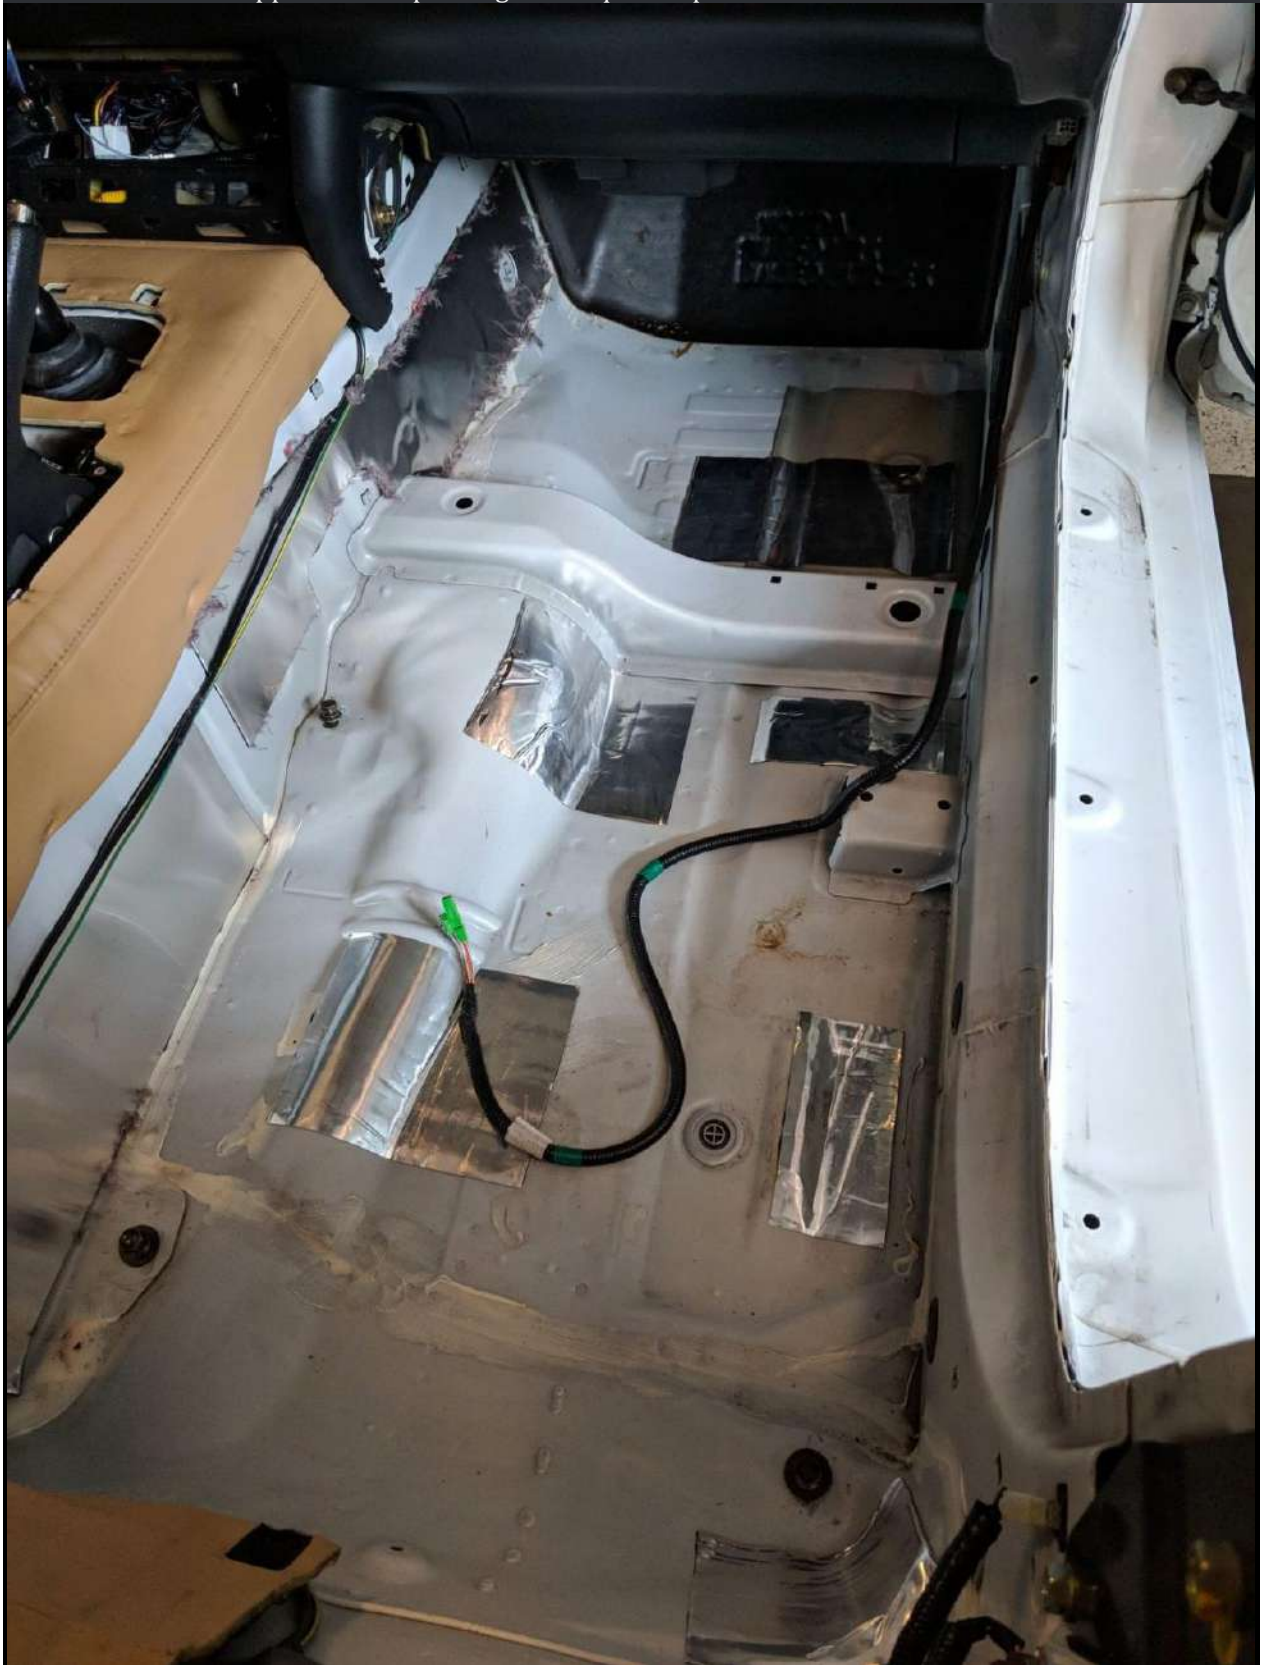
CDL tiles were applied to the passenger's side floor. The goal is to have about 25% coverage towards the center 50-75% of each panel, per SDS, but the vehicle itself will dictate where things will actually be installed. Obviously, bolt holes and other attachment areas should be avoided.

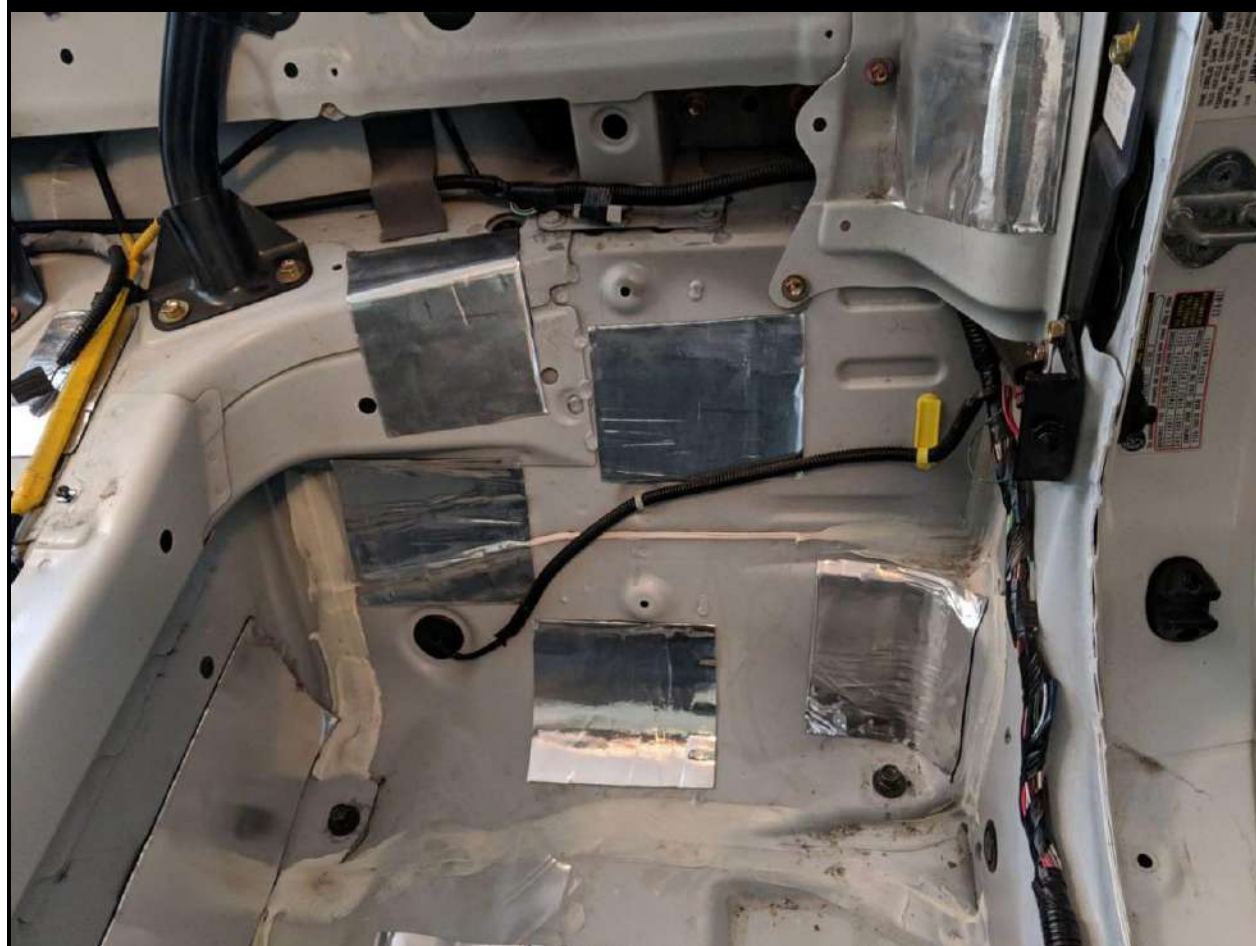
The rear of the driver's side compartment was covered with CDL tiles
