Honda S2000 Sound Deadening Installation

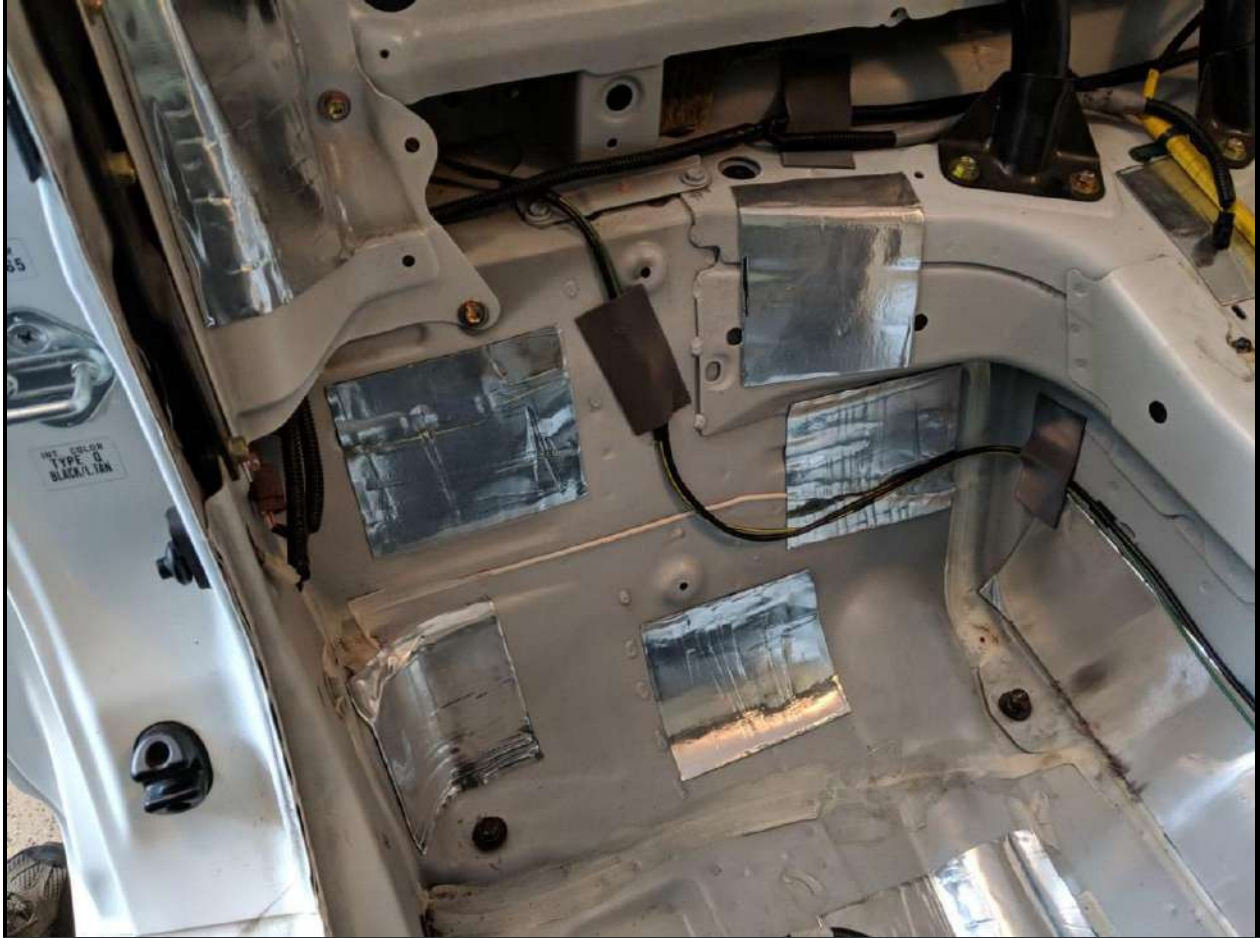
And the passenger's side received similar treatment

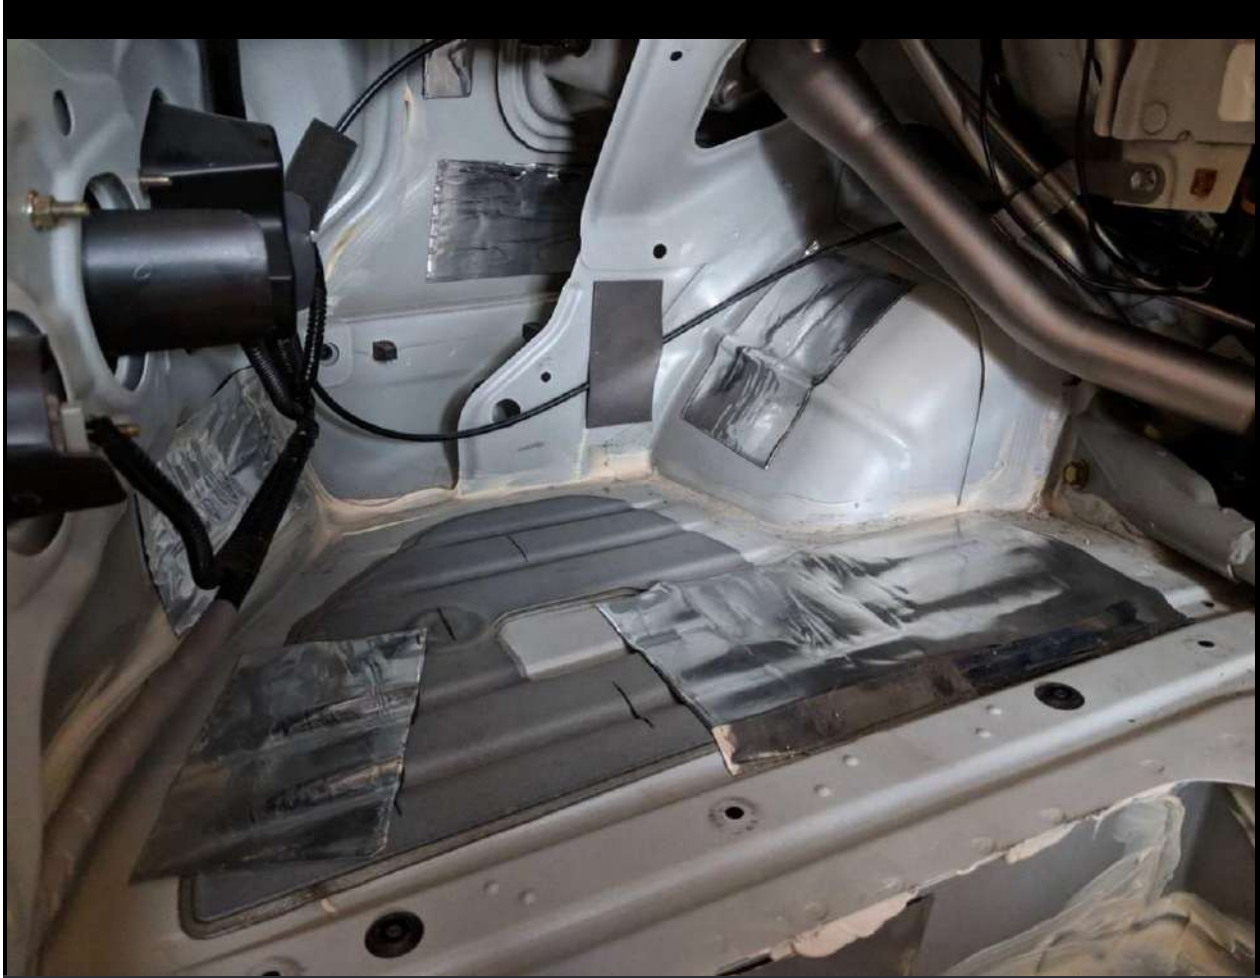
The driver's side of the trunk gets CDL tile treatment

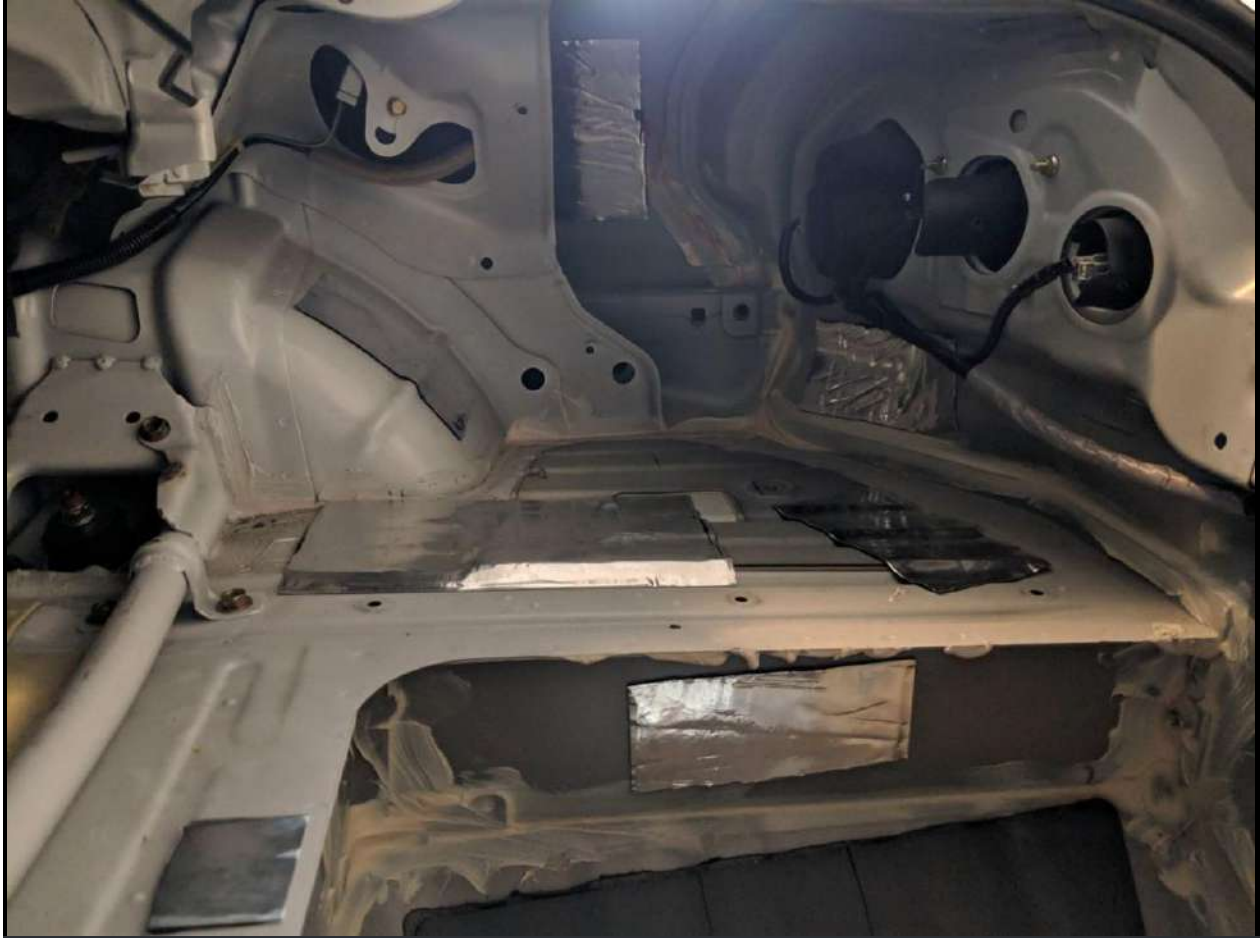
The passenger's side of the trunk gets the same treatment

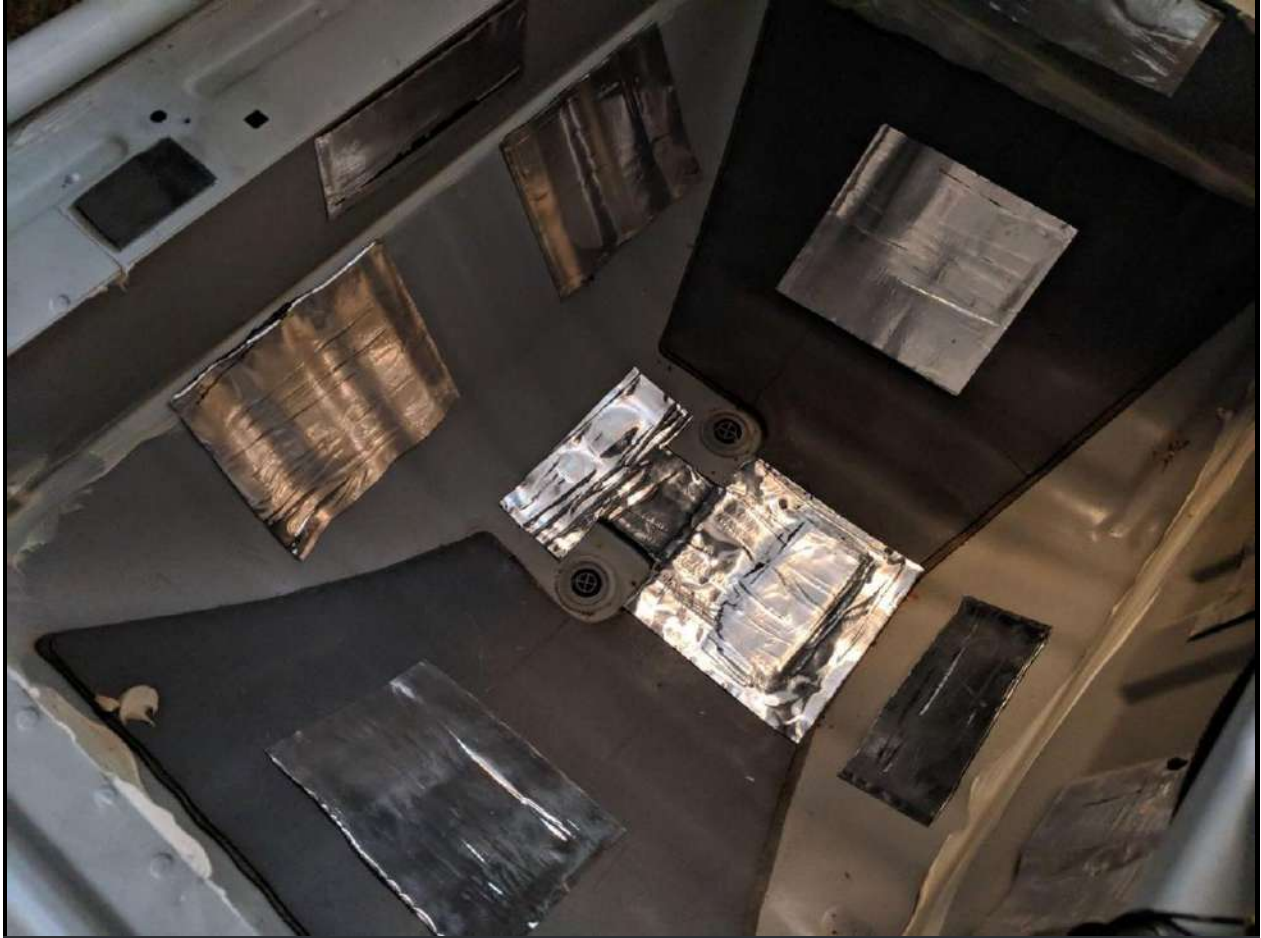
The well in the trunk also gets treated with CDL tiles

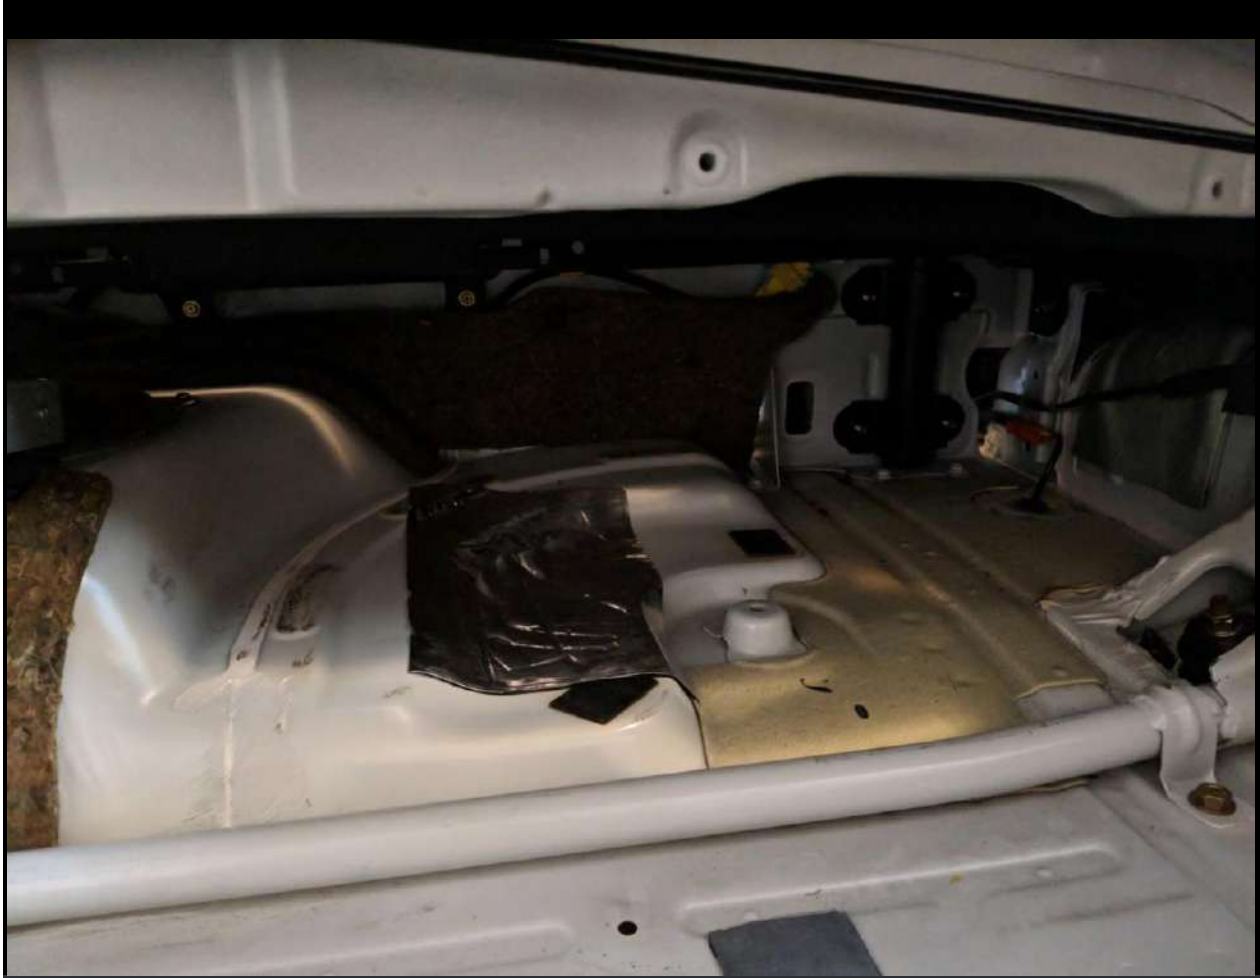
As does the spare tire compartment

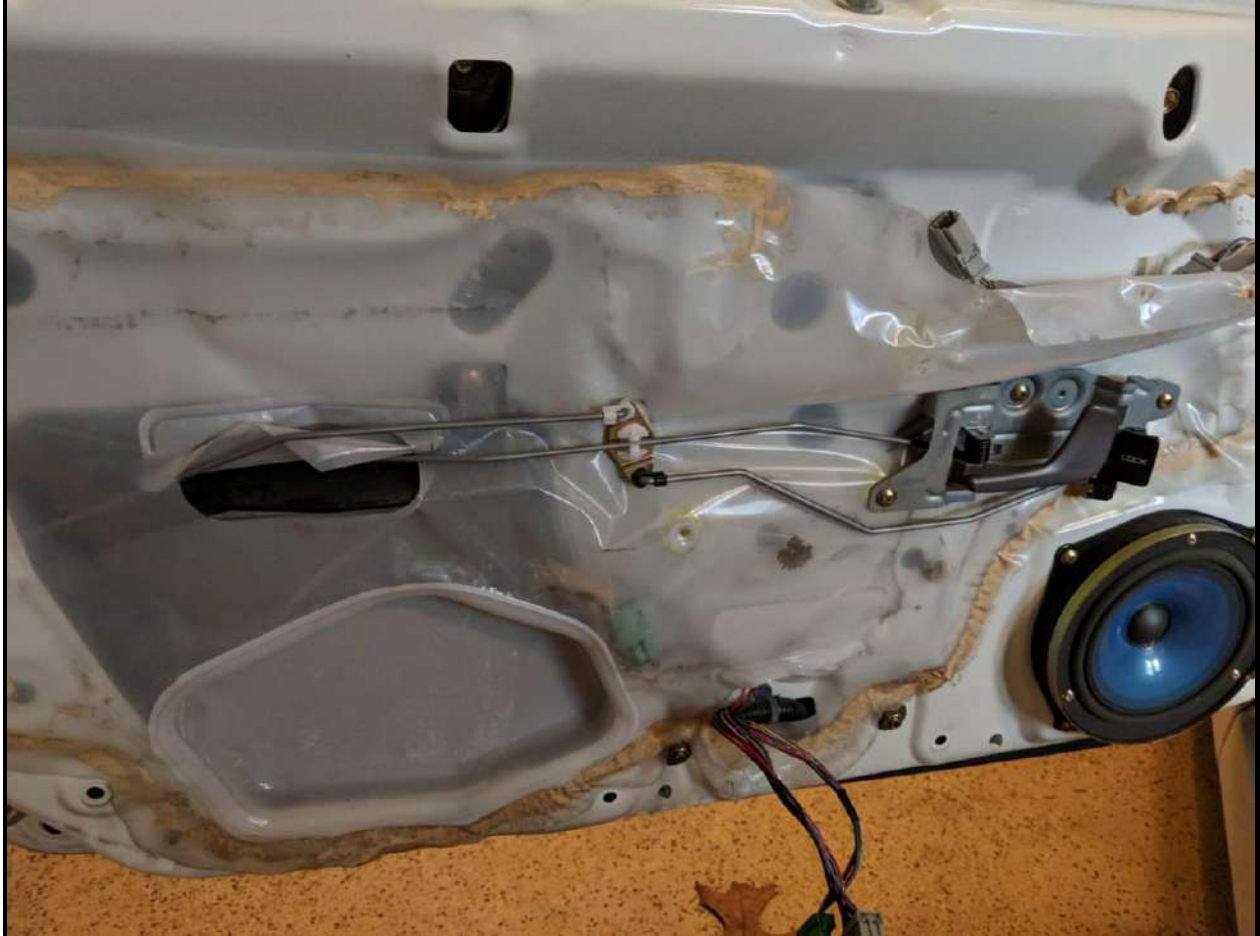
It's a good idea to take lots of pictures of components before disassembling them. In this case, I took pictures of the door latch/lock mechanism, as I would have to take it apart to remove the vapor barrier, to access the inner skin of the door.

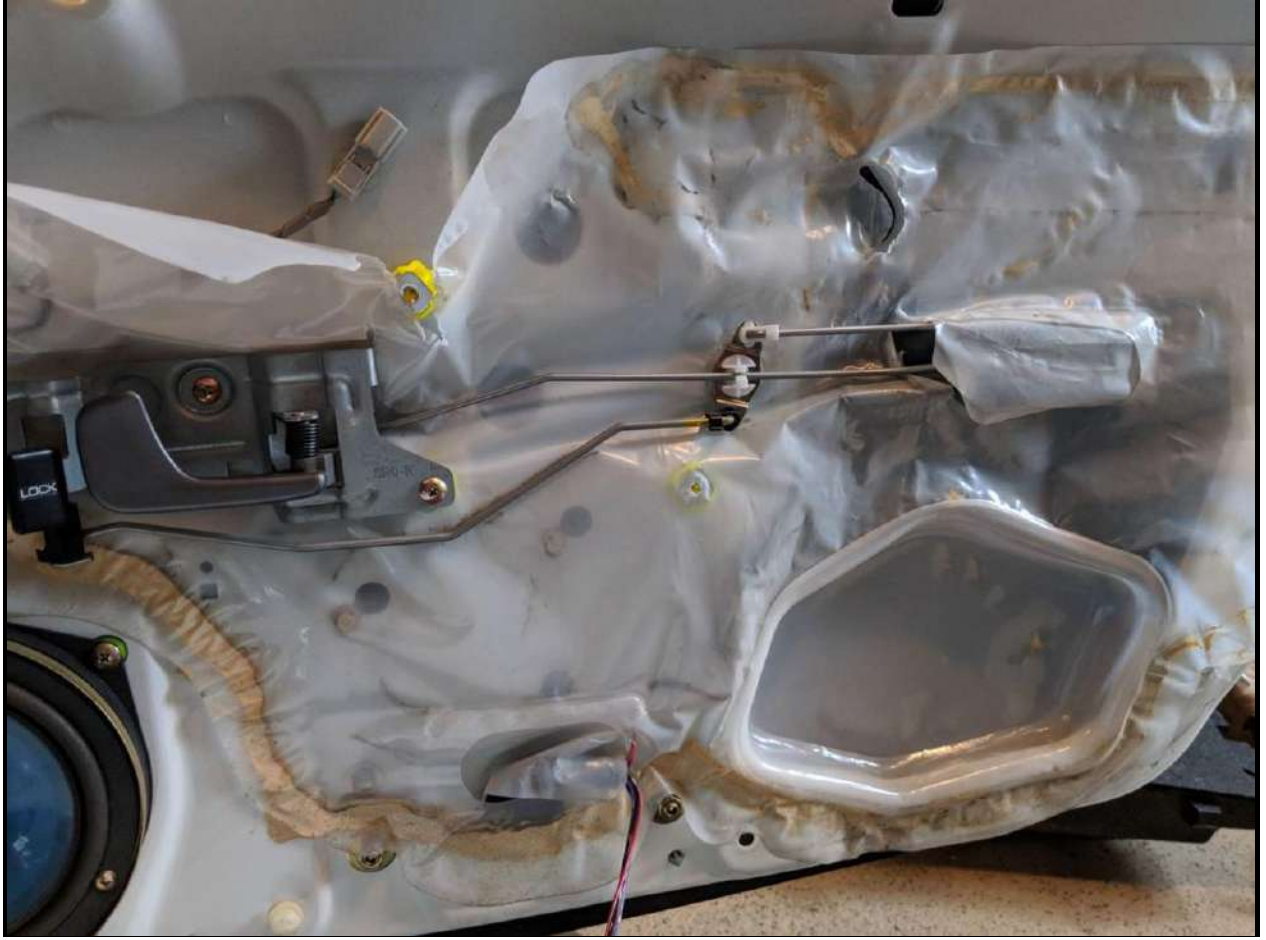
This is the passenger's side door before I started to take it apart.

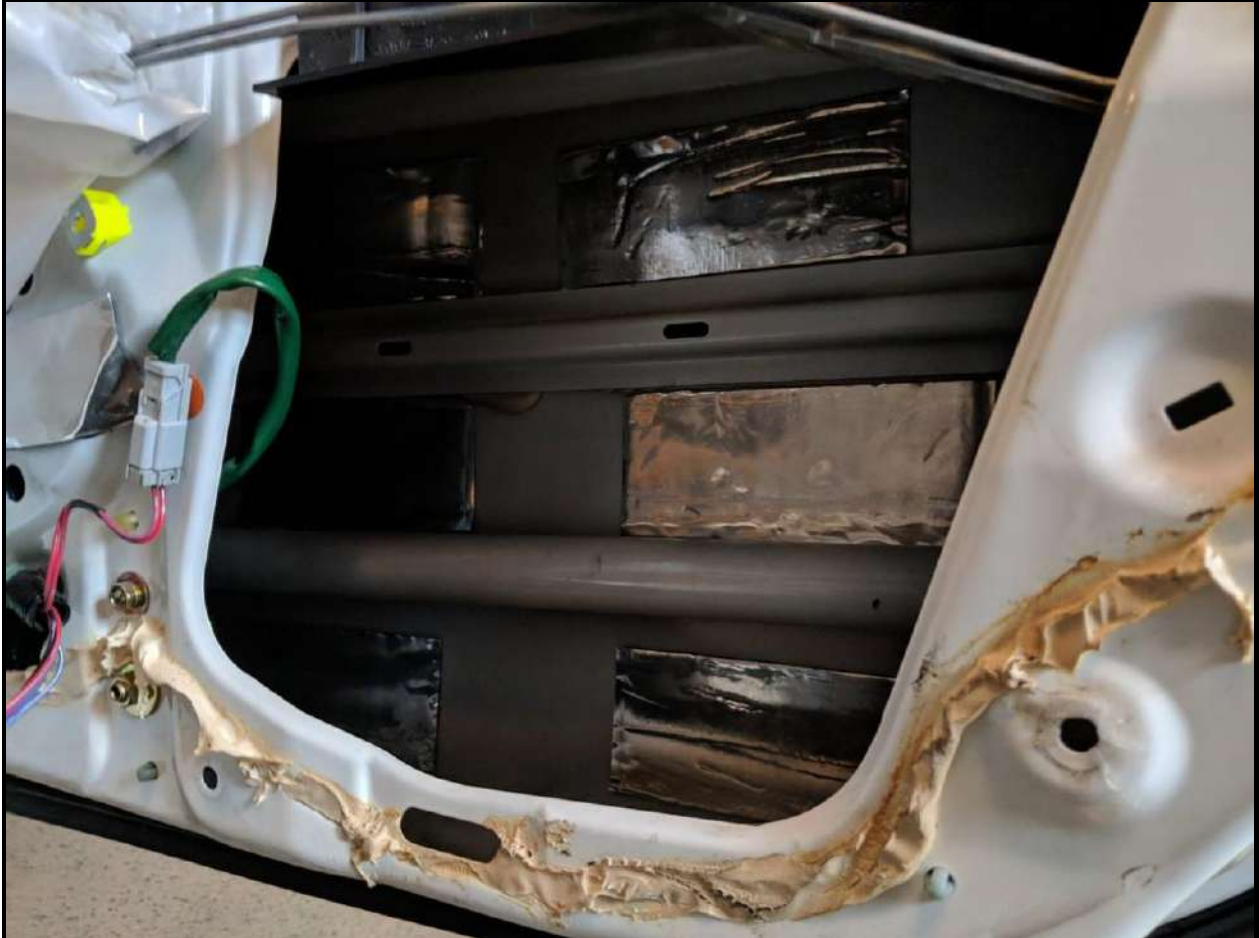
Once the outer skin of the door is accessible, it gets CDL tile treatment. The inner skin and trim panel also get CDL tile treatment.

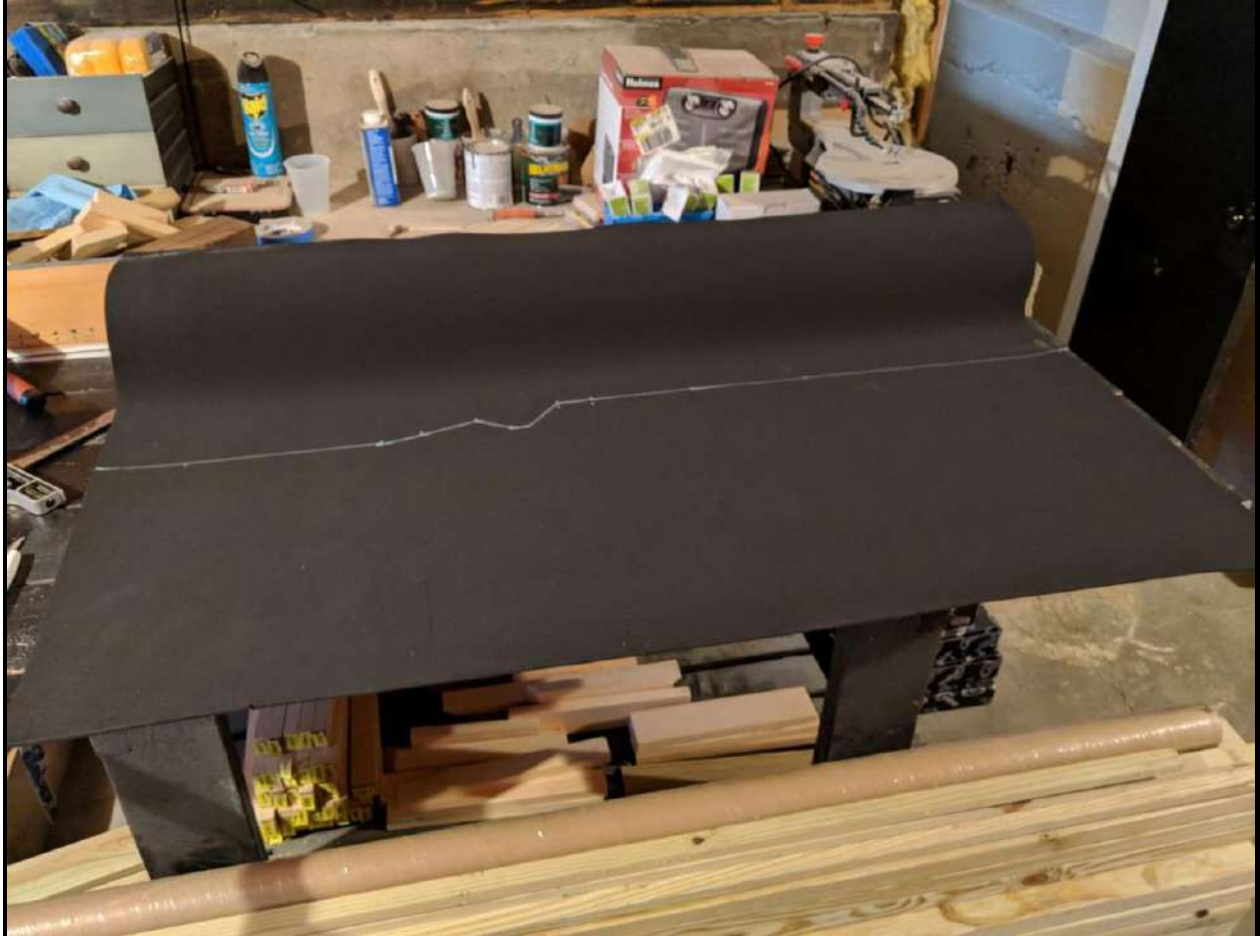
With all the CDL tiles applied, we can begin installation of the other 2 layers of sound deadening materials, Closed Cell Foam (CCF) and Mass Loaded Vinyl (MLV). The MLV will make you regret starting this project, it's very difficult to work with. Keep going though, the results will be worth it. Here, I've taken a series of measurements for the driver's side floor, and I've applied them to a sheet of CCF. This piece is then cut out.

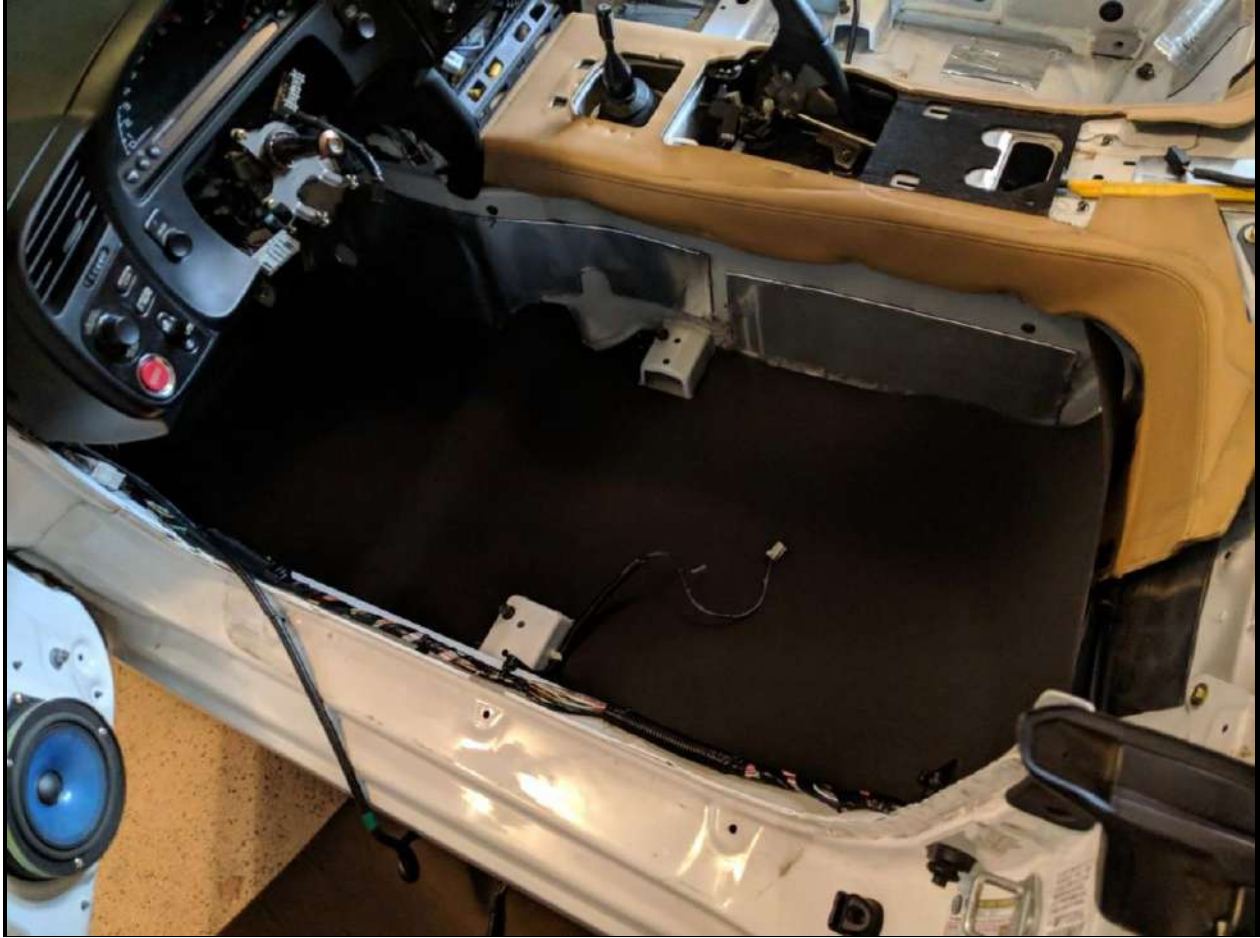
The CCF piece is test-fitted and further trimmed, for a tight fit.

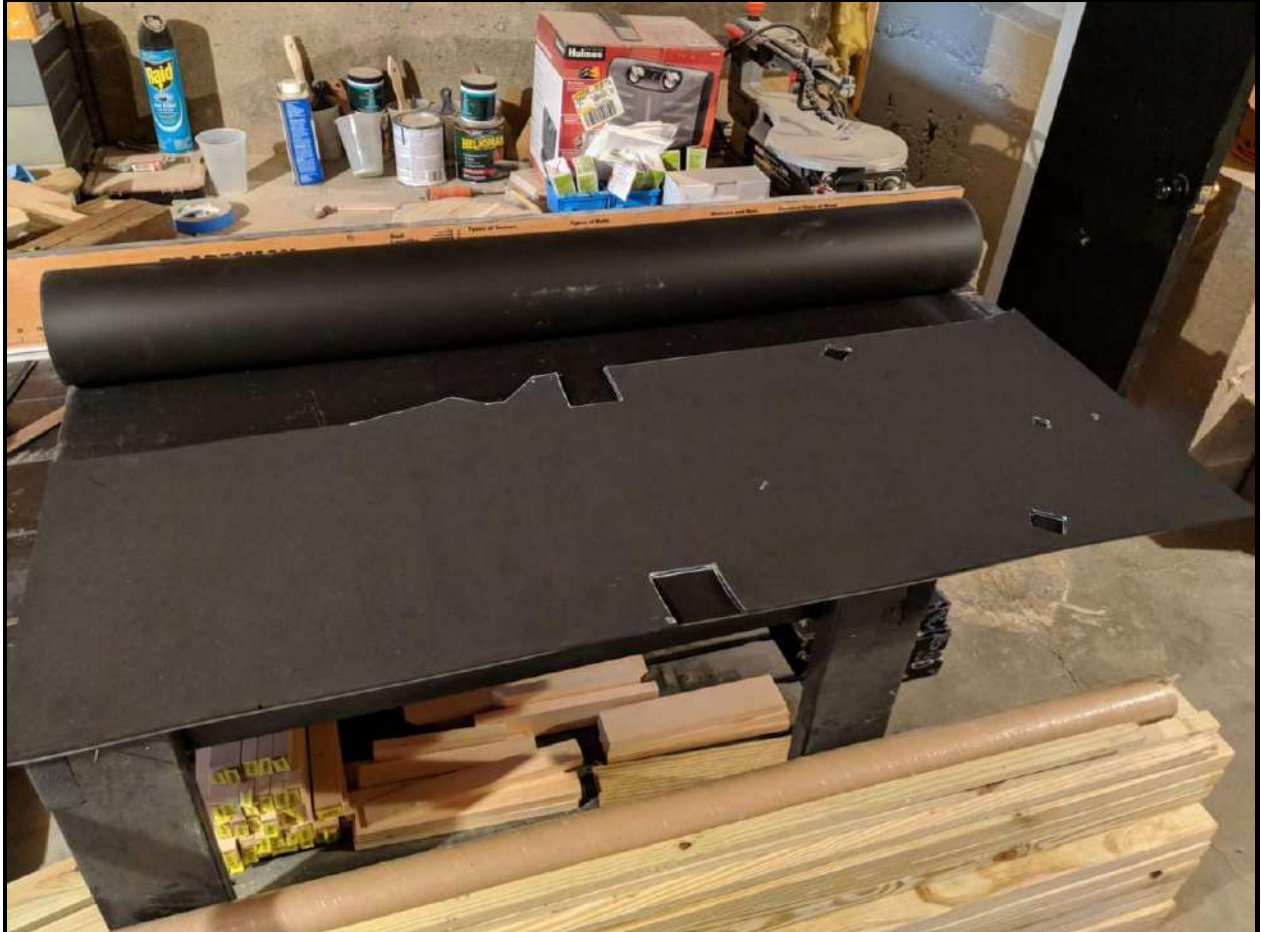
Here, the shape of the correctly sized CCF is transferred to MLV and cut out. Note the holes that will be cut for mounting hardware for the seats and carpet.

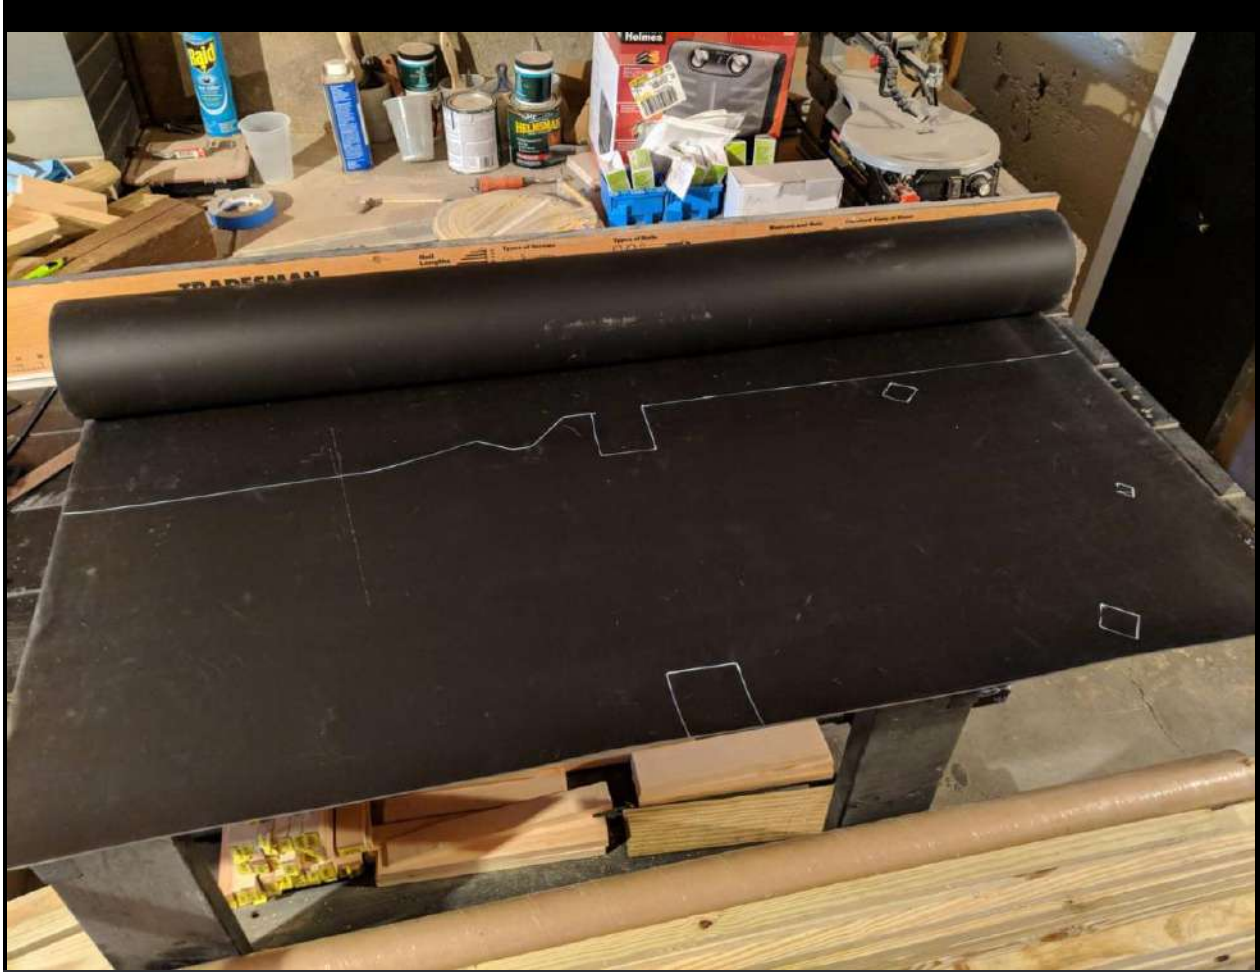
The completed shape transfer, before cutting

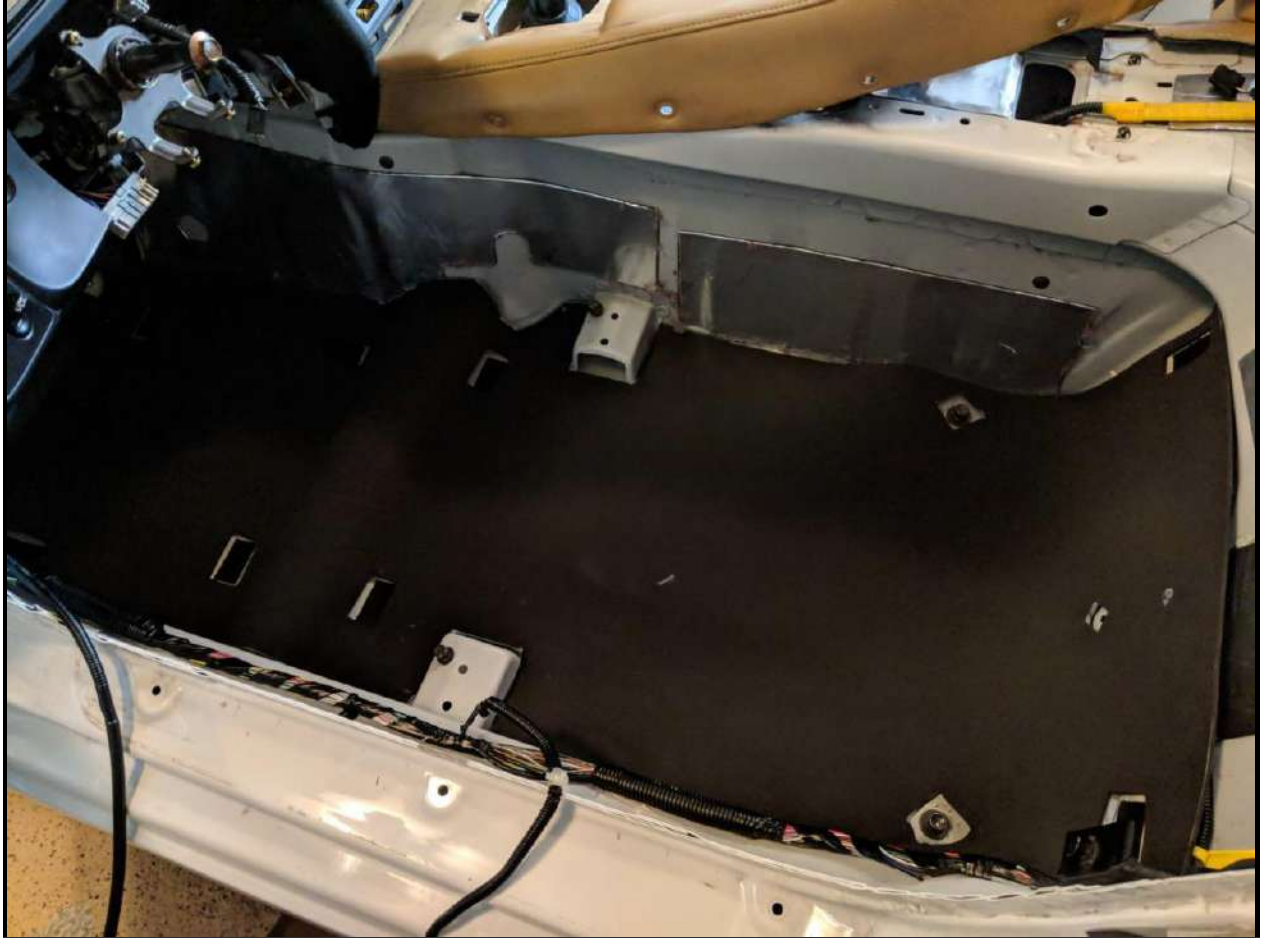
When the MLV is test-fitted successfully, double-sided velcro tape pieces are applied to the panel to which the CCF and MLV is to be applied. The locations of the velcro tape need to be cut out from the CCF. The CCF will be sandwiched between the MLV and the panel, with the velcro tape holding the MLV in place. Here you can see the CCF for the driver's side floor with the new holes for the velcro tape.

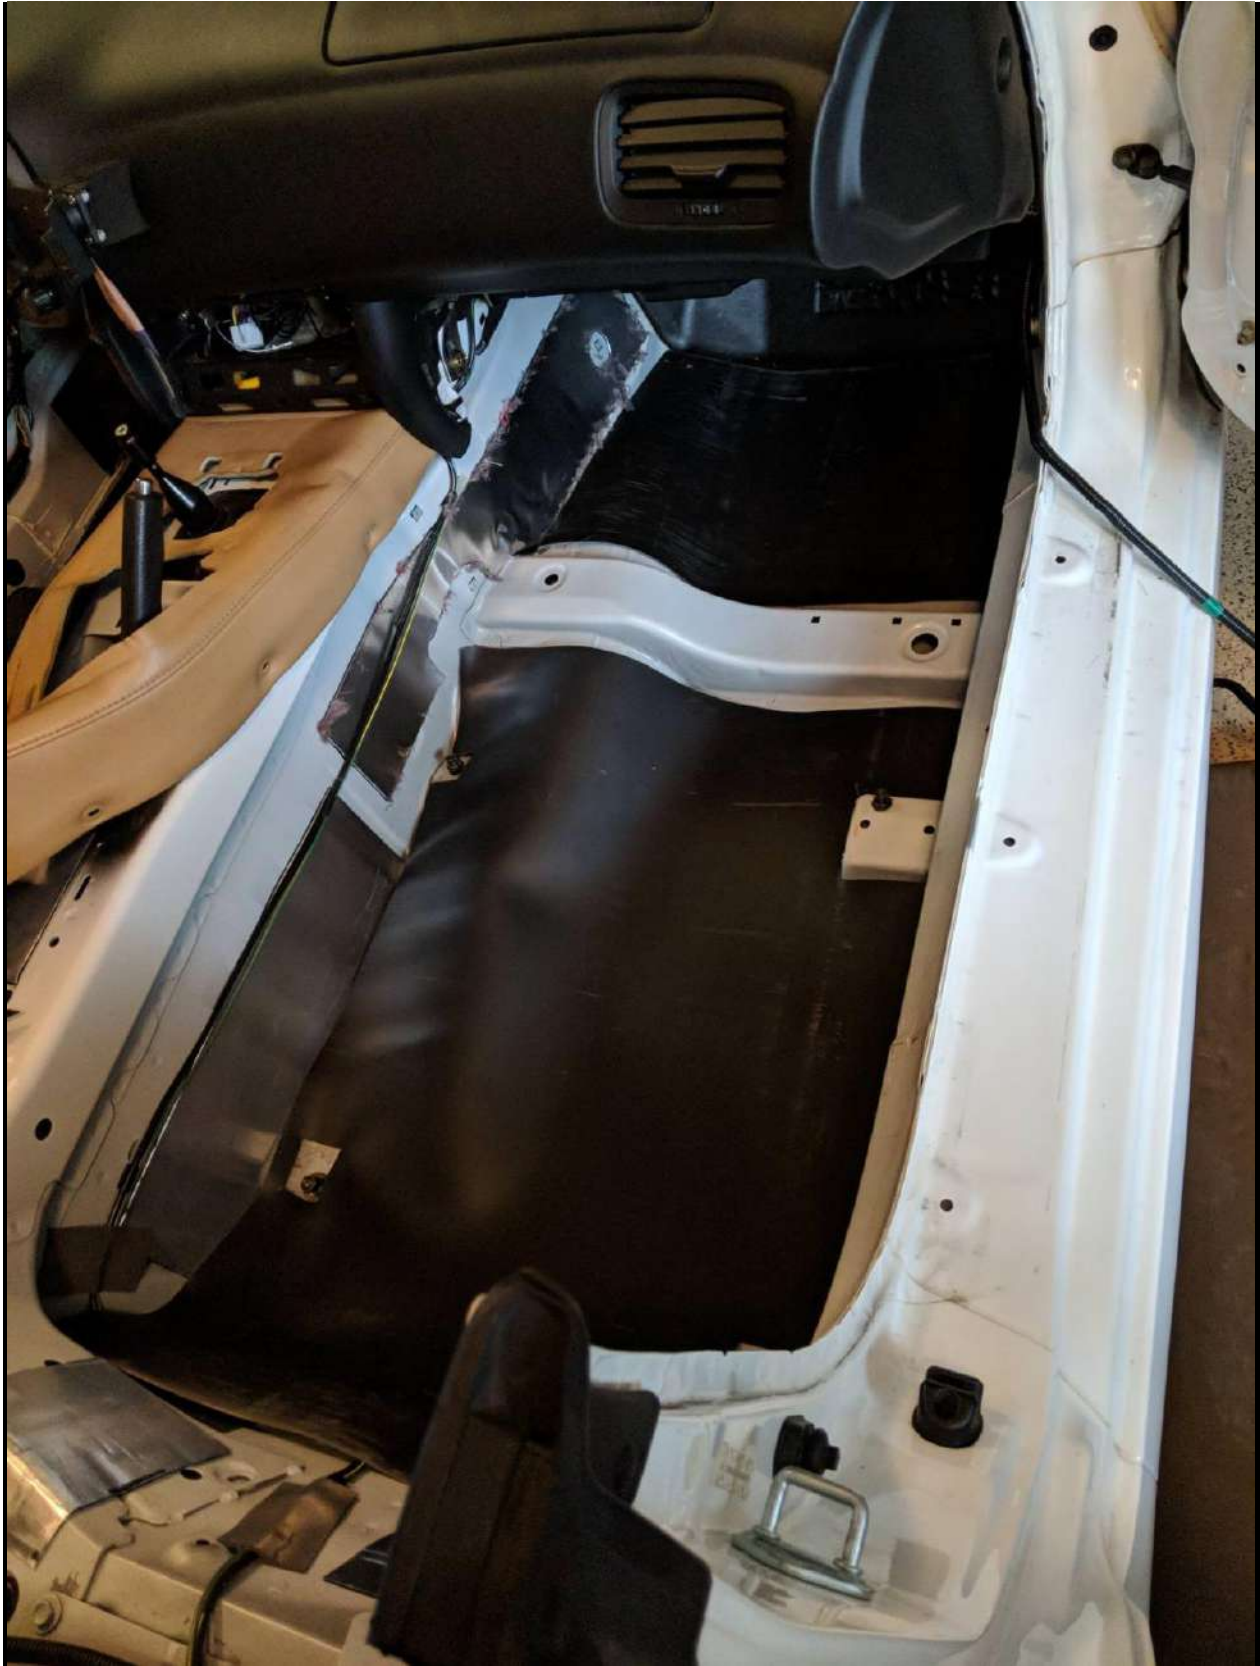
This was the most challenging part of this project, the passenger's side floor. The MLV simply can not be formed to complex shapes. The floor here has compound curves for what appears to be a relief to accommodate the catalytic converter. Although the CCF can be shaped without much difficulty, the MLV will need to be built up from numerous pieces. Here, you can see the 2 primary pieces.

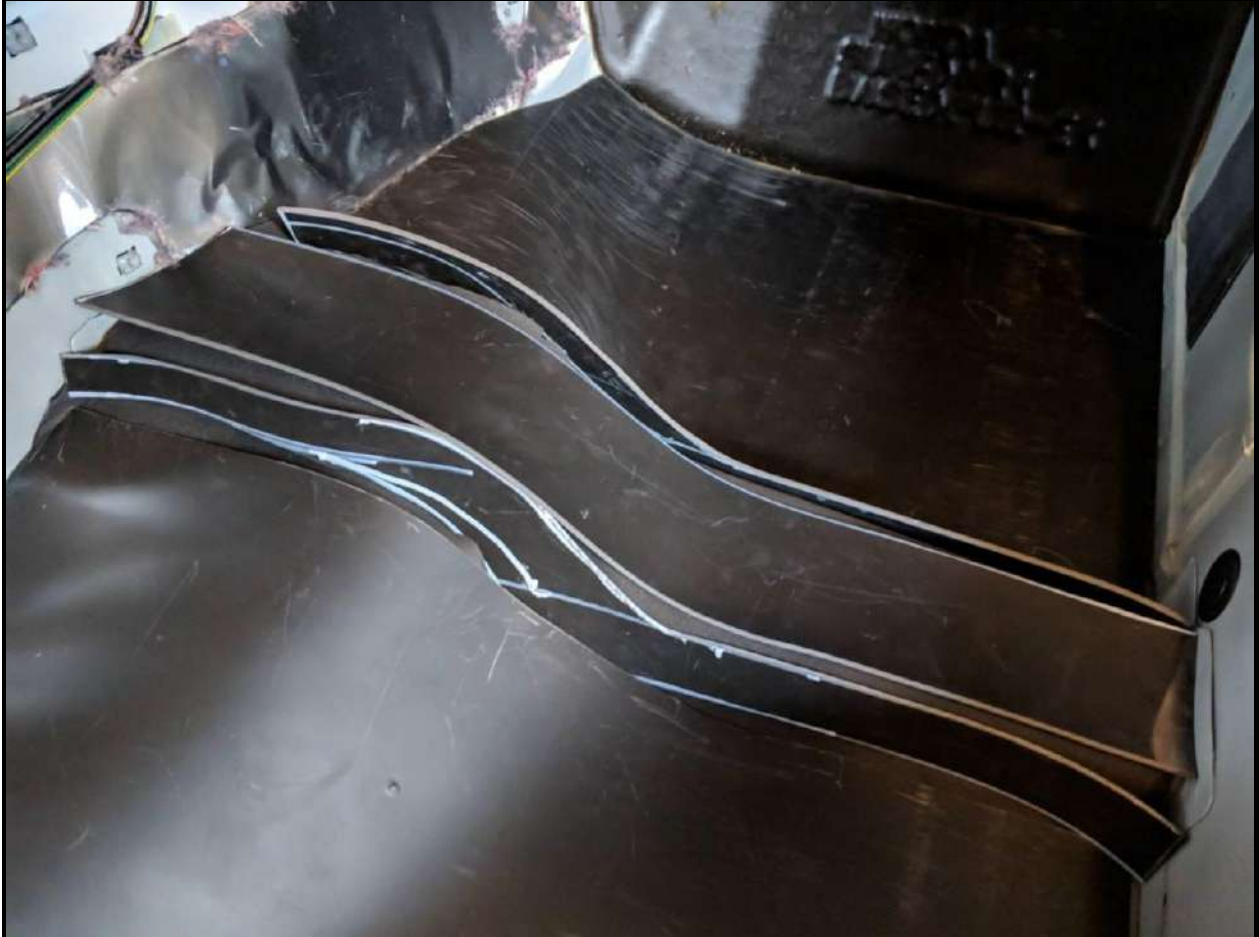
Here you can see 3 more pieces of MLV cut to wrap around a structural support.

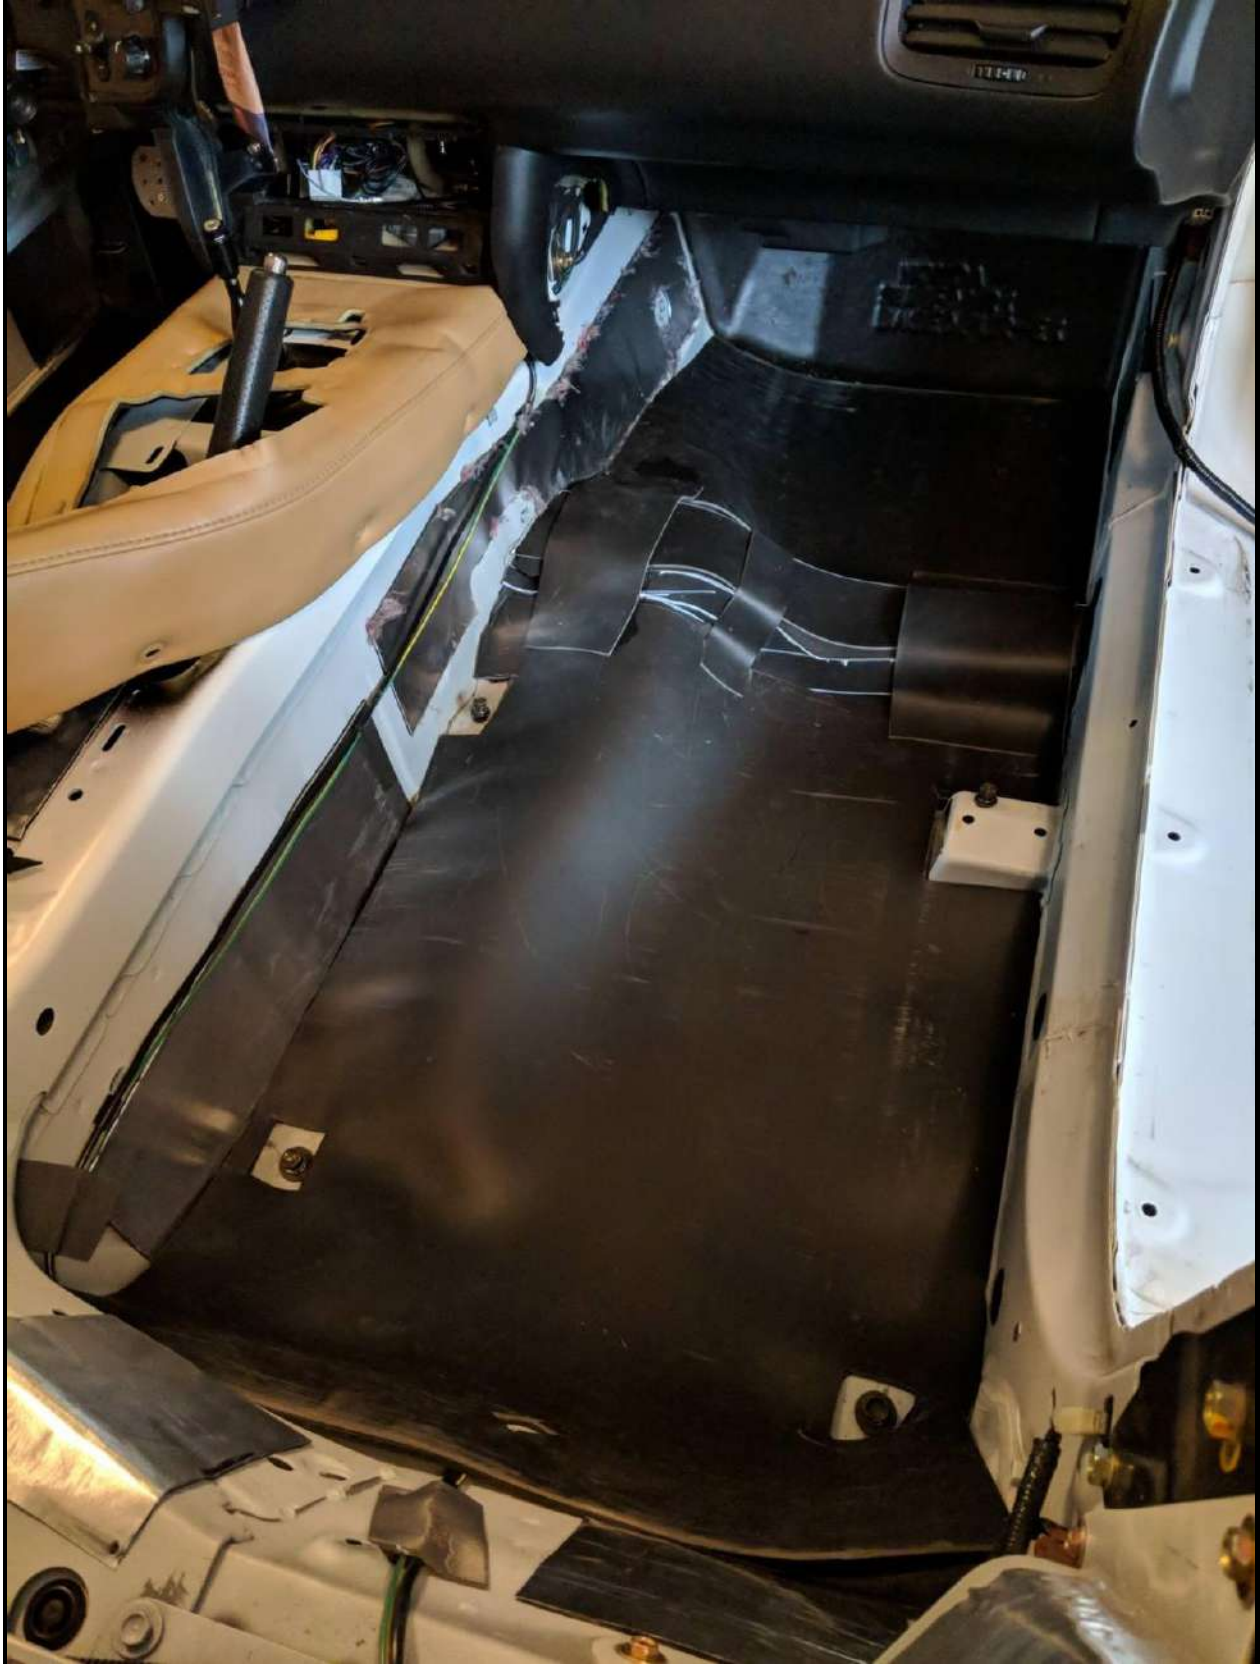
All of the pieces are attached together with more MLV and a healthy application of rubber cement. Here, you can see some of the pieces that were glued in place. Eventually, all of the seams between adjacent pieces of MLV should be covered with more MLV glued in place.

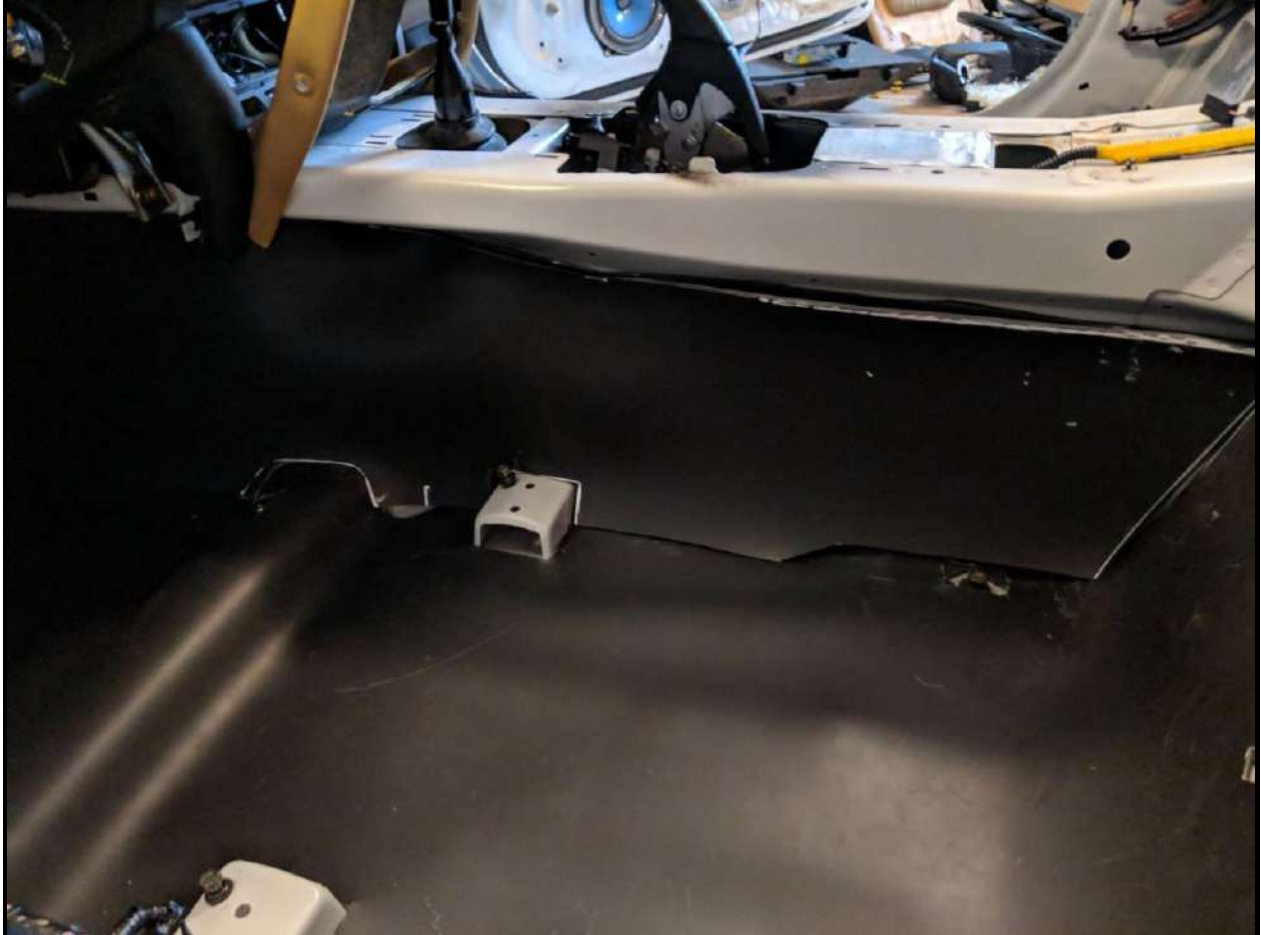
The CCF and MLV for the driver's side of the center tunnel is sized, cut, and installed
