Honda S2000 Sound Deadening Installation

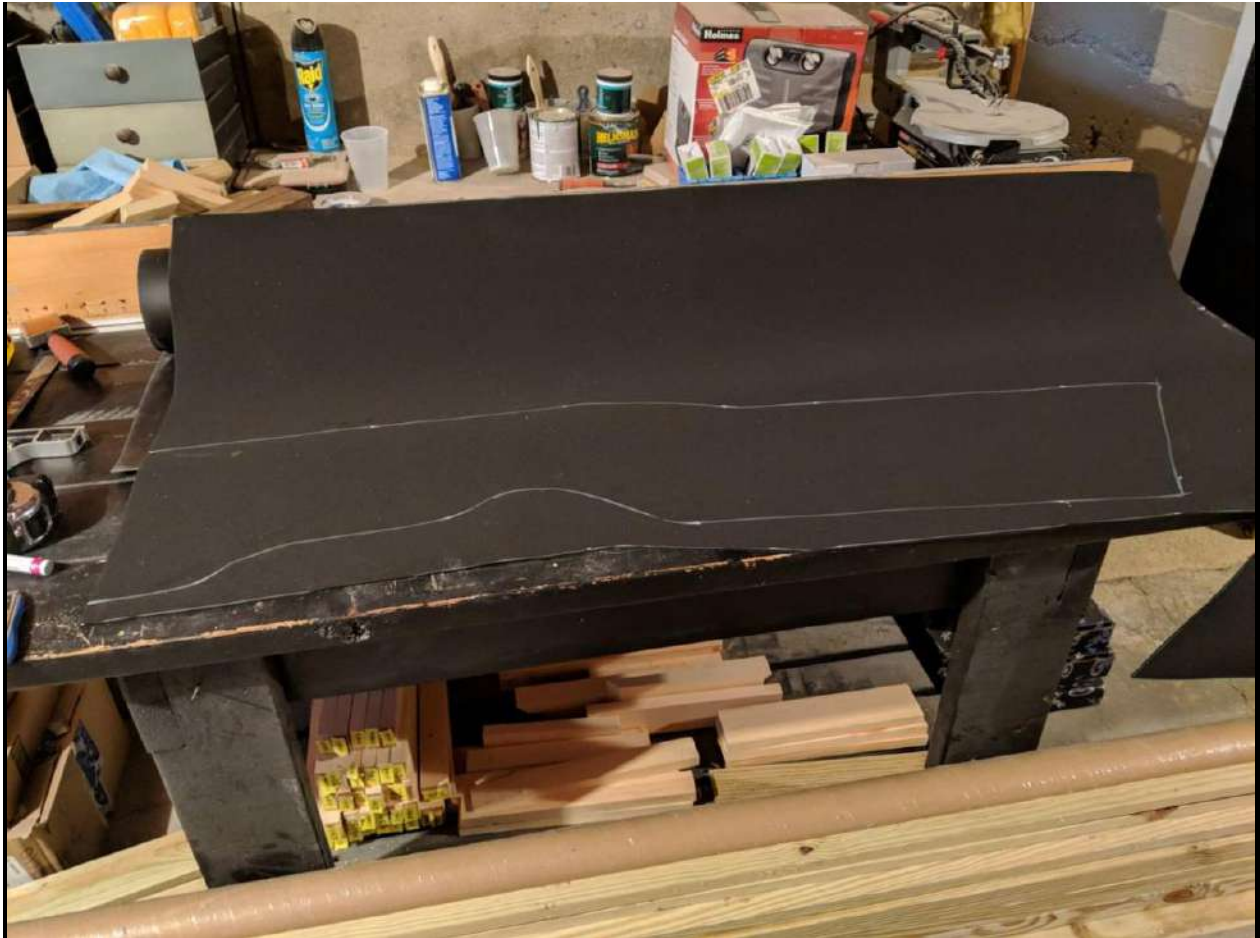
The CCF for the passenger's side of the center tunnel is measured and traced out. From here it is cut out and then trimmed to fit. Once it fits properly, the size is transferred to MLV, for a matching piece.

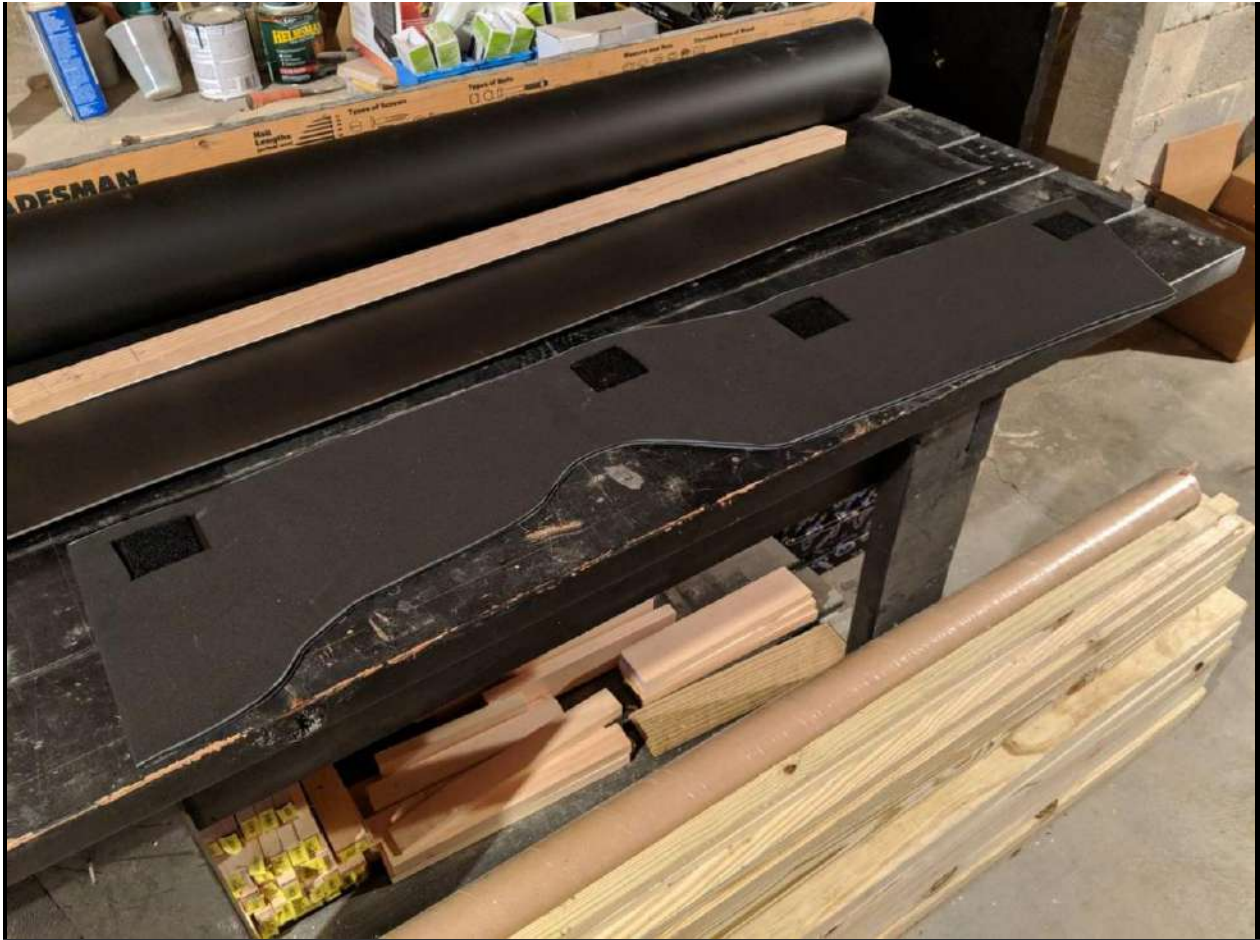
Here, the CCF, with the holes cut for the velcro tape, is laid onto the MLV for the passenger's side of the center tunnel

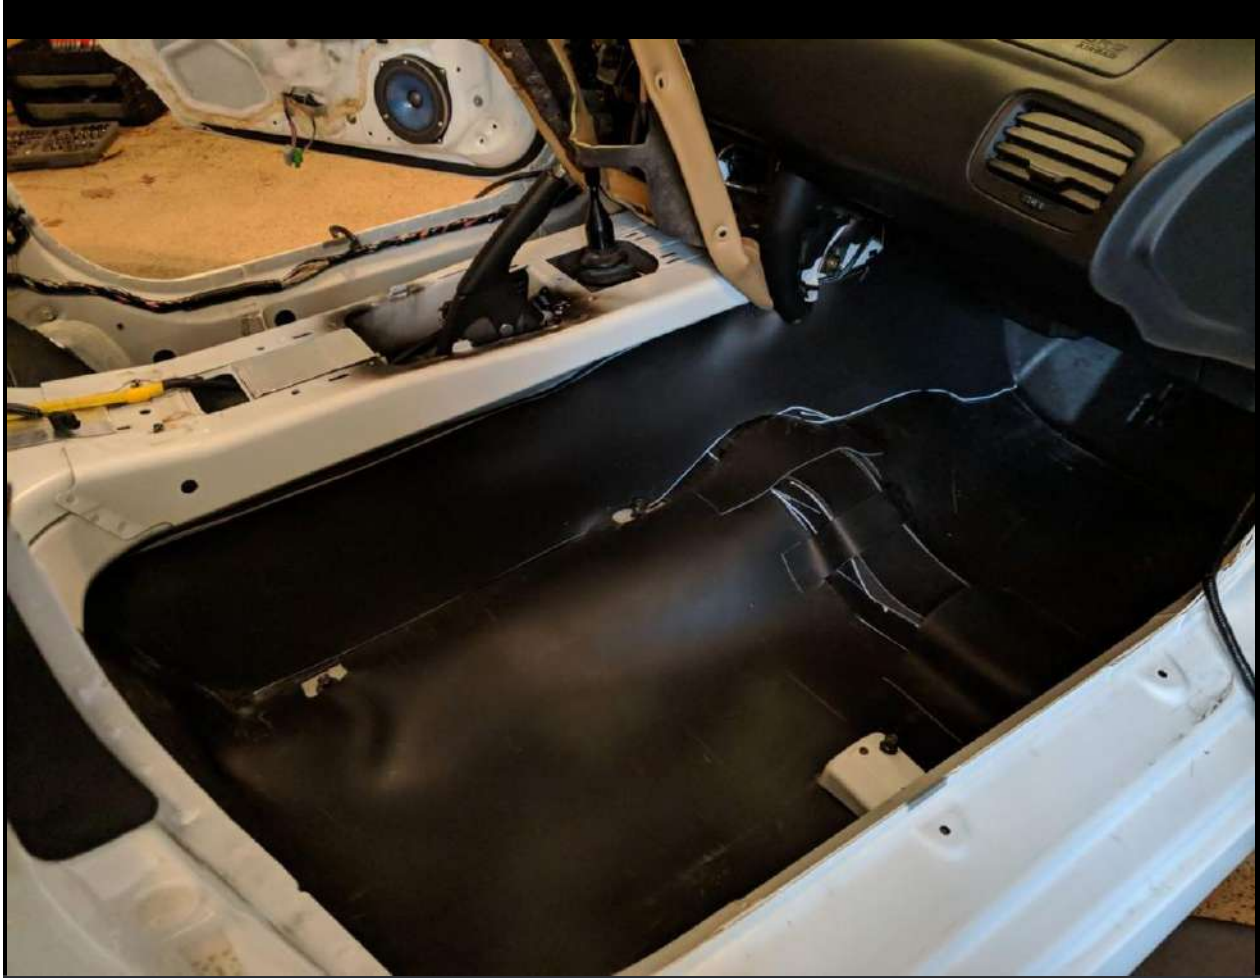
And the two pieces are installed on the tunnel itself

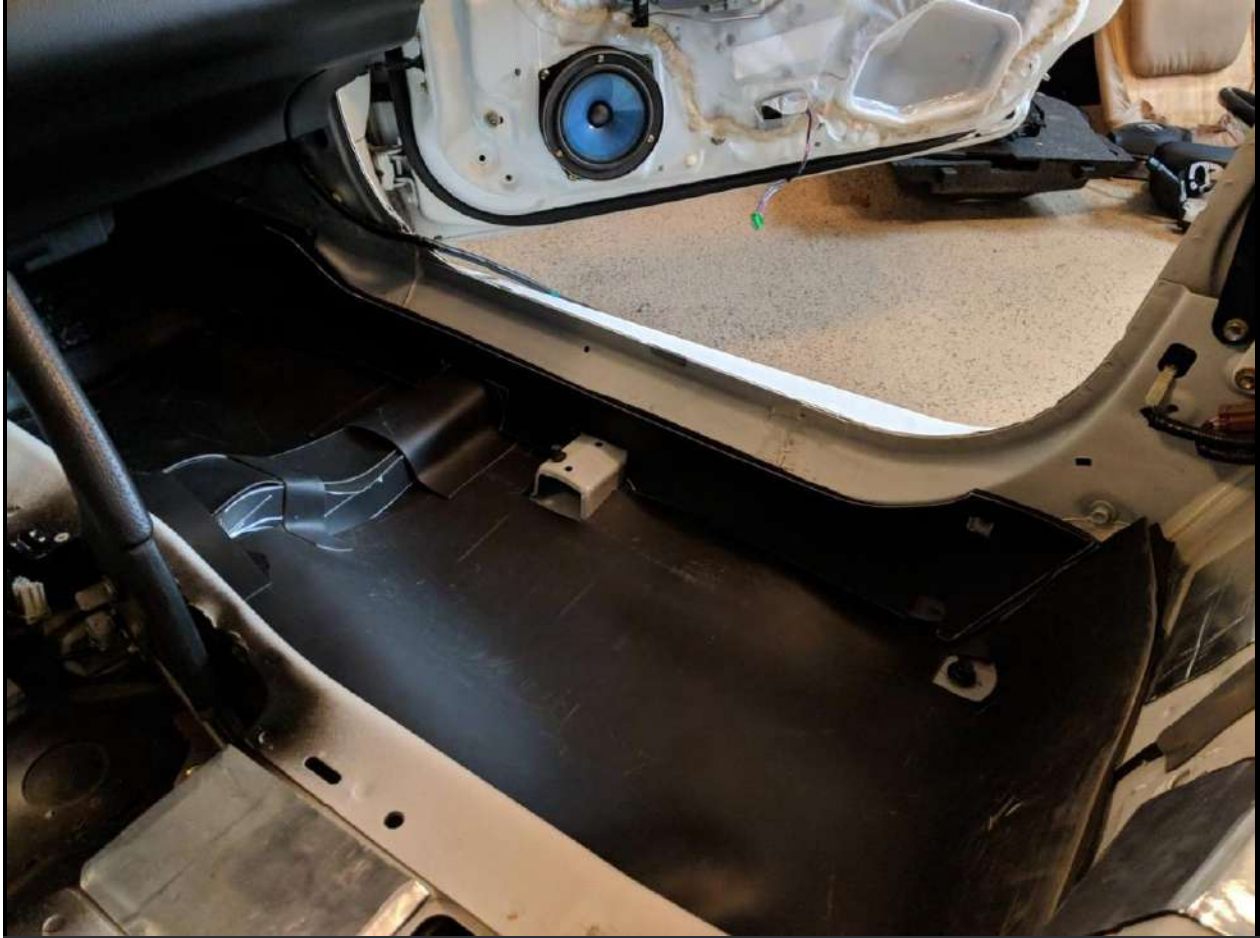
The passenger's side kick panel and under door area is treated with CCF and MLV

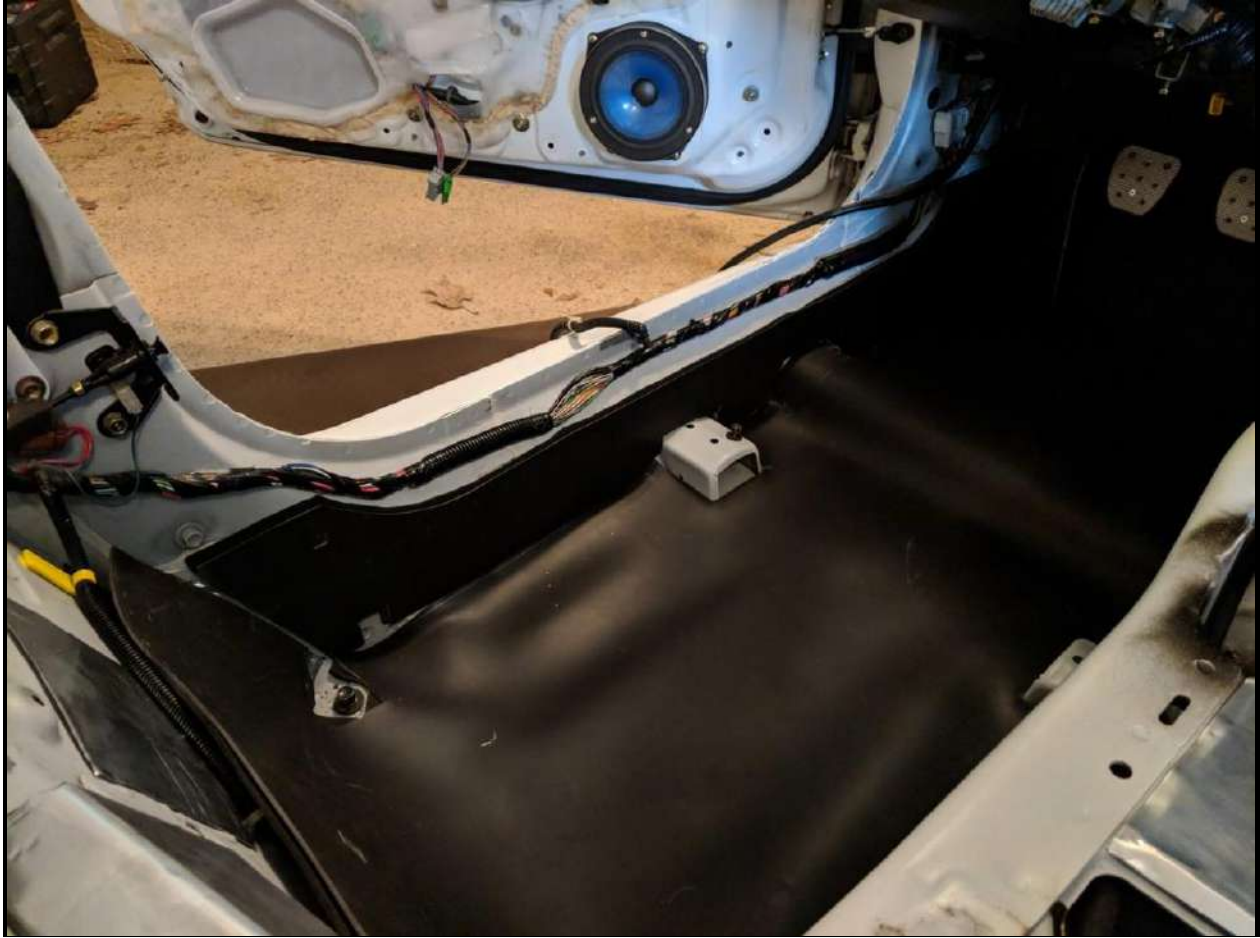
And the same for the driver's side

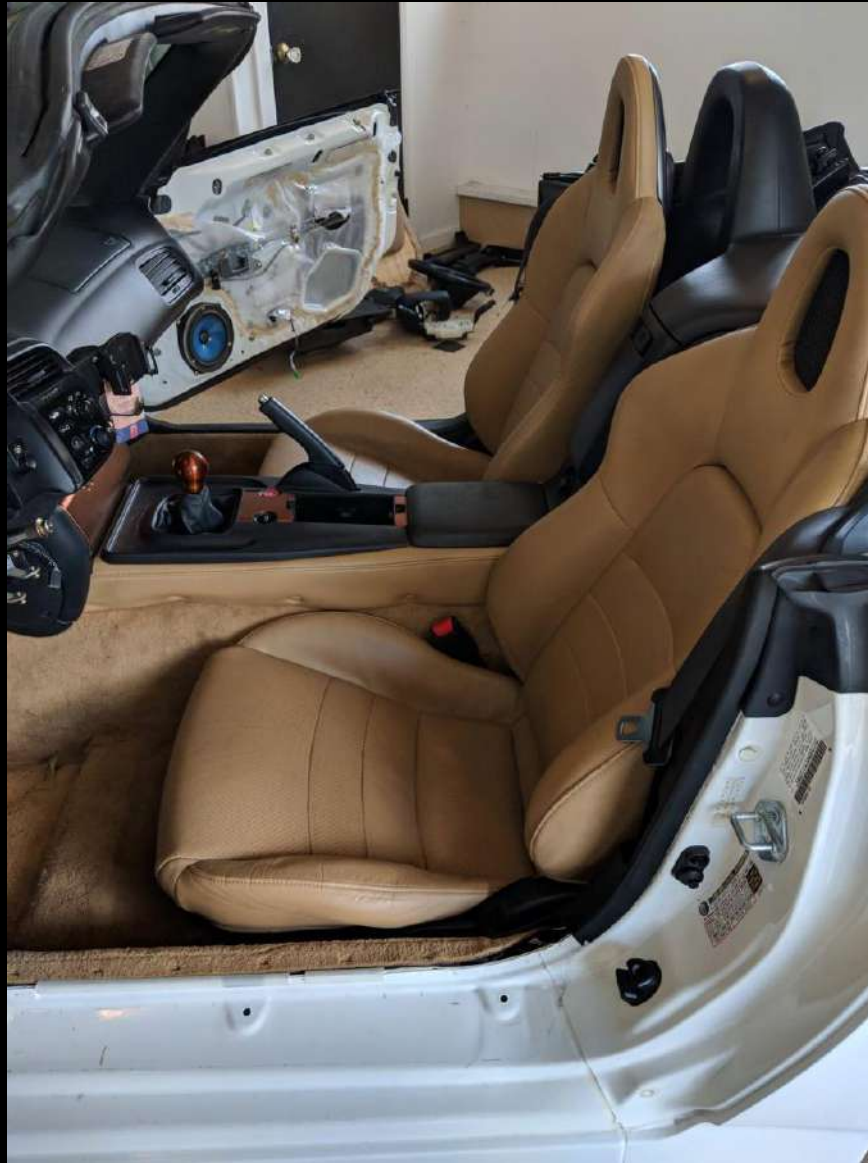
The back of the passenger compartment also got treated with CCF and MLV, and the majority of the interior can now be reinstalled. The carpet will fit somewhat more loosely now, as there is slightly less surface area to cover. You can either trim the excess or tuck it behind adjacent panels.

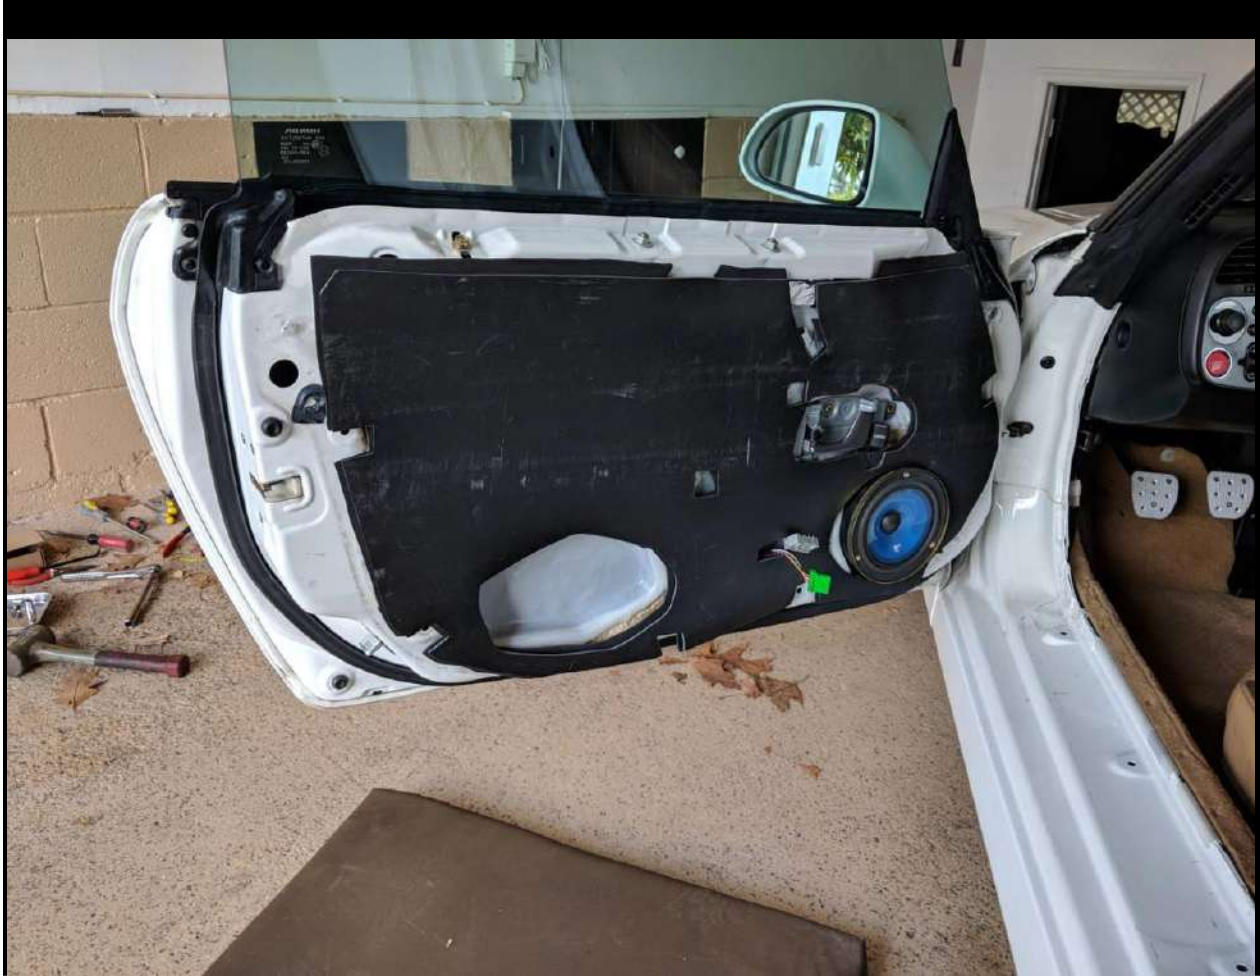
This is the first mockup for the driver's side door treatment. Both CCF and MLV are applied here

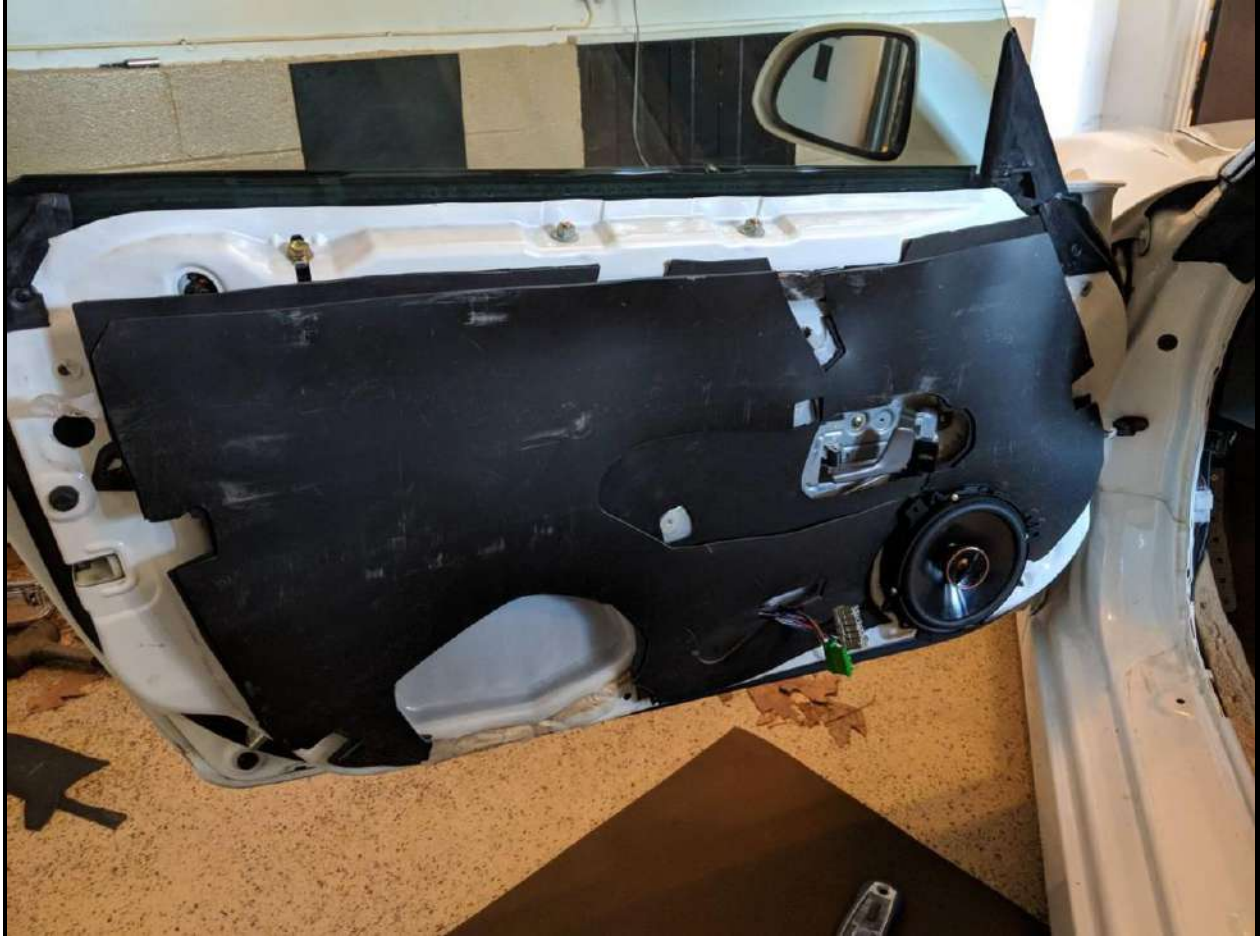
Some trimming was done to the CCF and MLV, to allow the door panel to sit properly on the door. A large center section had to be removed, as it was fouling the door latch/lock mechanism

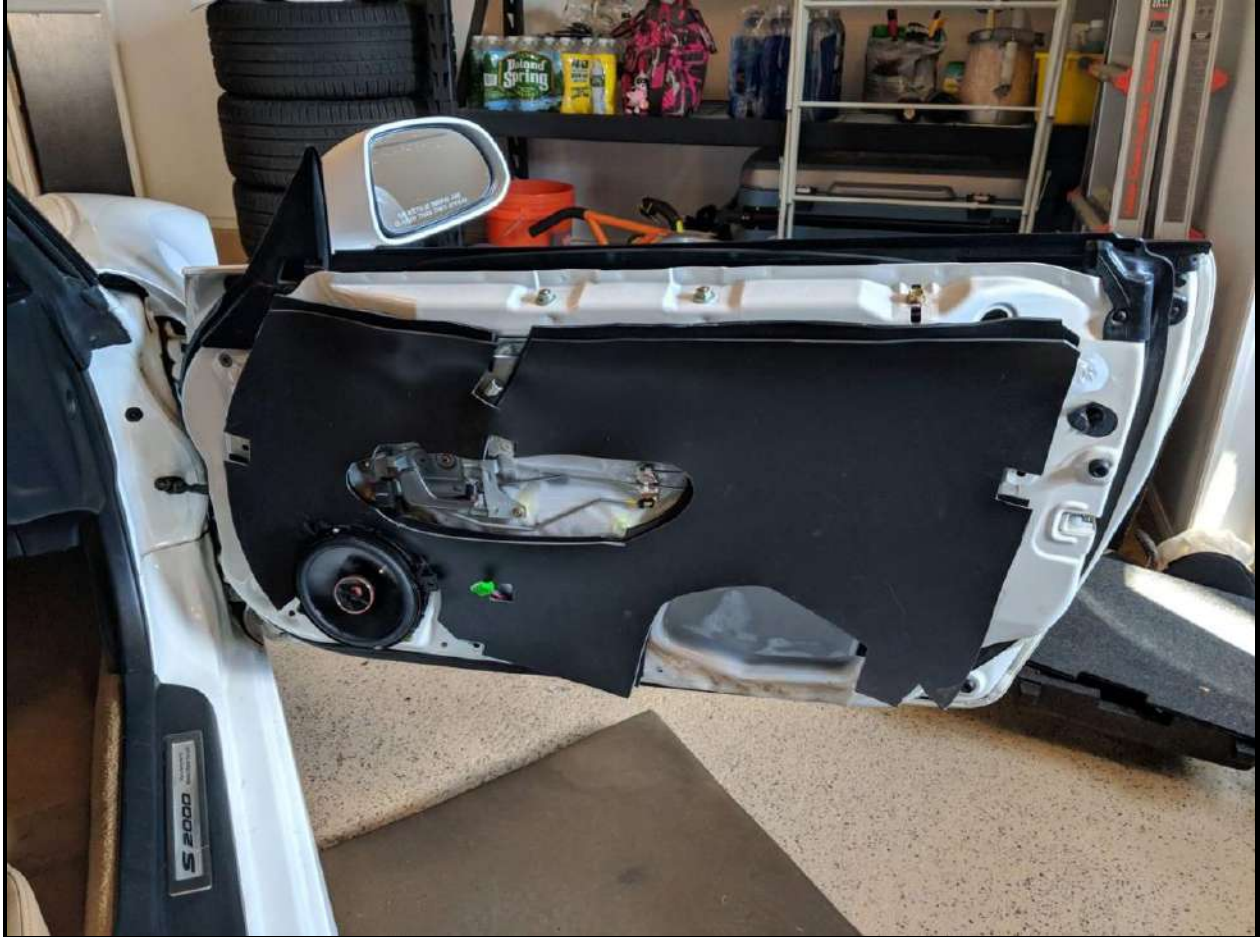
The passenger's side door treatment is also mocked up and trimmed

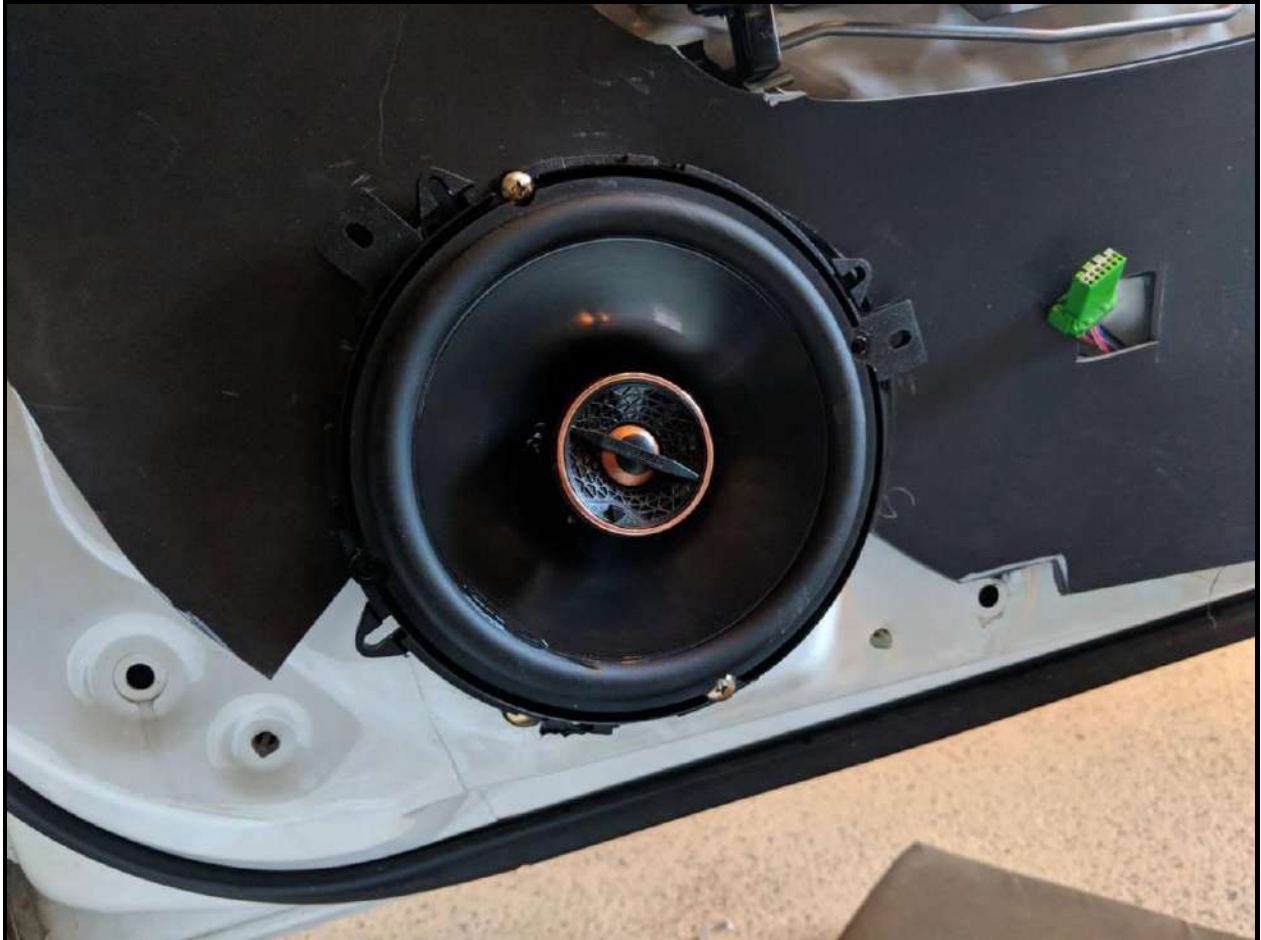
While the doors were open, I replaced the stock speakers with Infinity Reference speakers. These were installed with Metra adapters, so the stock speakers can easily be reinstalled. The trim rings included with the new speakers had to be trimmed so that they would not foul the door panels.

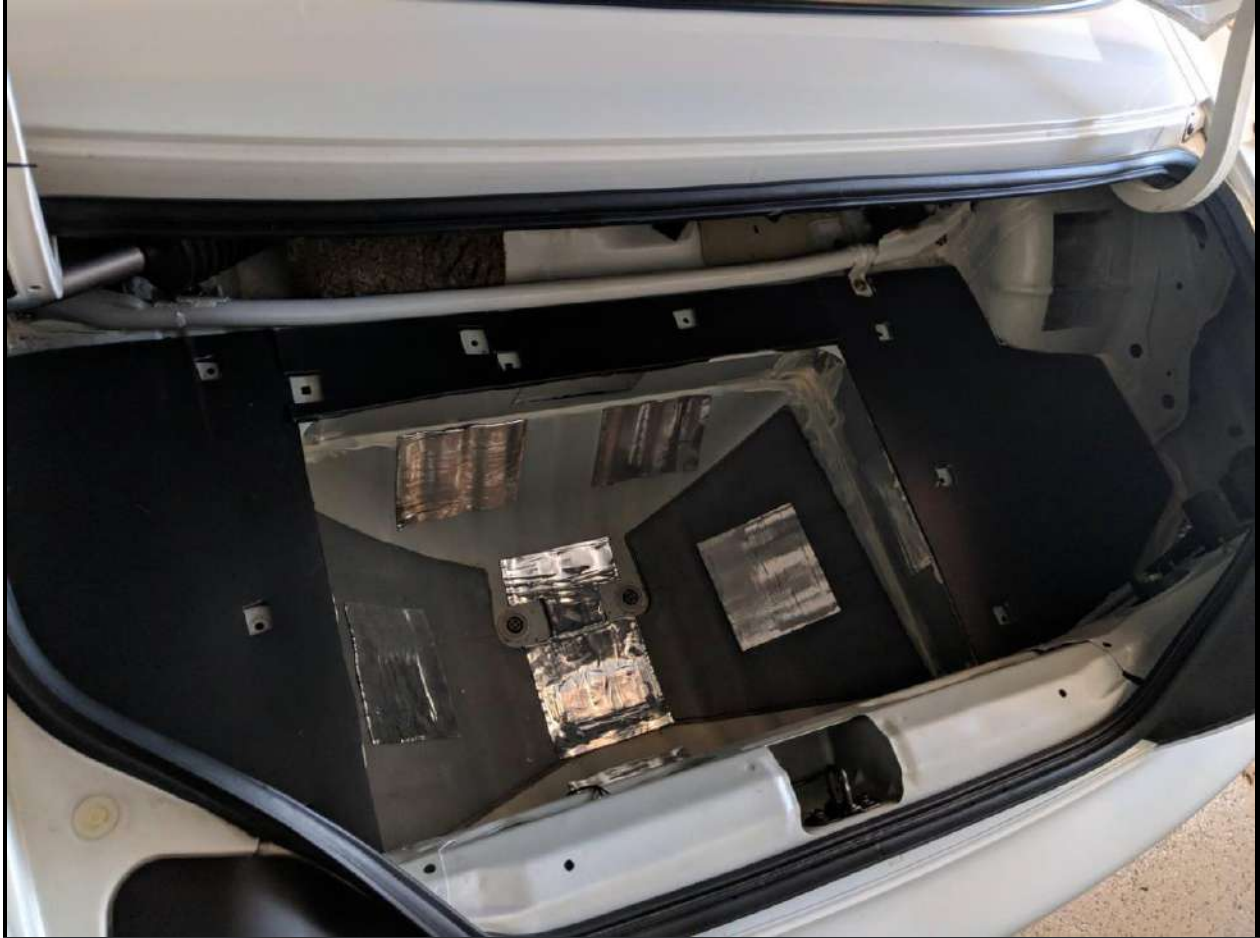
The floor of the trunk is treated with CCF and MLV, with holes cut out for mounting the trim panels

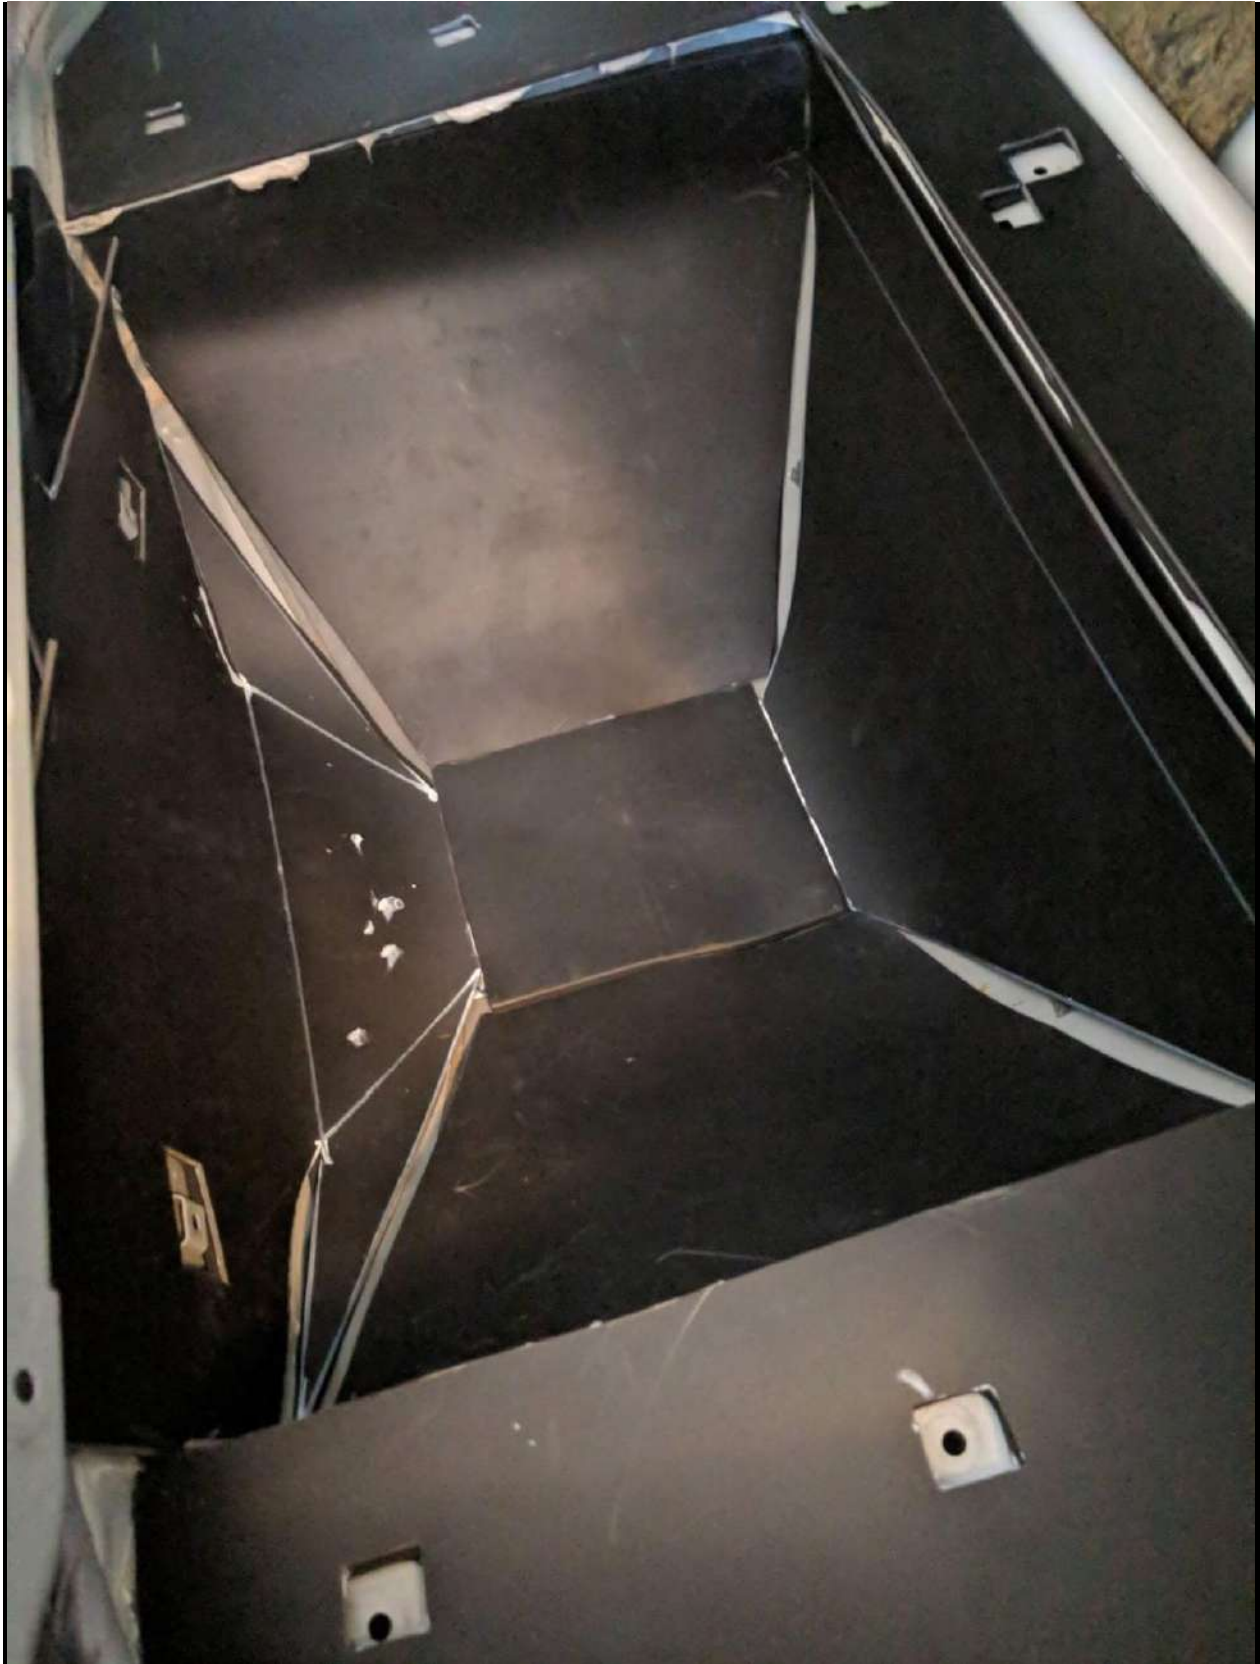
The back of the trunk and the trunk well are also treated with CCF and MLV

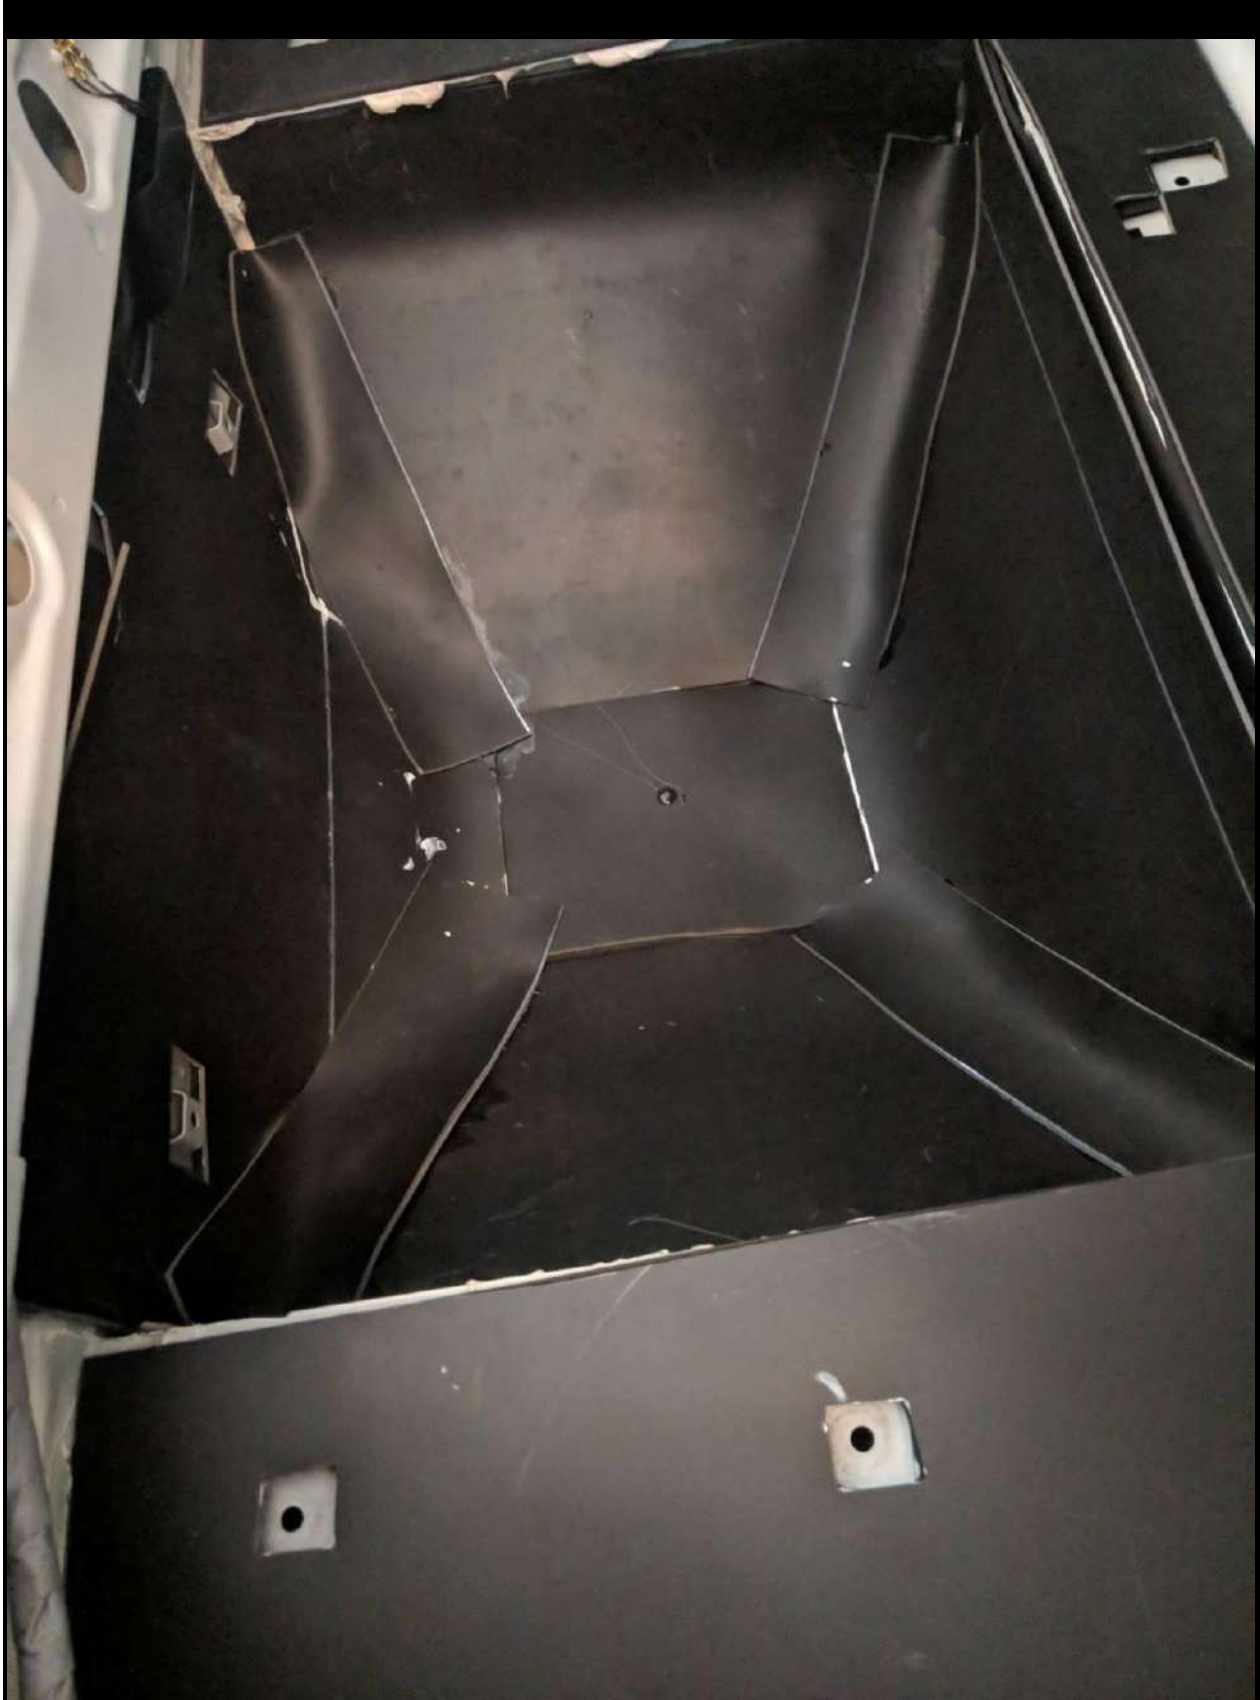
Here you can see an example of covering the MLV seams with strips of more MLV and rubber cement. The MLV treatment throughout the vehicle should have the seams sealed similarly :-)

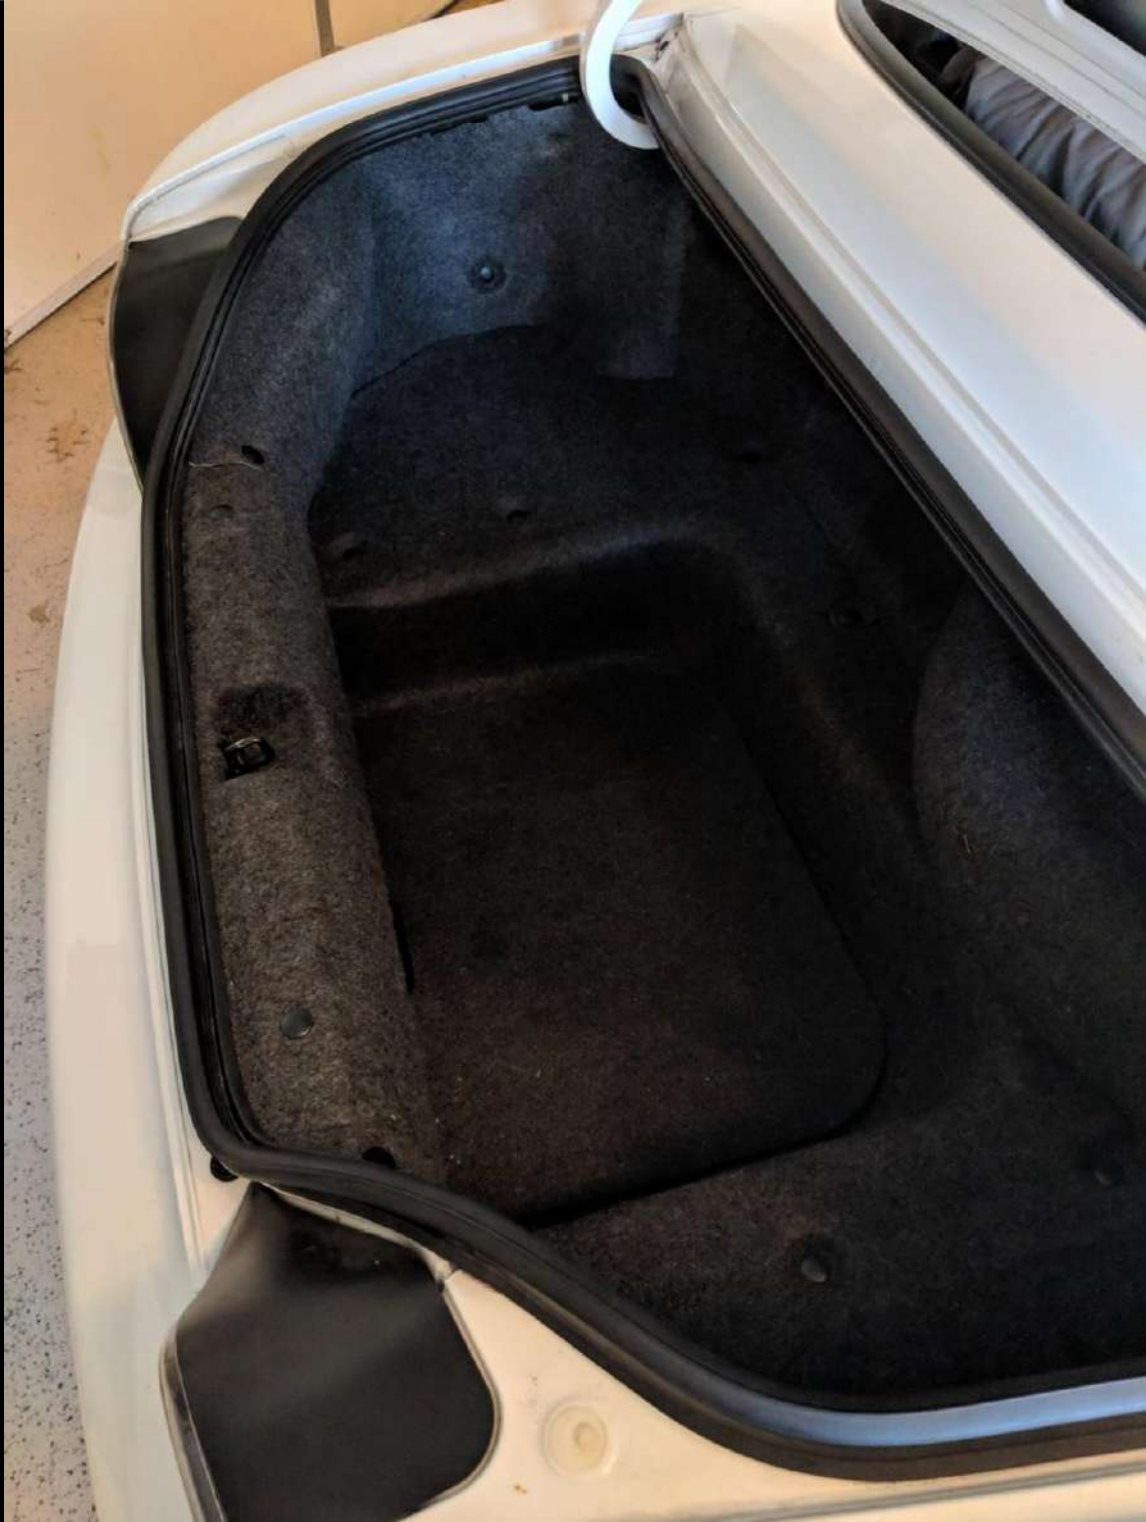
The trunk trim panels are reinstalled

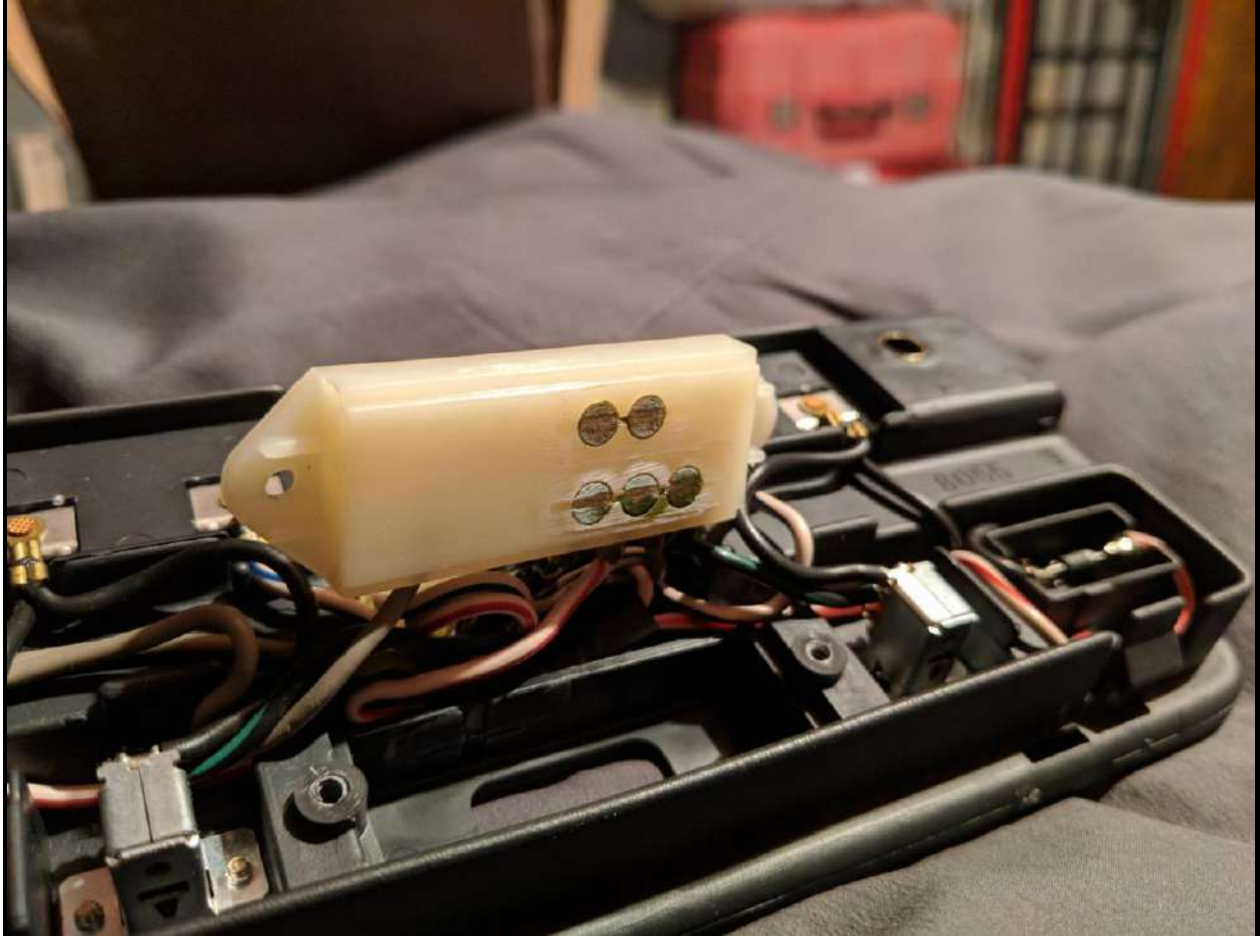
While I had the car apart, I worked on a few other things. One issue was the intermittent operation of the dome light. I took the switch apart, and found the contacts covered in corrosion and lithium grease. I cleaned the contacts up, and the dome light works perfectly now.

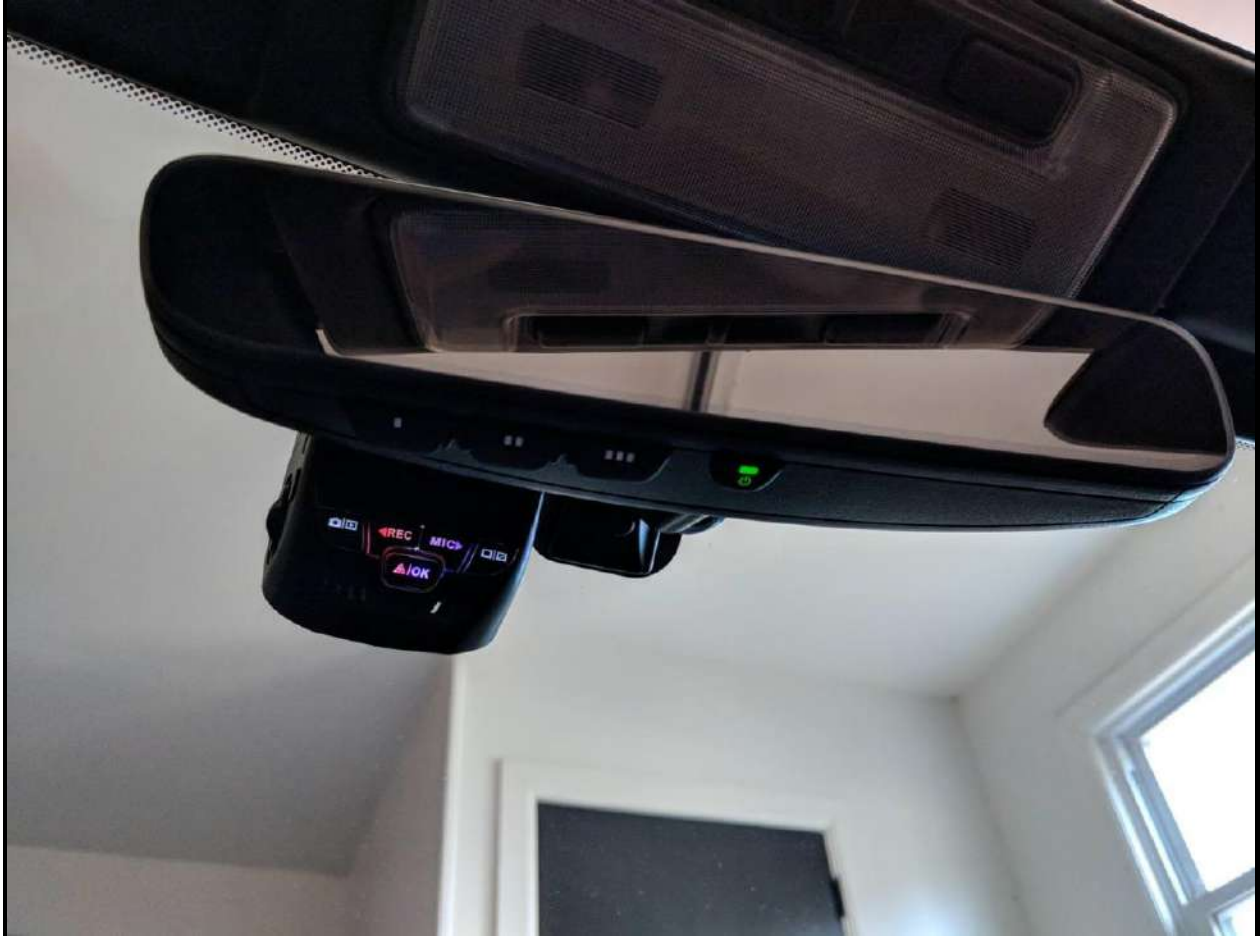
I also installed a frameless autodimming rearview mirror with HomeLink, and a dash cam. The wiring for both was run behind the header trim panel, down the driver's side A pillar, and down to the fuse box which has spare power taps for Constant Source, Ignition Source, and Lighting Source. I connected the dash cam and autodimming power to the Ignition Source and the HomeLink power to the Constant Source.

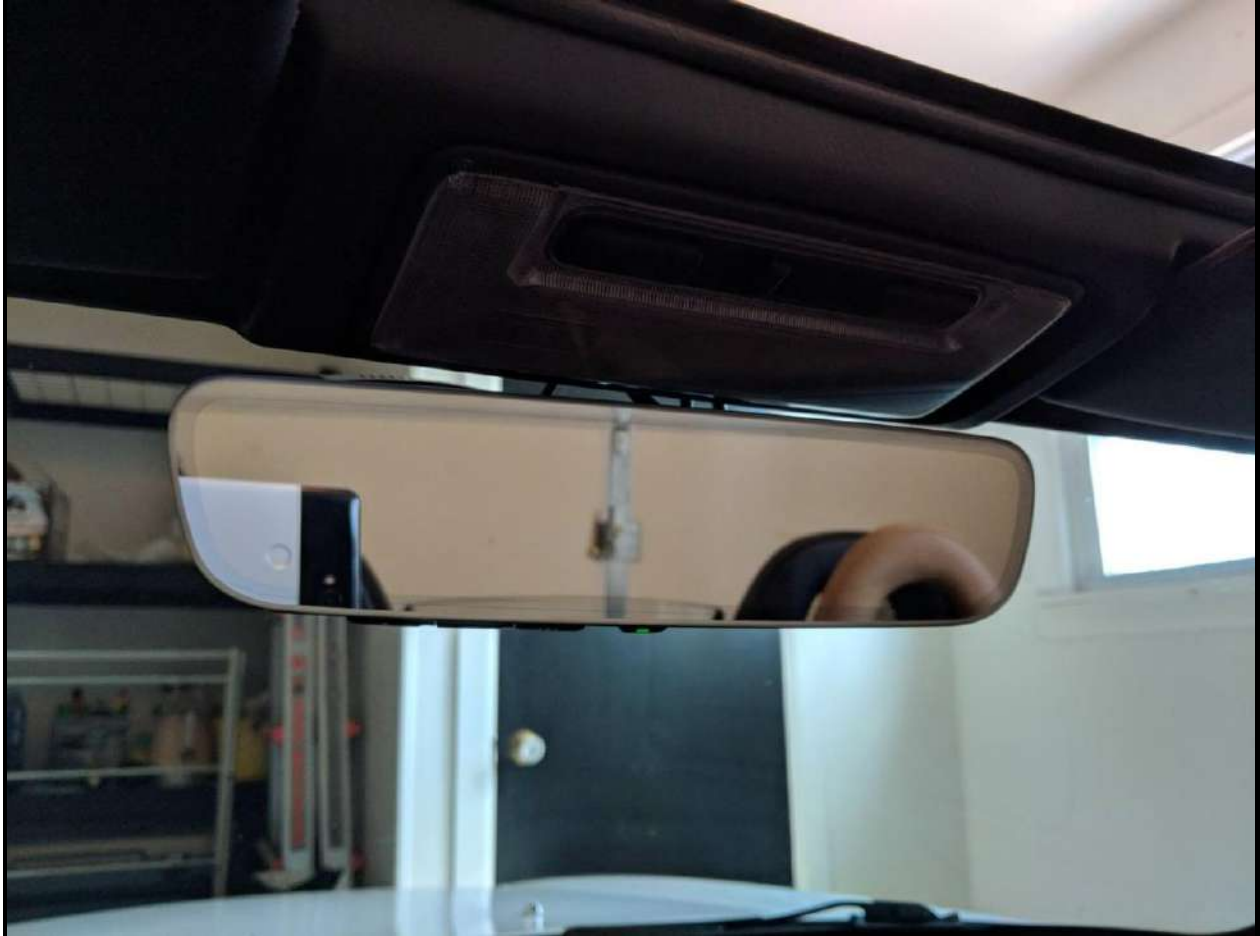
Here you can see the mirror as the driver would normally see it. It obscures the dash cam and EZ Pass tag well.
