Honda S2000 Sound Deadening Installation

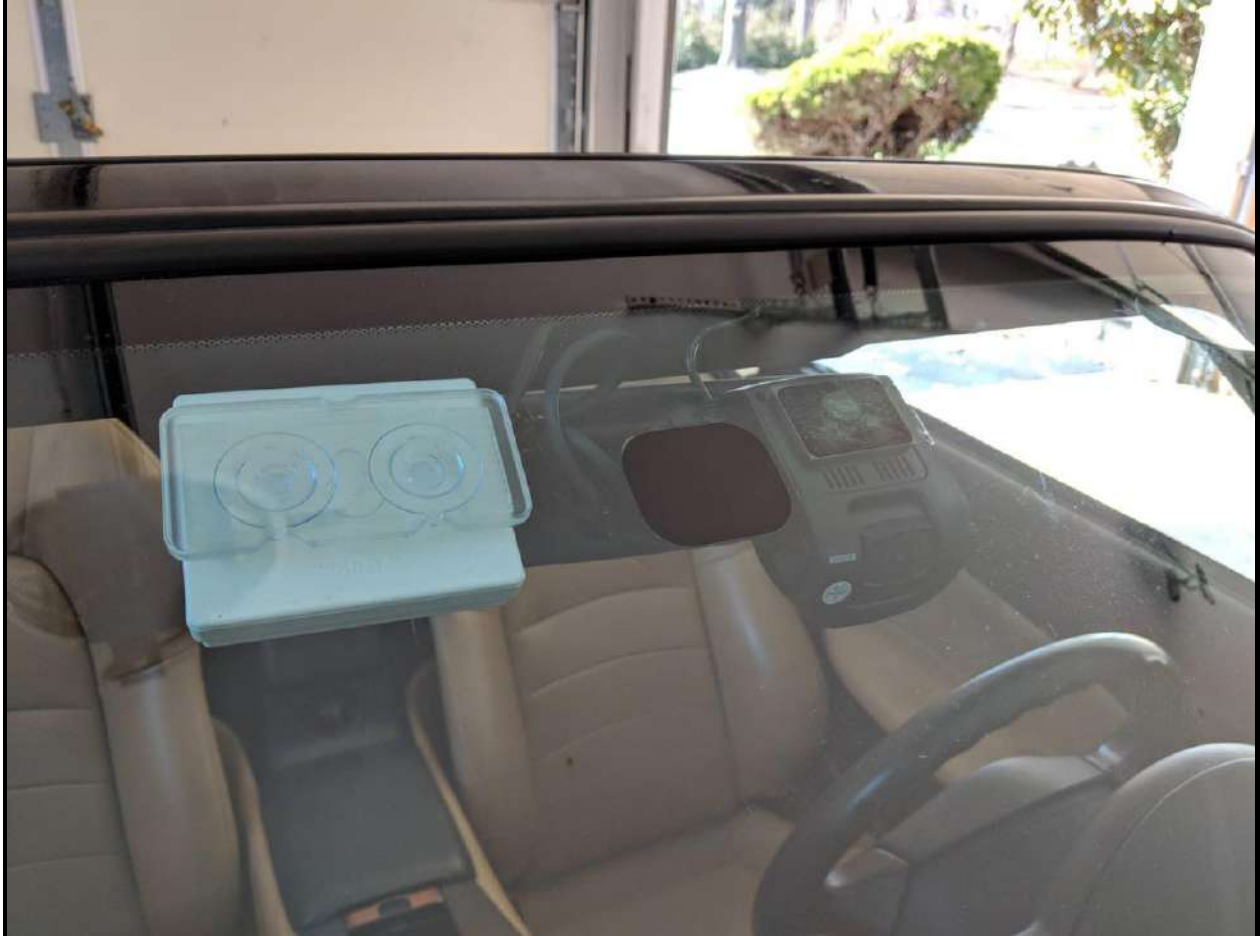
From the other side of the windshield, you can see the dash cam and mirror mount, as well as the small amount of exposed wiring.
