Applies To: **See VEHICLES AFFECTED**
February 13, 2004

Fuel Fill Cap Binds and Possible MIL Comes On With DTC P1456 (Supersedes 04-002, dated January 30, 2004)

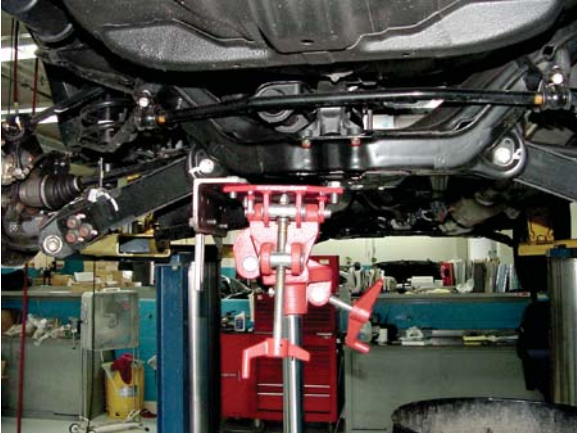
1. Raise the vehicle on a lift, and remove the left rear wheel.
2. Remove the three EVAP canister mounting bolts. Let the canister hang in place.
3. Support the rear suspension cross beam with a powertrain lift or commercially available jack as shown.

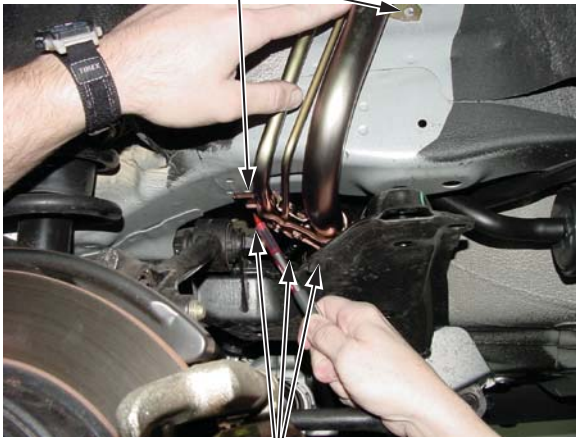
FUEL FILL PIPE
BRACKET BOLTS

4. Disconnect the fuel fill pipe hoses from the fuel fill pipe.

Disconnect the
fuel fill pipe hoses.

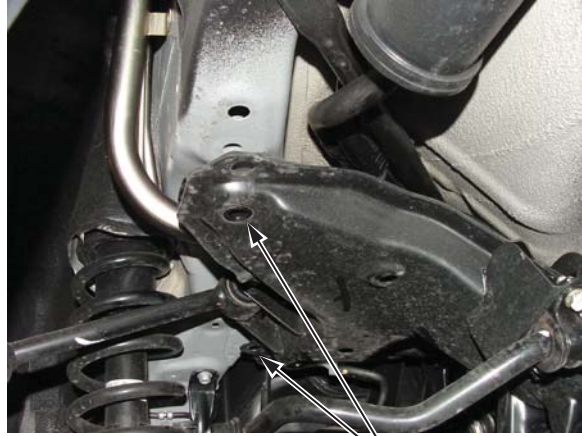
5. Remove the two lower rear cross beam bolts, the two fuel fill pipe bracket bolts, and the fuel fill pipe gasket.

Remove the cross
beam bolts.

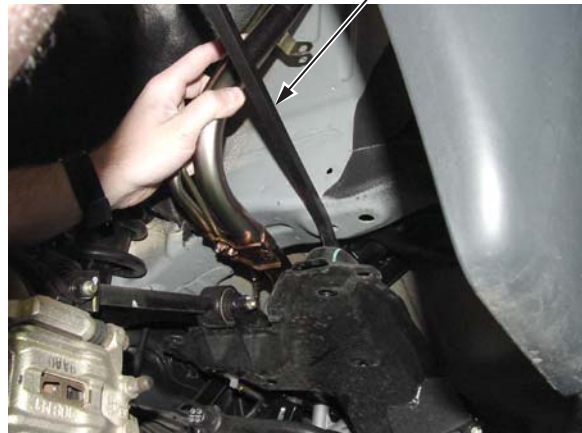
PRY BAR

6. Using a pry bar, move the rear cross beam down to make room to remove the fuel fill pipe.

7. Install the new fuel fill pipe, the fuel fill pipe gasket, and the hoses. Torque the two cross beam bolts to 69 N·m (51 lb-ft). Reinstall the EVAP canister and the wheel.
8. Connect the HDS to the vehicle's DLC (data link connector), and do the EVAP function test:
 - From the HDS main menu, select **Honda System**.
 - From the Honda System menu, select **PGM-FI**.
 - From the PGM-FI menu, select **Inspection**.
 - From the Inspection menu, select **EVAP Test**.
 - From the EVAP Test menu, select **Function Test**.
 - Follow the instructions on the screen.
9. Check the results of the EVAP function test.
 - If the vehicle passed the test, return it to the customer.
 - If the vehicle failed the test, do the DTC P1456 troubleshooting in section 11 of the appropriate CR-V service manual.

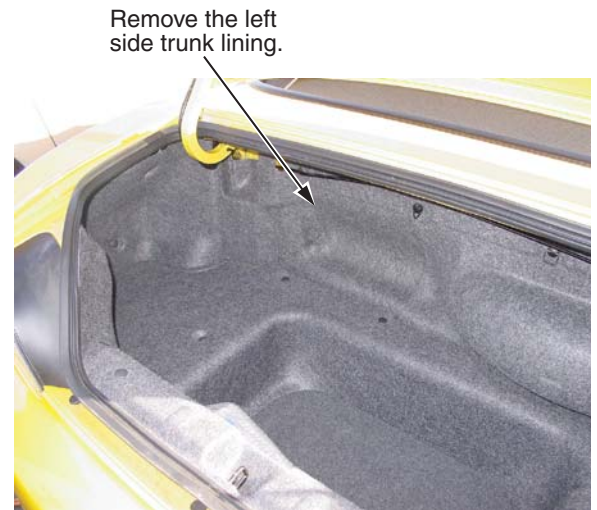
1. Remove the left side trunk lining.

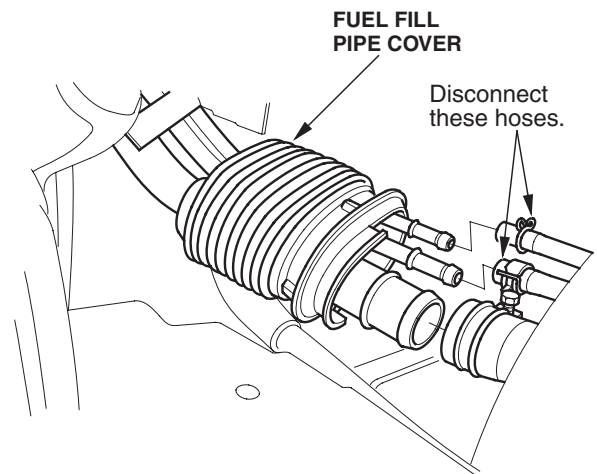
2. Slide up the fuel fill pipe cover, and disconnect the fuel fill pipe hoses.

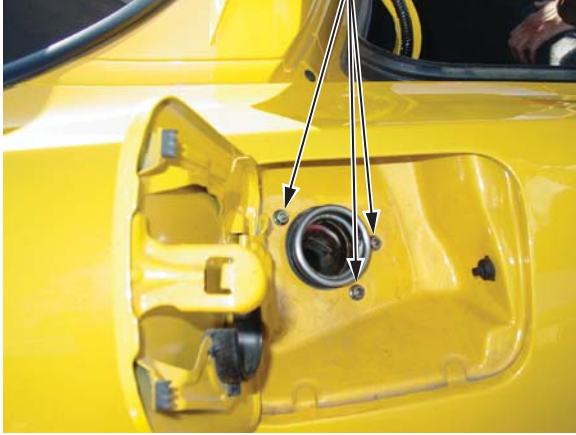
3. Remove the fuel fill pipe attachment nuts.

Remove these nuts.

4. Install the new fuel fill pipe with the original nuts.
5. Install the fuel fill pipe hoses with the original clamps. Make sure the fuel fill pipe cover is seated properly. Install the trunk lining.
6. Connect the HDS to the vehicle's DLC (data link connector), and do an EVAP function test:
 - From the HDS main menu, select **Honda System**.
 - From the Honda System menu, select **PGM-FI**.
 - From the PGM-FI menu, select **Inspection**.
 - From the Inspection menu, select **EVAP Test**.
 - From the EVAP Test menu, select **Function Test**.
7. Check the results of the EVAP function test.
 - If the vehicle passed the test, return it to the customer.
 - If the vehicle failed the test, do the DTC P1456 troubleshooting in section 11 of the 2002–04 S2000 Service Manual.

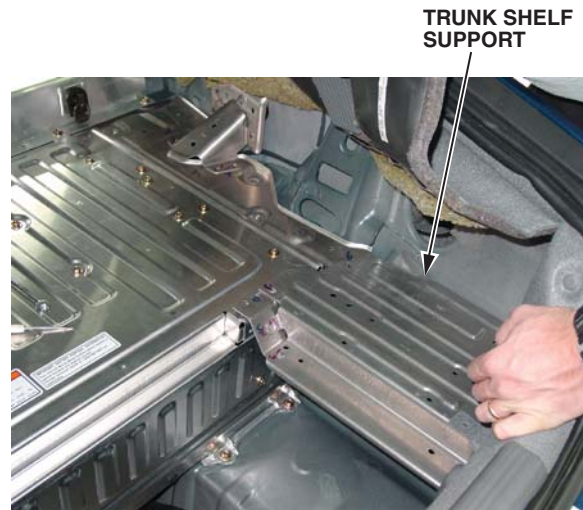
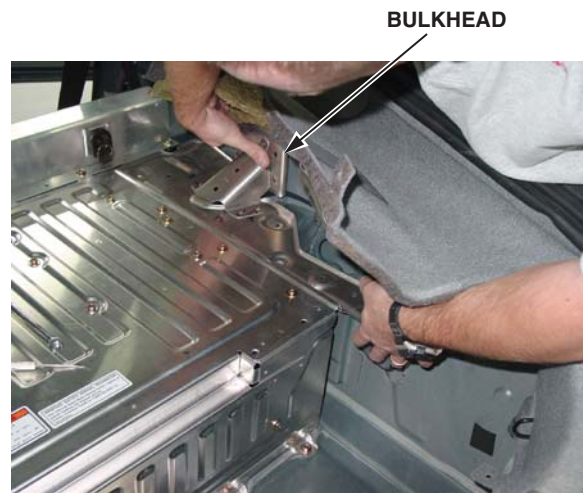
1. Remove the trunk lining and the cargo box. (See page 20-44 of the 2000–04 Insight Service Manual.)
2. Remove the right trunk side bulkhead and the right side trunk shelf support.

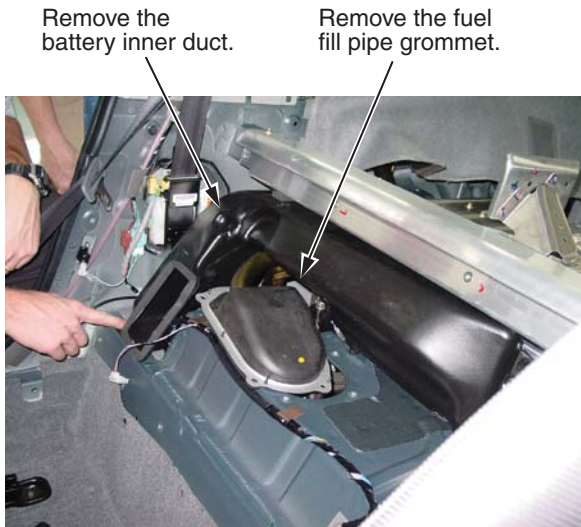
4. Remove the battery inner duct and the fuel fill pipe grommet.

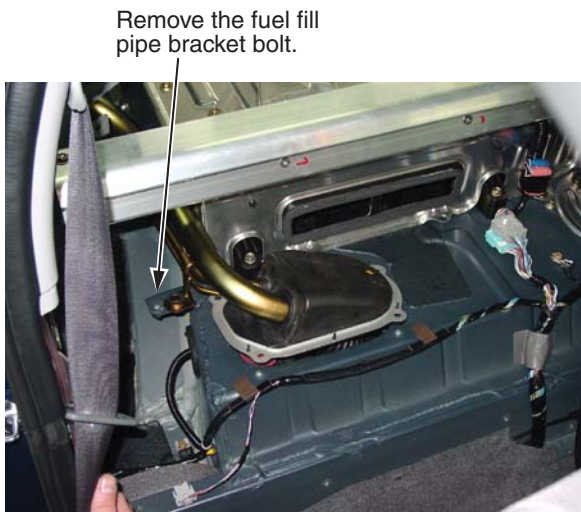
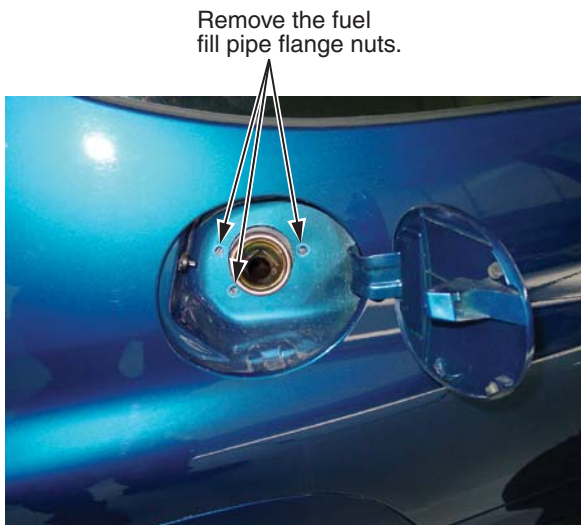
5. Slide the fuel fill pipe grommet upward. Then disconnect the fuel fill pipe hoses.
6. Remove the fuel fill pipe bracket bolt and the three fuel fill pipe flange nuts.

7. Install the new fuel fill pipe with the original nuts and bolt.
8. Install the fuel fill pipe hoses with the original clamps. Install the fuel fill pipe grommet.
9. Reinstall all removed parts.
10. Connect the HDS to the vehicle's DLC (data link connector), and do the EVAP function test:
 - From the HDS main menu, select **Honda System**.
 - From the Honda System menu, select **PGM-FI**.
 - From the PGM-FI menu, select **Inspection**.
 - From the Inspection menu, select **EVAP Test**.
 - From the EVAP Test menu, select **Function Test**.
 - Follow the instructions on the screen.
11. Check the results of the EVAP function test.
 - If the vehicle passed the test, return it to the customer.
 - If the vehicle failed the test, do the DTC P1456 troubleshooting in section 11 of the 2000-04 Insight Service Manual.
