The subject of "windshield tape" has come up in various threads, and I promised to document my effort to remove mine from my new '02 blue. Here it is, in detail. I wanna thank the others who have done this before and raised the subject in the first place. I would not have known anything about this without you guys having posted about it. **Thanks.**

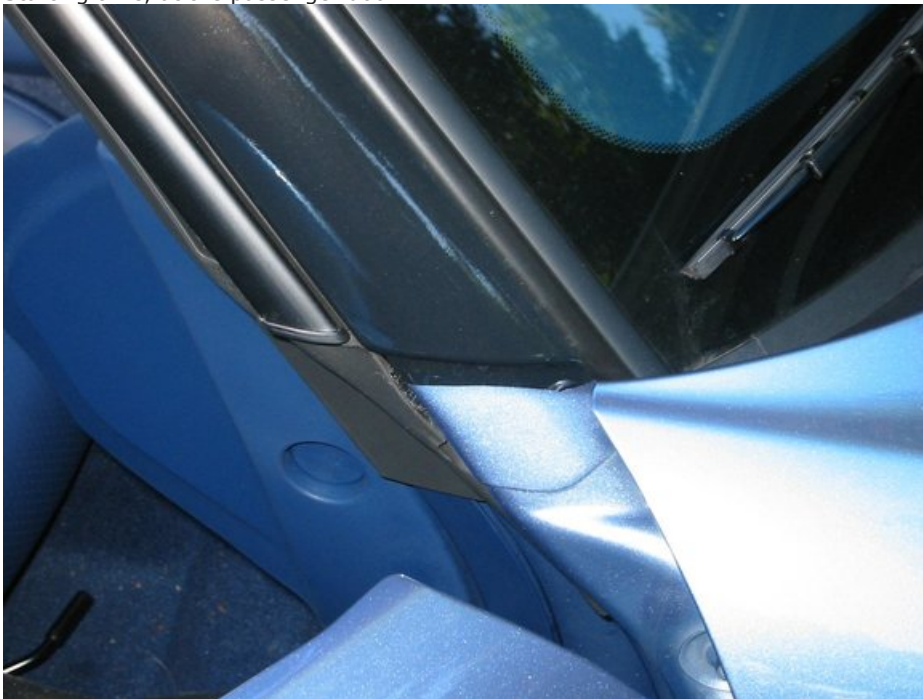
Starting time, at the passenger door..

OK, here we go. First, the tape on my car was in three sections; two side strips and one top strip. The way my tape was overlapped, I had to remove these in two sections. I do not know if Honda does it the same way on every car, but, hey, this is Honda... probably! Anyway, I started by opening the passenger door and finding the bottom of the tape. Using my nail to pry up one corner, I started peeling up. The first picture shows the starting point at the base of the frame on the passenger door side. The following two pix show the first peels. I will continue the documentation afterwards.

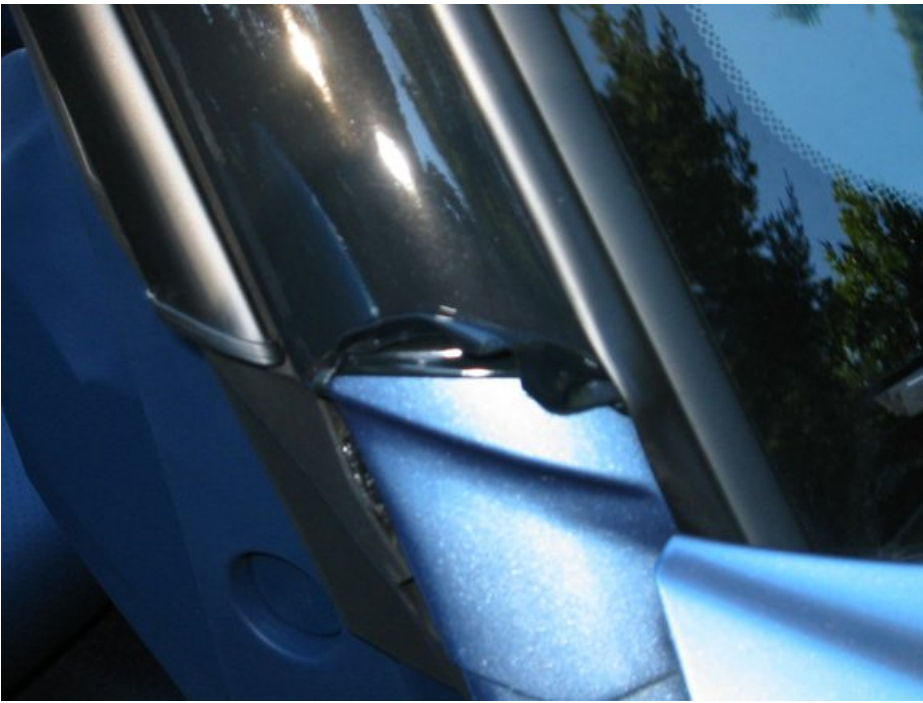
first peel...

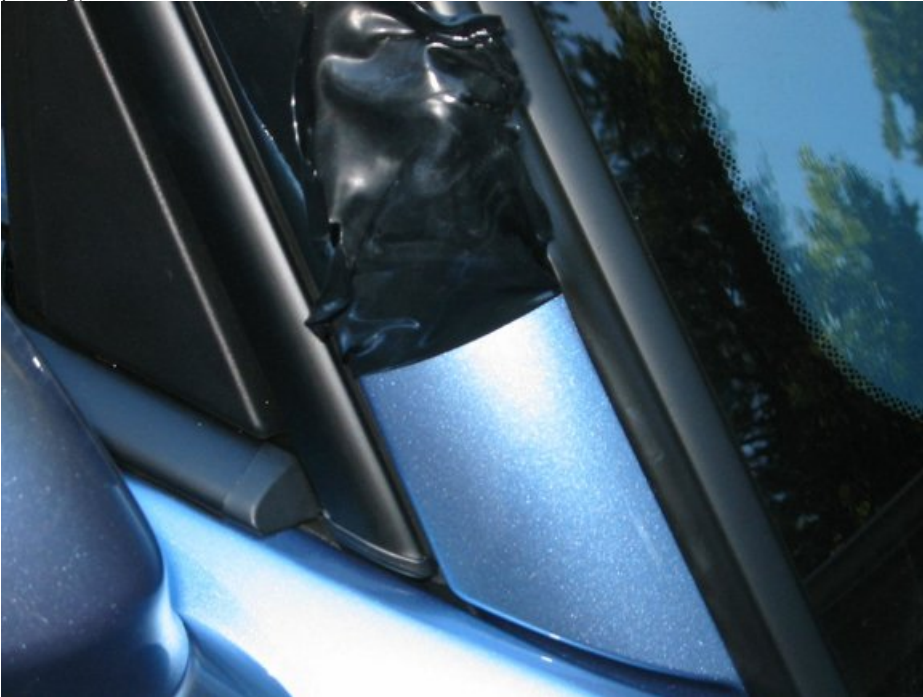
peeling, cont...

The technique is pretty intuitive; you pull from the sides, at about 90 degrees straight out from the body, or even a little sharper. If you keep your fingers on the sides, you won't leave any bits of the tape under the mouldings. Clearly the mouldings are glued on after the tape is applied, so there are a few spots where you wanna push up the molding a bit and jiggle the tape so it doesn't tear. After you remove the tape, just press the moulding back down as it belongs. I had no problems with this. Don't confuse the sticky moulding glue with the tape -- the glue stays 😊

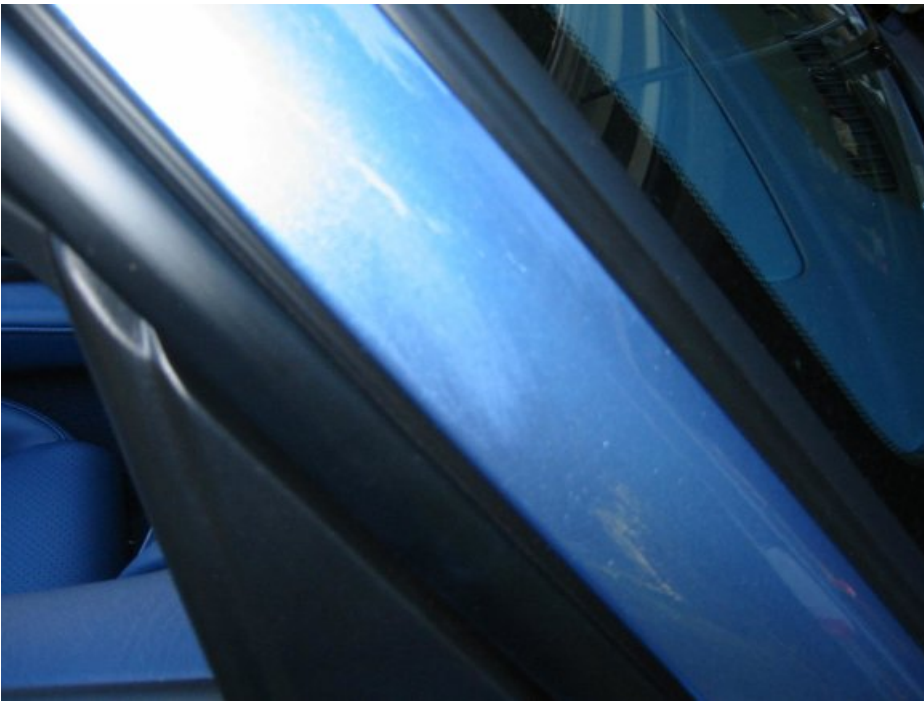
Anyway, at this point I encountered the two scuffed-paint sections on my windshield frame. The first one isn't that visible in the picture, but the second one is pretty clear. I think you'll see what I mean...

passenger side paint scuff (from factory!)

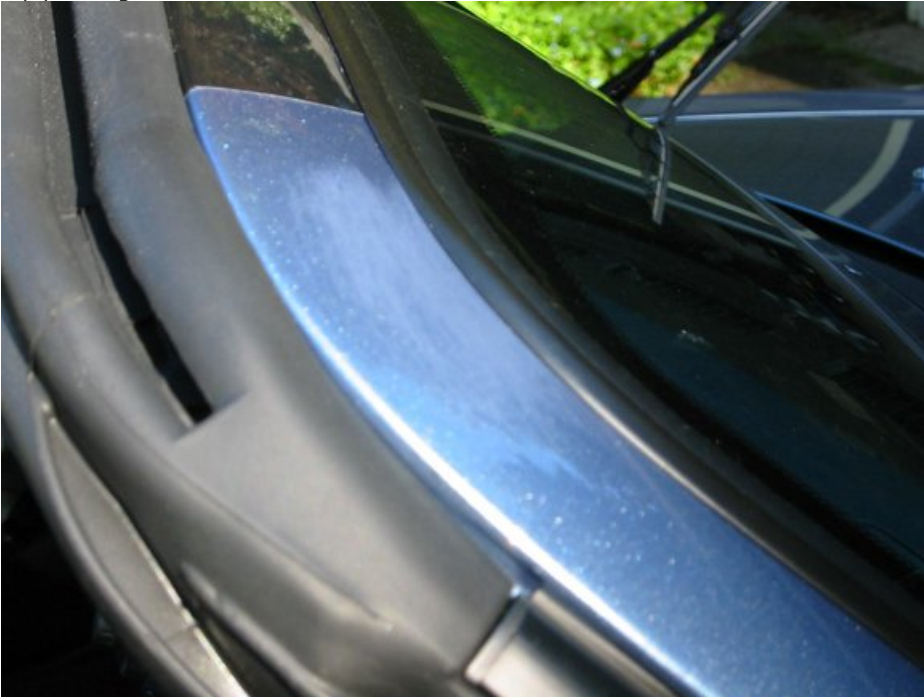
top passenger corner scuff...

This last photo shows you the bad spot, and also shows you the tape seam where the passenger side tape ends.

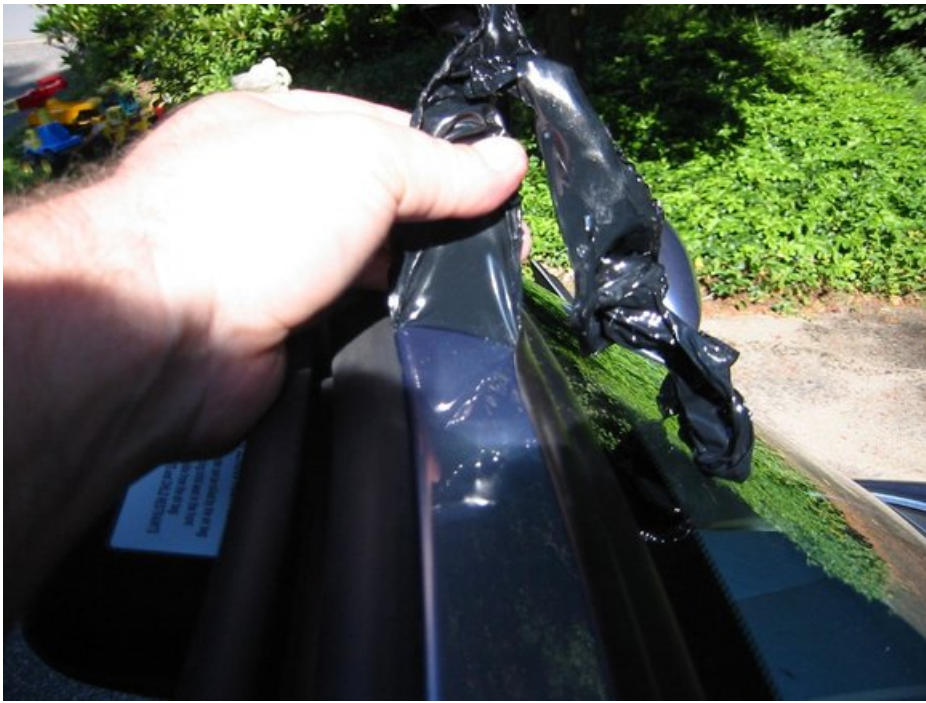
top peel...

Next, I used my thumbnail to pry up the top tape seam and just continue along. because the top tape is tucked under the top of the driver side tape, this was just one long pull (a little at a time, that is). Here are the final pix.

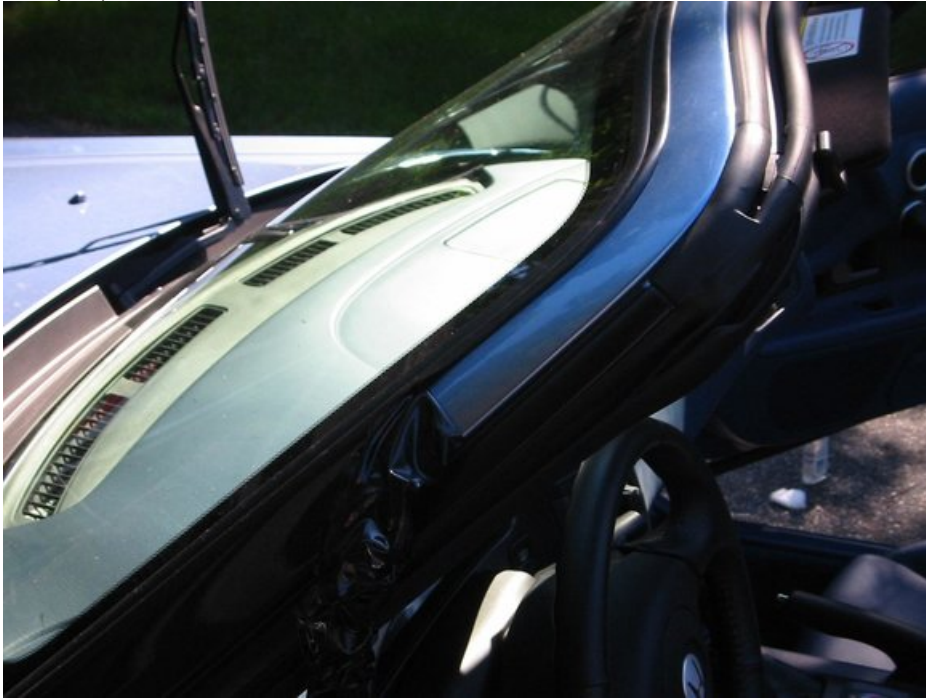
final peel, driver's side
